ESCAMBIA COUNTY ADA Study of County Facilities and Parks

**FINAL REPORT
2/24/16**

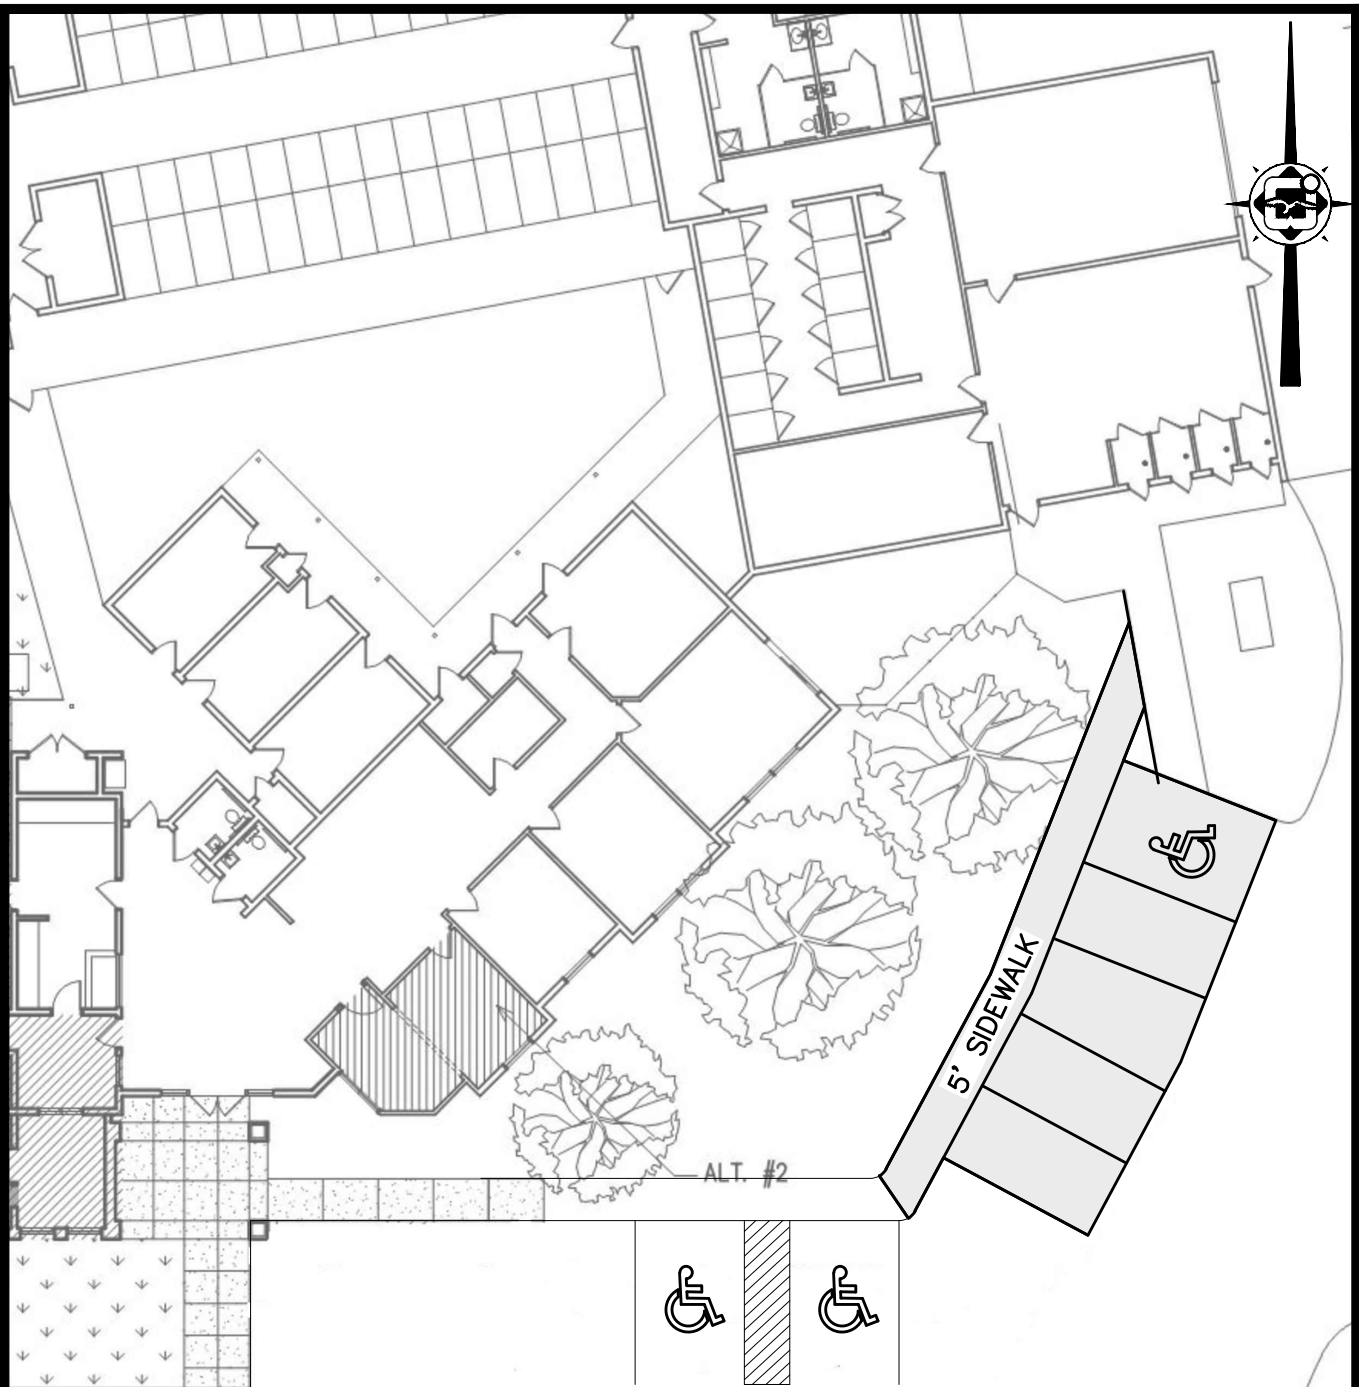
Priority 1 Parking and Sidewalks	Compliance	Notes/Dimensions	Recommended Improvement	Opinion of Cost
Parking				
No handicapped parking at Animal Dropoff Entrance	N	No handicapped space at this location	Construct one (1) new handicapped parking space in existing lot	\$2,700
Sidewalk				
Existing sidewalk does not match new space	N		Construct new section of sidewalk to meet code	\$1,500

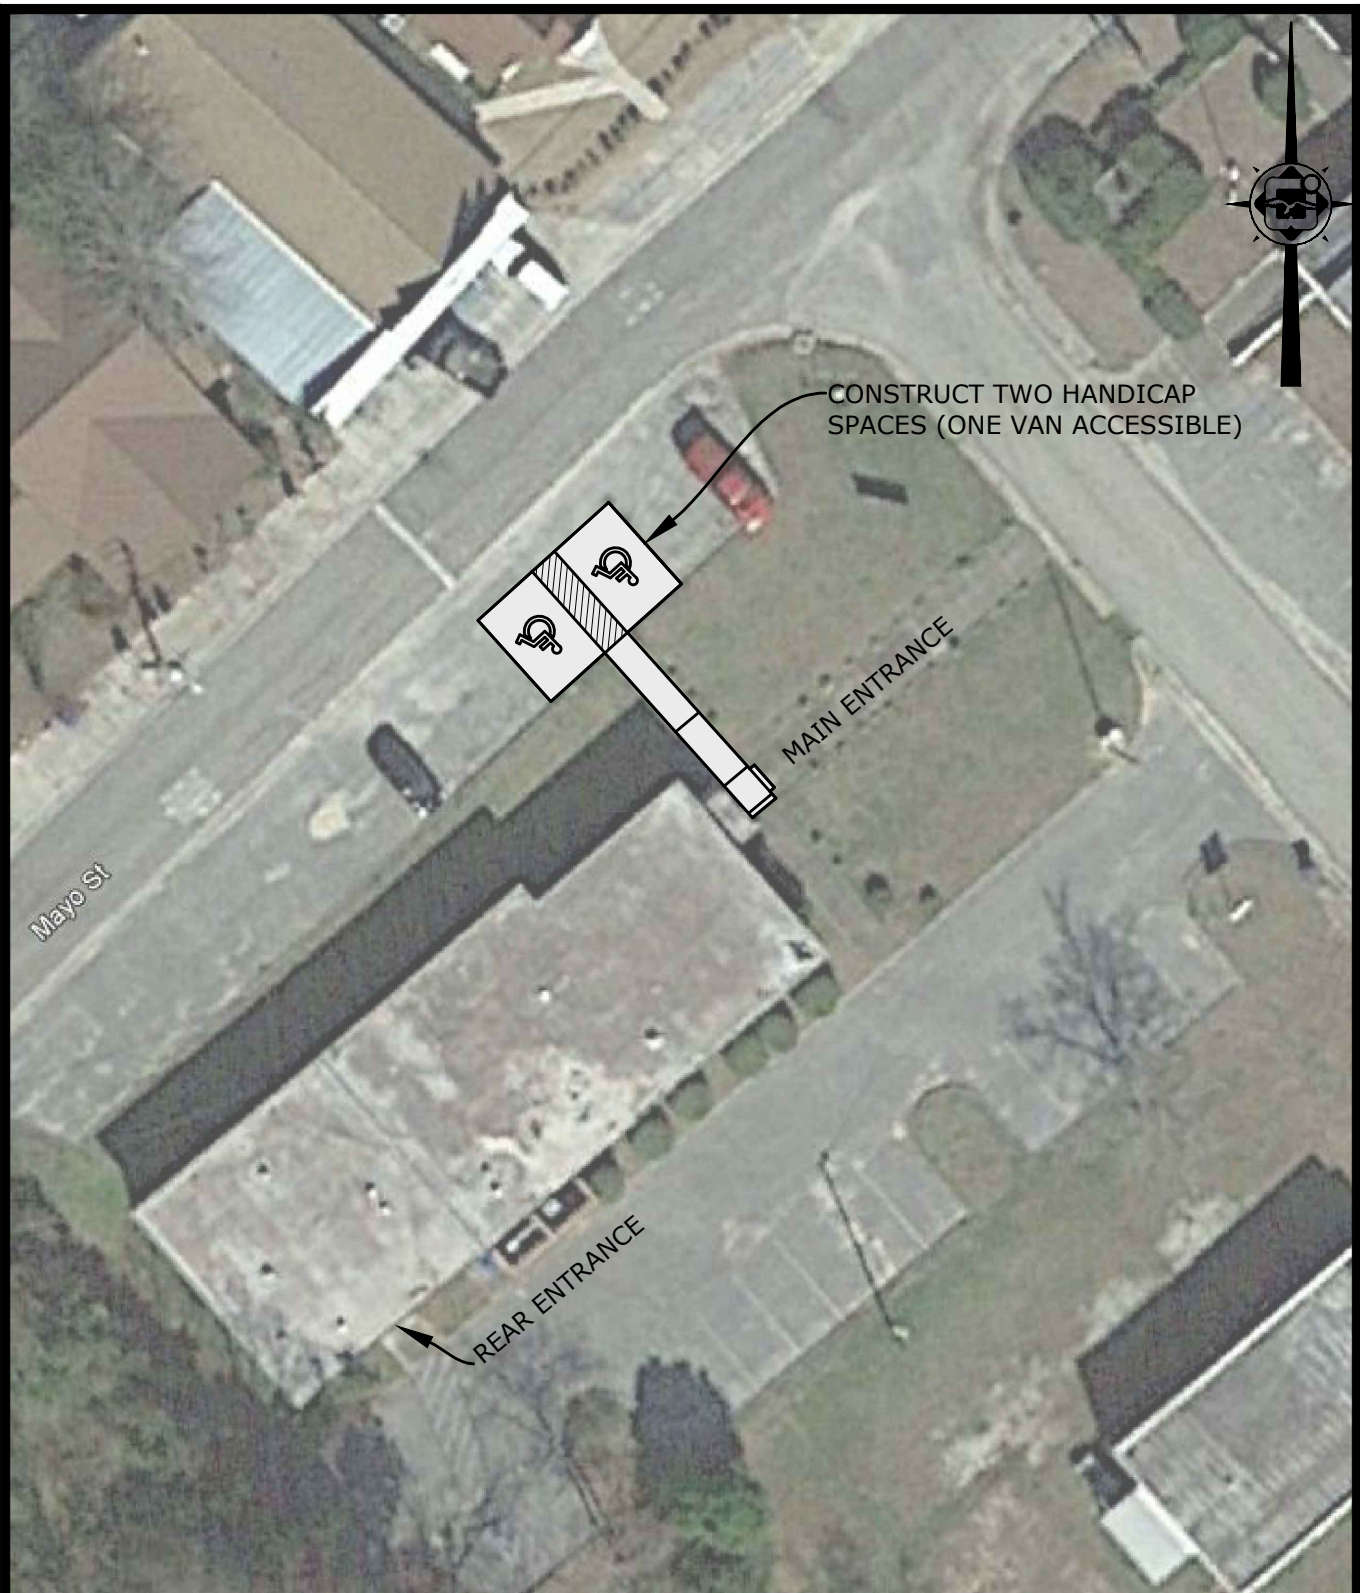
Priority 1 Parking and Sidewalks	Compliance	Notes/Dimensions	Recommended Improvement	Opinion of Cost
Parking				
Parking at Entrance - No handicapped parking at main entrance	N	Existing handicapped parking is at rear of building for entrance in back door	Construct two (2) new handicapped parking spaces in existing lot	\$5,400
Sidewalk				
No existing handicapped access to front door	N	Steps to door	Construct new section of sidewalk and ramp to meet code	\$1,200

CONSTRUCT TWO HANDICAP SPACES (ONE VAN ACCESSIBLE)

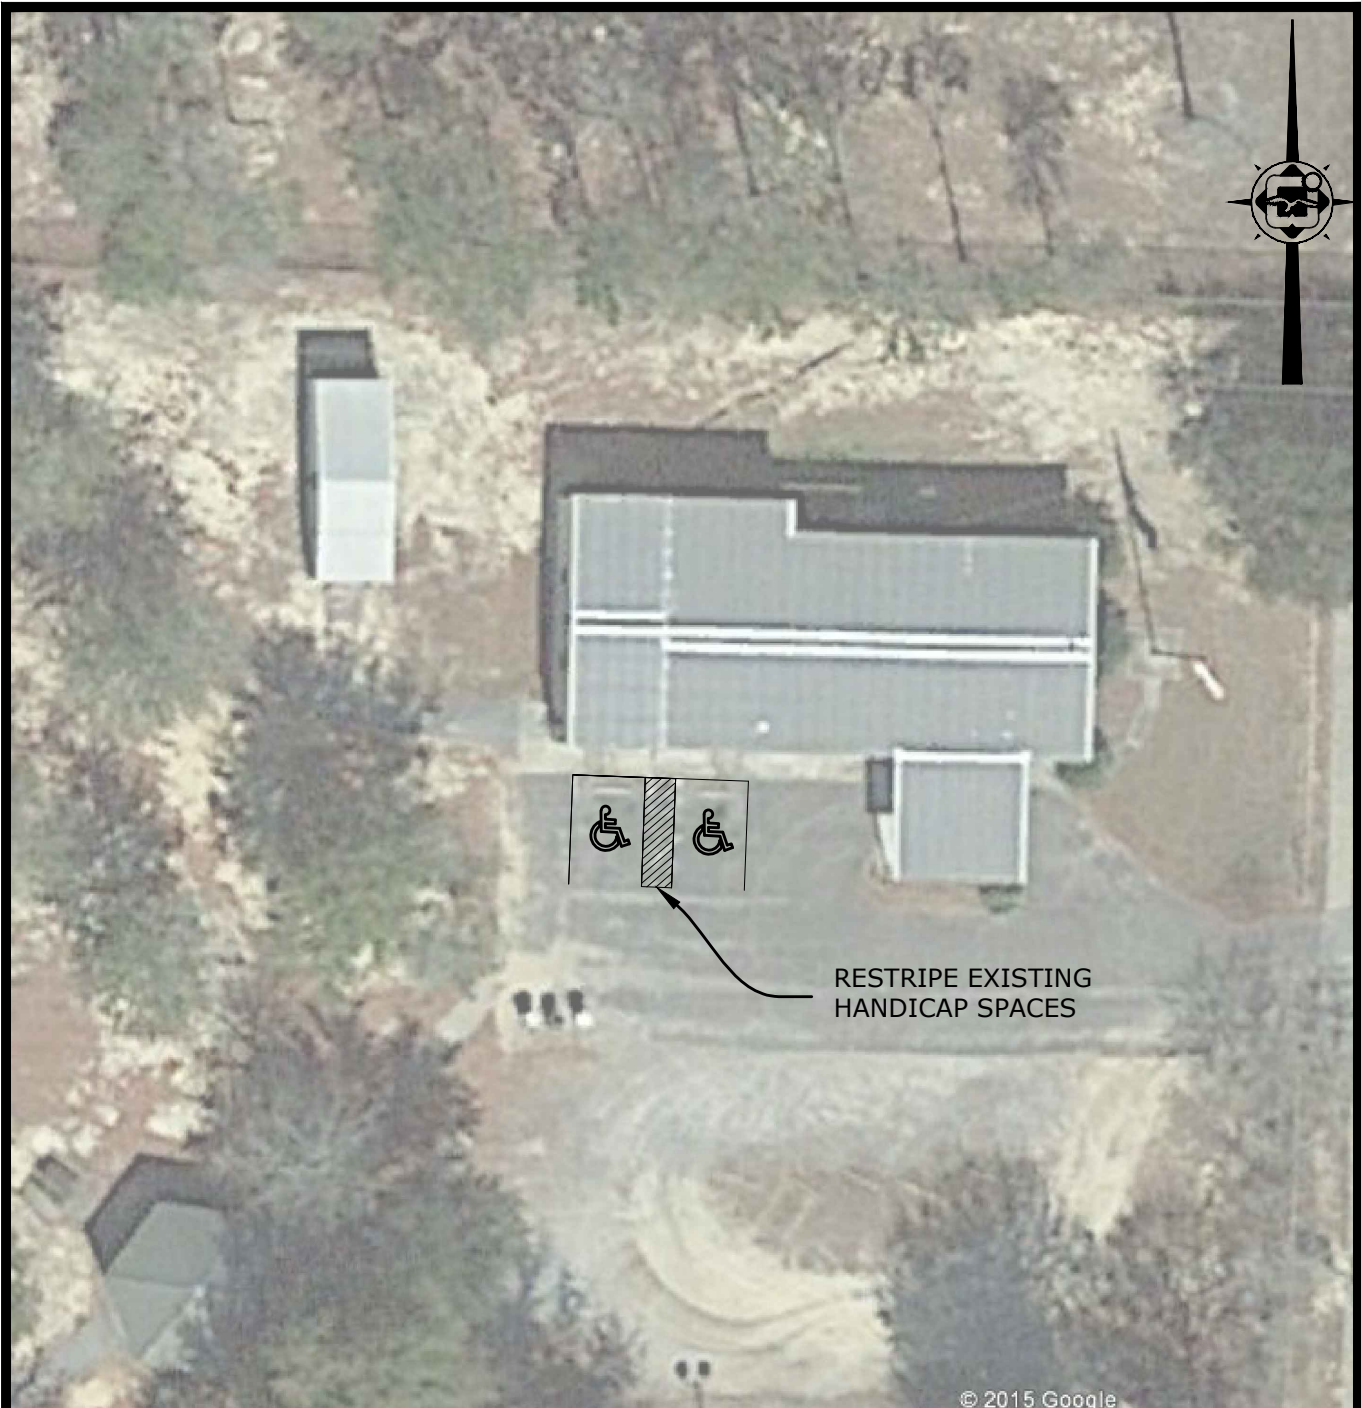
Priority 1 Parking and Sidewalks	Compliance	Notes/Dimensions	Recommended Improvement	Opinion of Cost
Parking				
Parking at Entrance - Existing parking is adequate	Y	Paint on spaces has faded	Repaint existing handicapped spaces	\$400

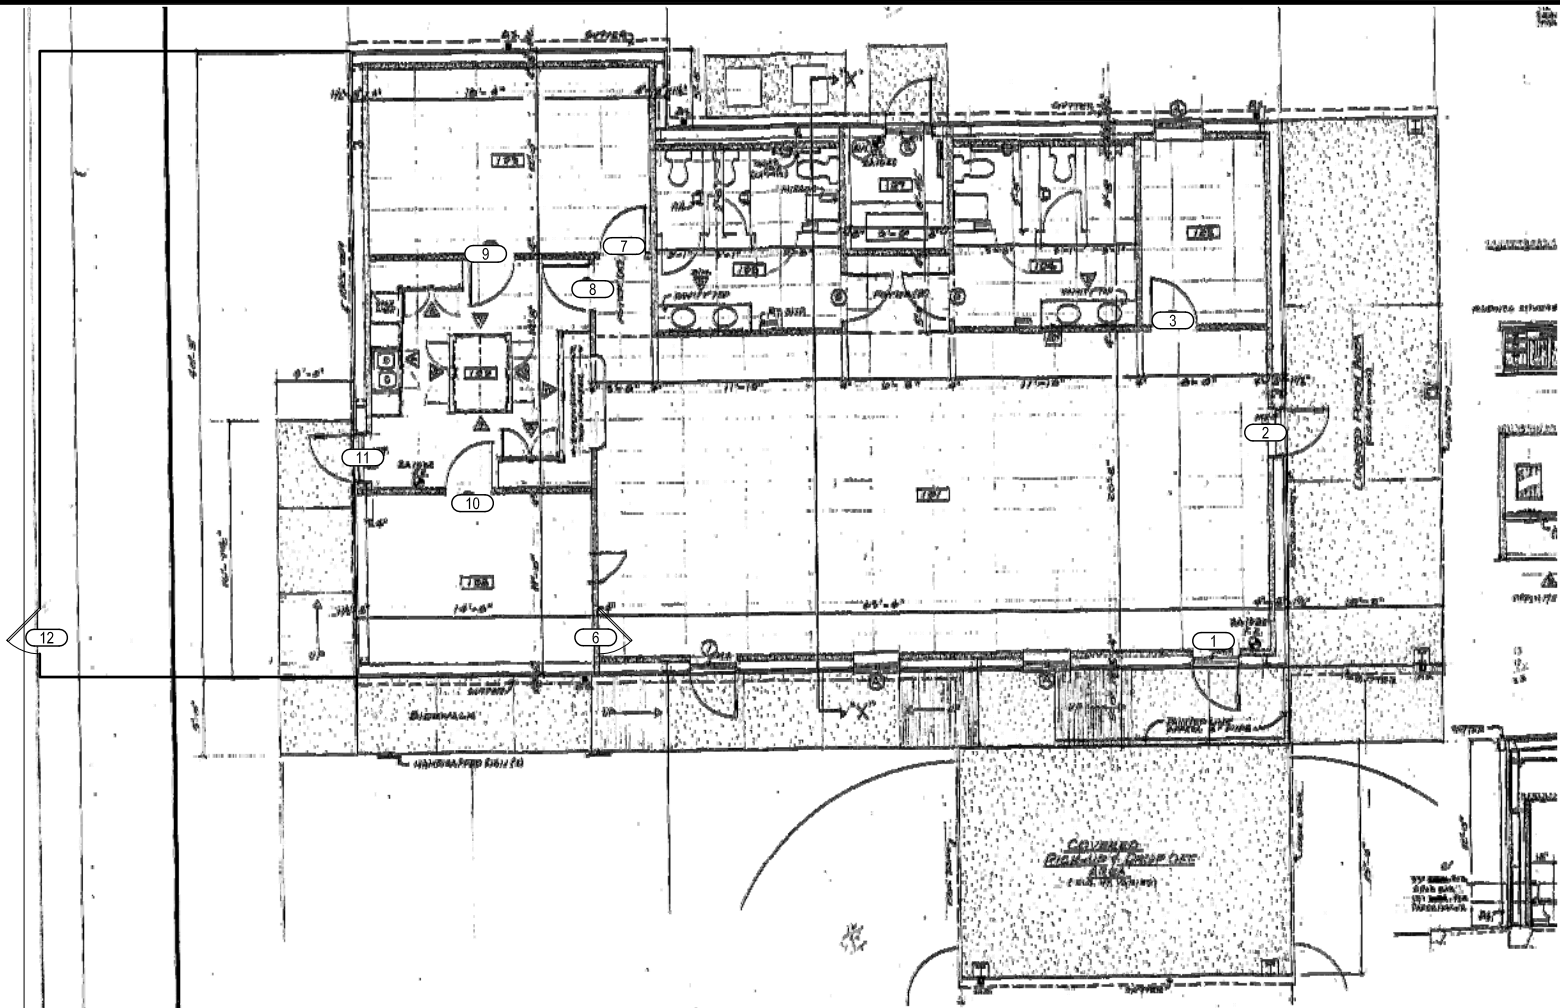
FLOOR PLAN

Main Entrance and Building	Compliance	Notes/Dimensions	Recommended Improvement	Opinion of Cost
Do all inaccessible entrances have signs indicating the location of the nearest accessible entrance?	N		Provide Signs for accessible entrances and directing visitors to accessible entrances.	\$200
If not all entrances are accessible, is there a sign at the accessible entrance with the International Symbol of Accessibility?	N			See above.
On both sides of the door, is the ground or floor surface of the maneuvering clearance level (no steeper than 1:48)?	N	See Fabre		
If the door has a closer, does it take at least 5 seconds to close from an open position of 90 degrees to a position of 12 degrees from the latch?	N	2 sec.	Adjust Closer	\$30
Are all public spaces on at least one accessible route?	N	Kitchen appliances restrict route, and counter heights are not accessible.	Redesign Kitchen. Provide ADA compliant clearances and counter height.	\$34,000

Interior Doors				
Is the door equipped with hardware that is operable with one hand and does not require tight grasping, pinching and twisting of the wrist?	Varies	Door 8 is missing hardware, door 11 has a knob	Replace door hardware with levers as needed.	\$500
Can the door be opened easily 2.26796 kg (5 pounds) maximum force?	Varies	Doors 11 requires too much force.	Adjust closers.	\$30
If the door has a closer, does it take at least 5 seconds to close from an open position of 90 degrees to a position of 12 degrees from the latch?	Varies	Door 11 closes too quickly	Adjust closers.	See above.

Compliance	Notes/Dimensions	Recommended Improvement	Opinion of Cost
Women Toilet Room	N	Note: The toilet location is 1' off from the required distance and the lavatory would have to be relocated to meet 1991 ADA standards.	Reconfigure restroom to comply with 2010 ADA requirements. Review with Code Official to verify if building could meet 1991 ADA Standards.	\$10,000
On the wall on the latch side of the door?	N	Mounted on door	Reinstall sign on latch side of door at ADA compliant height.	\$30
Can the door be opened easily 2.26796 kg (5 pounds) maximum force?	N	10 lb.	Adjust closer	\$30
If the door has a closer, does it take at least 5 seconds to close from an open position of 90 degrees to a position of 12 degrees from the latch?	N	3 sec	Adjust closer	See above.
Is there at least 685.8 mm (27 inches) clearance from the floor to the bottom of the lavatory that extends at least 203.2 mm (8 inches) under the lavatory for knee clearance?	N	25"	Reinstall lavatory at correct height.	\$500

Compliance	Notes/Dimensions	Recommended Improvement	Opinion of Cost
MEN'S Toilet Room		The lavatory would have to be relocated to meet 1991 ADA standards. The stall is too narrow to meet 2010 ADA standards.	Reconfigure restroom to comply with 2010 ADA requirements. Review with Code Official to verify if building could meet 1991 ADA Standards.	\$10,000
On the wall on the latch side of the door?	N	Mounted on the door	Reinstall sign on latch side of door at ADA compliant height.	\$30
Can the door be opened easily 2.26796 kg (5 pounds) maximum force?	N	12 lb.	Adjust closer	\$30
If the door has a closer, does it take at least 5 seconds to close from an open position of 90 degrees to a position of 12 degrees from the latch?	N	3 sec	Adjust closer	See above.
Is there at least 685.8 mm (27 inches) clearance from the floor to the bottom of the lavatory that extends at least 203.2 mm (8 inches) under the lavatory for knee clearance?	N	25.5"	Reinstall lavatory at correct height.	\$500

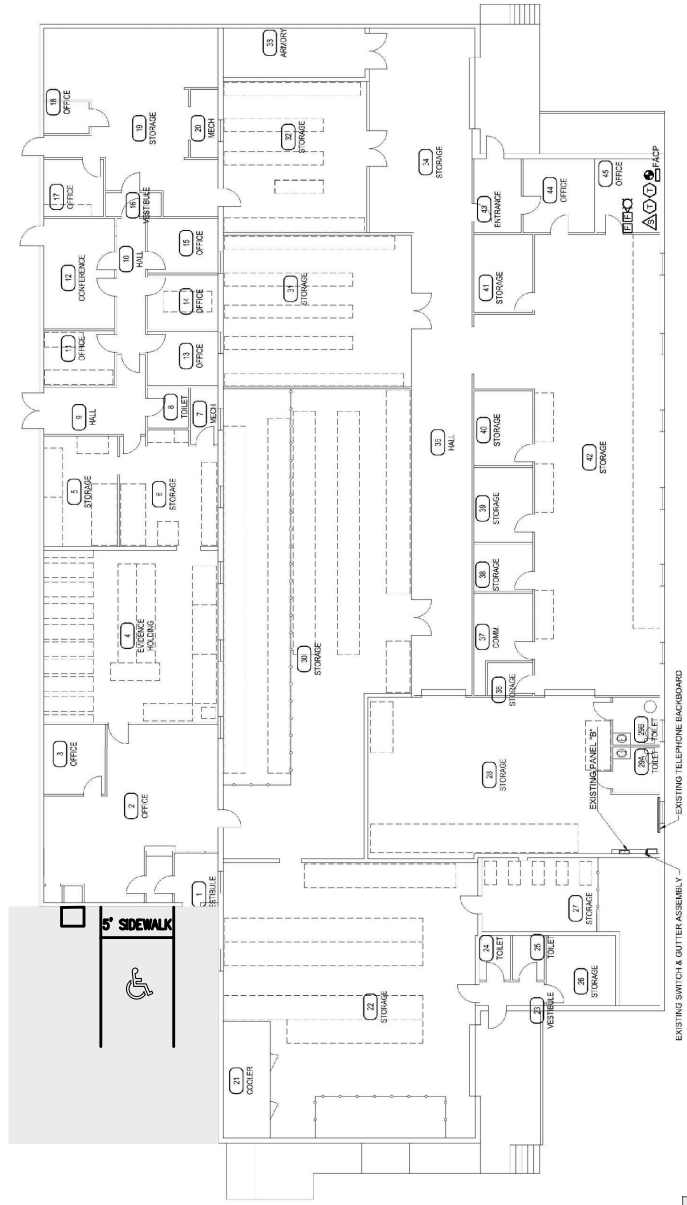
Priority 1 Parking and Sidewalks	Compliance	Notes/Dimensions	Recommended Improvement	Opinion of Cost
Parking				
No existing handicapped parking at main entrance	N	Additional concrete parking area will need to be removed and replaced to regrade area	Construct one (1) new handicapped parking space in existing lot and new sidewalk to main entrance	10,000

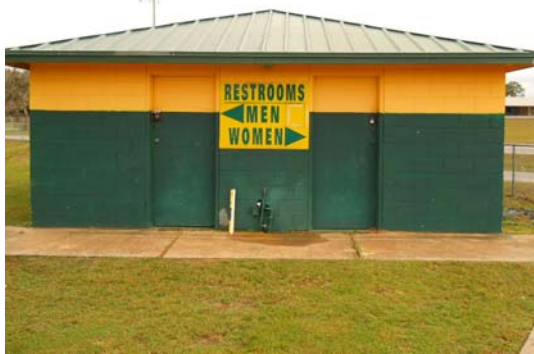
Building 1 Restrooms

Building 1 Restrooms- Women's restroom sink and toilet are installed ½-1" off 1991 ADA Standards. This condition should be reviewed with building official. Rooms are not large enough to meet 2010 ADA standards without removing existing CMU walls. Other minor corrections are required to meet ADA standards.

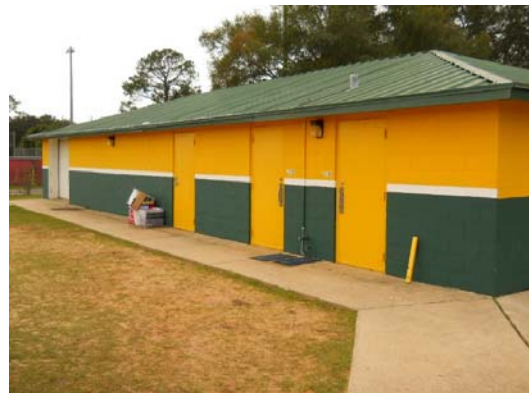
Building 2 Restrooms

Building 2 Restrooms- Minor corrections in restrooms need to be addressed to meet 1991 ADA Standards.

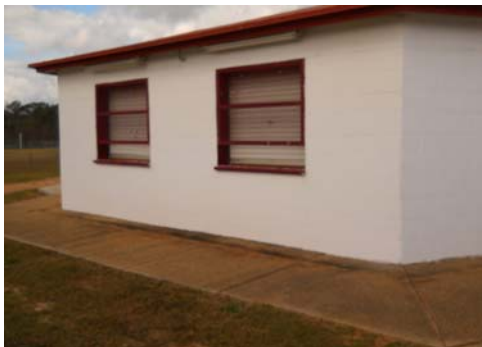
Building 4 Restrooms & Concession

Building 4 Concessions & Restrooms- Accessible toilet room partitions do not meet 1991 ADA Standards. Door layout and toilet location will need to be reconfigured and will be required to meet 2010 ADA Standards. Accessible stall is large enough to meet these requirements.

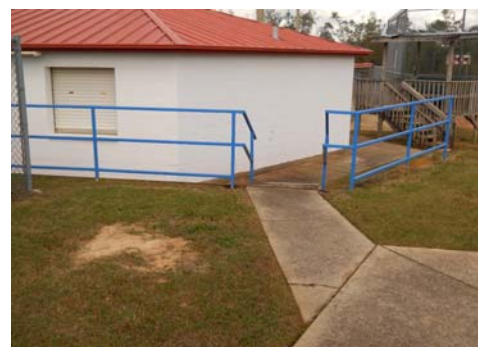
Building 5 Restrooms & Concession

Building 5 Concessions & Restrooms- Accessible toilet room partitions do not meet 1991 ADA Standards. Door layout and toilet location will need to be reconfigured and will be required to meet 2010 ADA Standards. Accessible stall is large enough to meet these requirements.

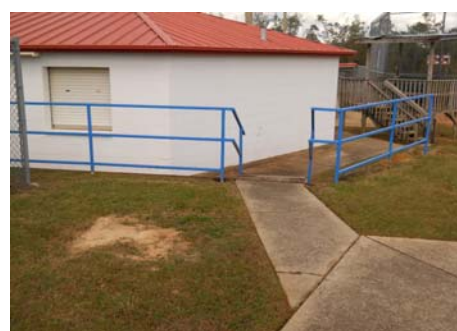
Building 6 Restrooms & Concession

Building 6 Concessions & Restrooms- Accessible toilet room partitions do not meet 1991 ADA Standards. Door layout and toilet location will need to be reconfigured and will be required to meet 2010 ADA. Accessible stall is large enough to meet these requirements.

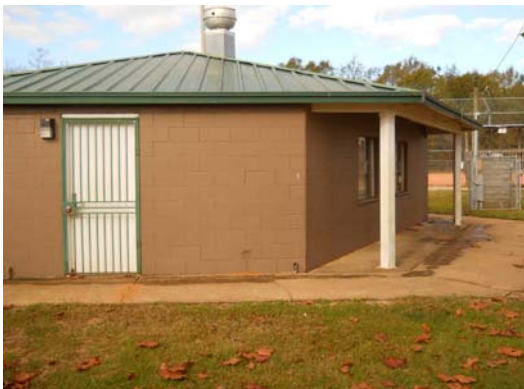
Building 3 Restrooms & Concession

Building 3 Concessions & Restrooms- Accessible toilet room partitions do not meet 1991 ADA Standards. Door layout and toilet location will need to be reconfigured and will be required to meet 2010 ADA. Accessible stall is large enough to meet these requirements.

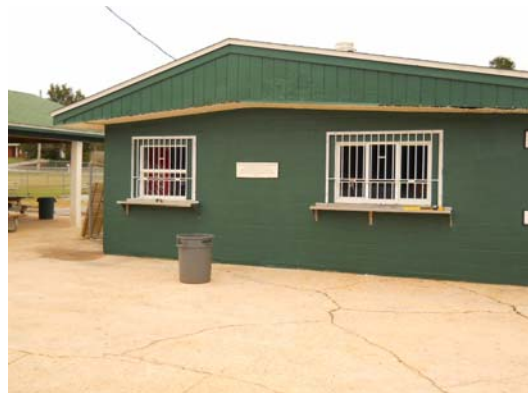
Building 5 Concession

Building 5 Concessions- Concession counter height is not in accordance with ADA standards. One counter and window should be reconfigured to meet ADA standards.
