# **Preliminary Engineering Assessment (PEA)**

## **Pensacola Beach Gulf Pier**

Escambia County, FL

April 5, 2021

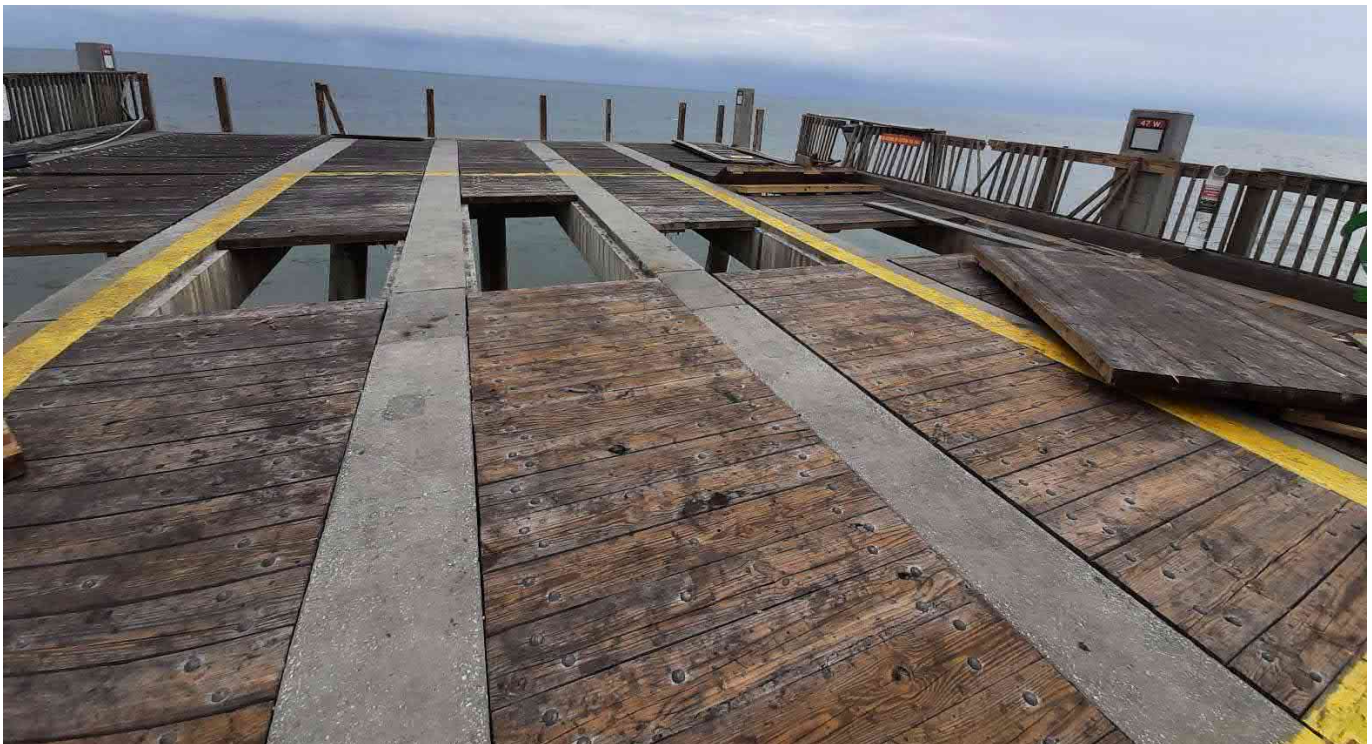
Hurricane Sally had a significant storm surge and the hydraulic forces from wave action dislodged multiple timber deck blowout panels. Panels are often subject to the highest uplift forces in locations where waves impact piles and pile caps. The hurricane wave action damaged the timber deck through direct impact, impact between items as panels were moved, and by shifting the panels that were not completely dislodged but allowed to move laterally after adjacent panels are blown out. The existing timber deck members also show signs of deterioration that are not related to the hurricane, but the opinion of probable repair costs does not include repairs for this deterioration. Figures 2 through 4 show the dislodged timber deck blowout panels adjacent to bents following the hurricane.

*Figure 2 – Timber Deck Blowout Panels adjacent to Bent 47.*

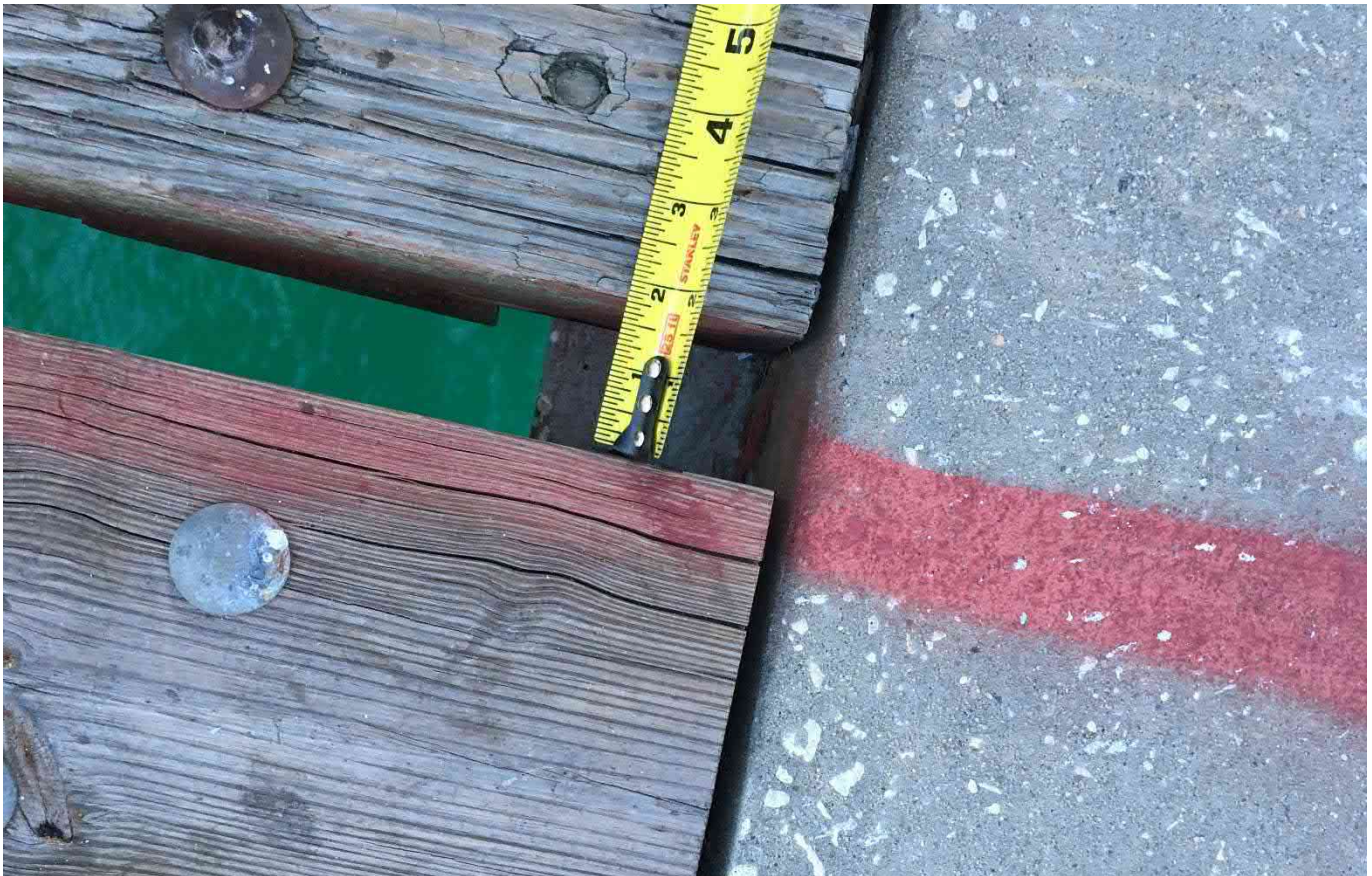
Without additional repairs, replacing blown out panels following a hurricane will not restore the deck to its pre-storm condition. Damaged or warped timbers result in a deck condition with gaps and dips that exceed the Americans with Disabilities Act Guidelines (ADA). ADA Section 302.3 limits the openings between deck members or timber gaps to 0.5" maximum. ADA Section 303.3 requires that changes in level between 0.25" and 0.5" high be beveled with a slope not steeper than 1:2. ADA Section 303.4 requires that changes in level greater than 0.5" high be ramped. Replacement of blown out panels requires replacement of any warped or damaged timbers, repairing concrete spalls, adjusting the spacing of all panels in the span and beveling edges to produce a deck surface that meets ADA Section 303 guidelines. Figures 5 and 6 show typical gaps and dips between blowout panels that exceed 0.5" and do not meet ADA guidelines.

Figure 6 – Timber Deck Blowout Panel Gap > 0.5"

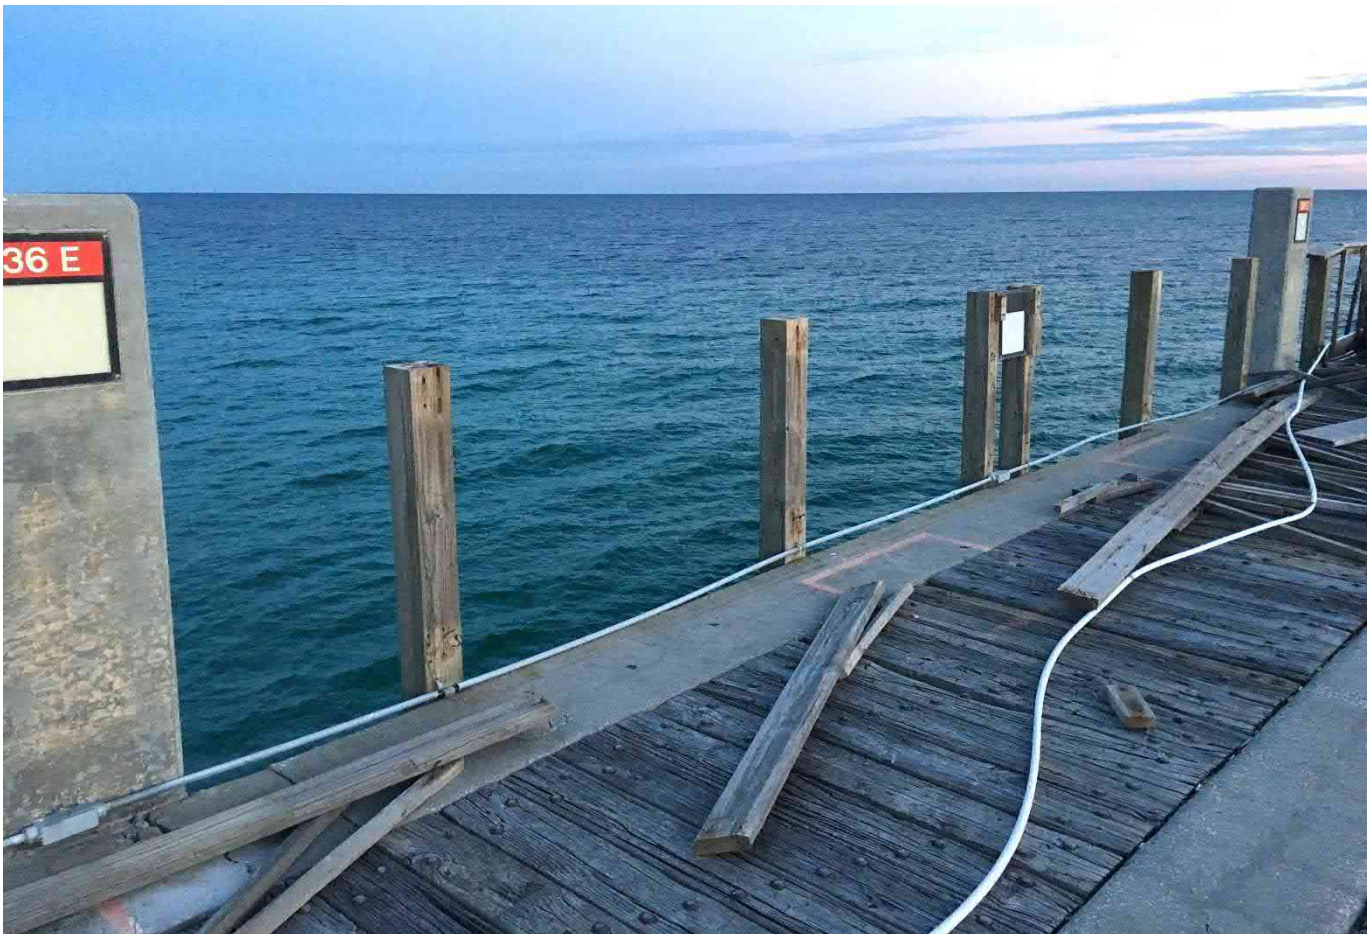
Wind and waves from Hurricane Sally severely damaged the pedestrian railing along the full length of the pier. Figure 7 shows a typical section of railing which has been completely blown out with only the posts remaining. Remaining posts have been loosened and the timber surface has been damaged where attachments have been ripped away. Also shown in Figure 7 is the damage to a water line and the pier lighting system which included railing lights at mid-span. Where sections of railing remain standing as shown in Figure 8, the railing is loose with timber members damaged and splitting. Typical damaged timber members are shown more closely in Figure 9 where the wood has split. These damaged members cannot be brought back to a condition that meets the building code strength requirements without using epoxy repairs which exceed the cost of the timber. Because it is not economically feasible to salvage the remaining pedestrian railing, the entire railing must be replaced to restore the structure to its pre-storm condition. Replacement of the railing will also require replacement of the attached utilities including electrical, lighting, and water as well as the signage located along the full length of the pier. A damaged viewing telescope was also attached to the railing. The flagpole located at Bent 46 was broken during the storm as shown in Figure 10. The storm also destroyed the entrance gate at Bent 7. Refer to the Photo Log in Appendix A for full documentation of the damage.

*Figure 7 – Pedestrian Railing Destroyed Typical Spans*

1. Replace all pedestrian railing. The new railing should meet ADAAG guidelines.
2. Replace the missing signage, fishing line receptacles, and viewing telescope attached to railing.
3. Replace the electrical wiring and all pier lights with equivalent turtle friendly led fixtures.
4. Replace the water line.
5. Replace the damaged timber deck sections and adjust the blowout panel spacing to meet gap and dip limits of the ADA Section 303 guidelines.
6. Repair and attach the damaged benches.
7. Replace the flagpole.
8. Replace the entrance gate.
9. Repair concrete spall damage and seal concrete cracks in accordance with current FDOT Specifications for Road and Bridge Construction.

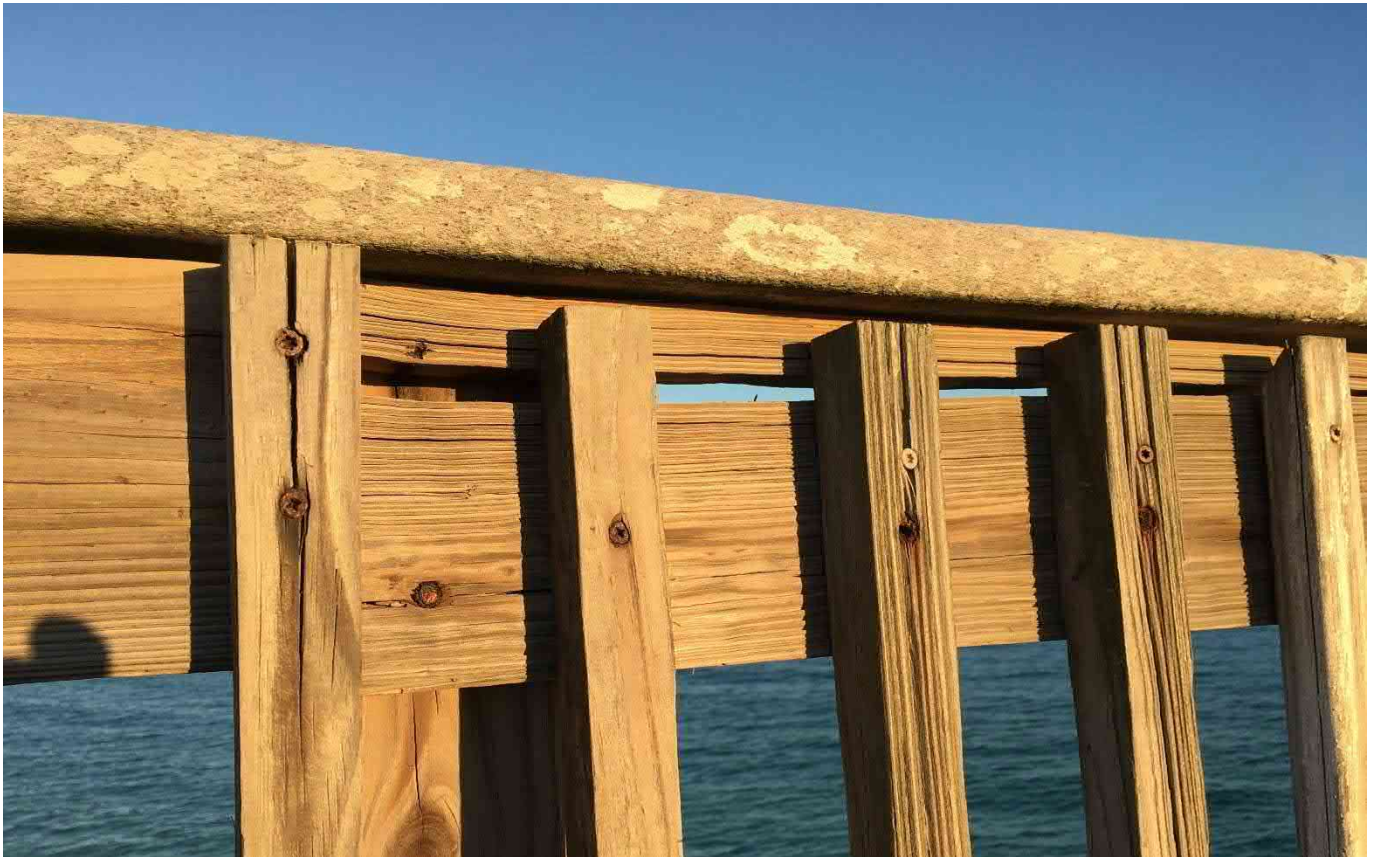
*Figure 9 – Pedestrian Railing Loose and Split Timber Members*

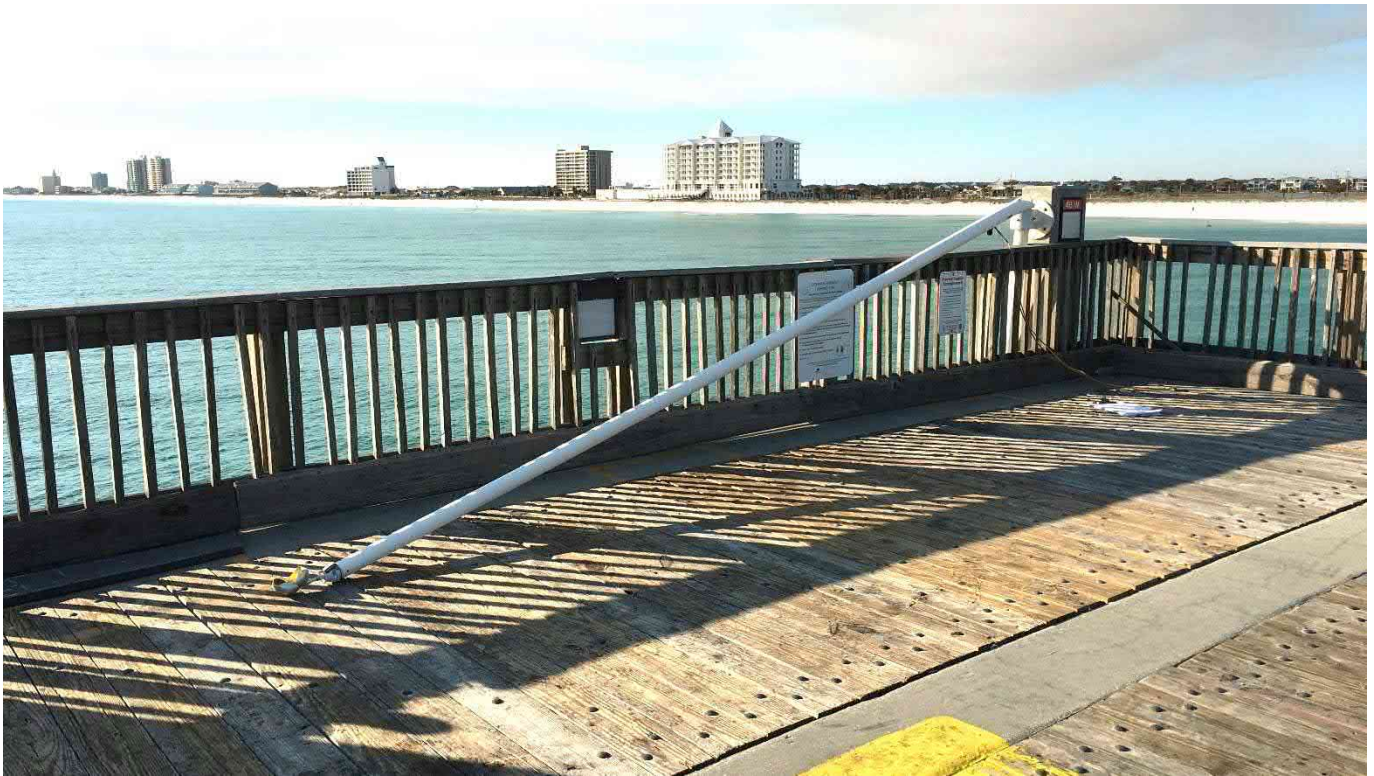
*Figure 10 – Broken Flagpole*

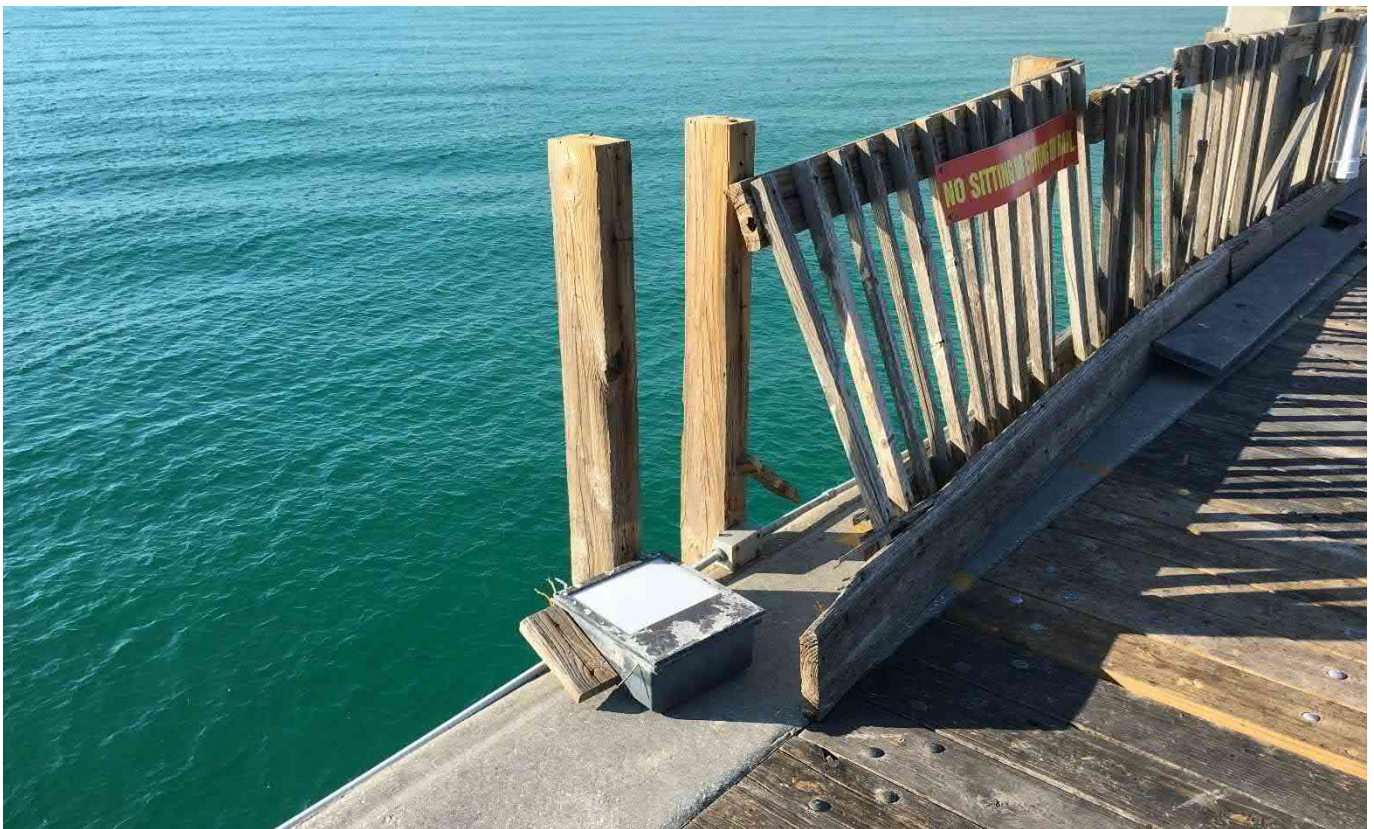
*Figure 11 – Damaged Light Fixture*

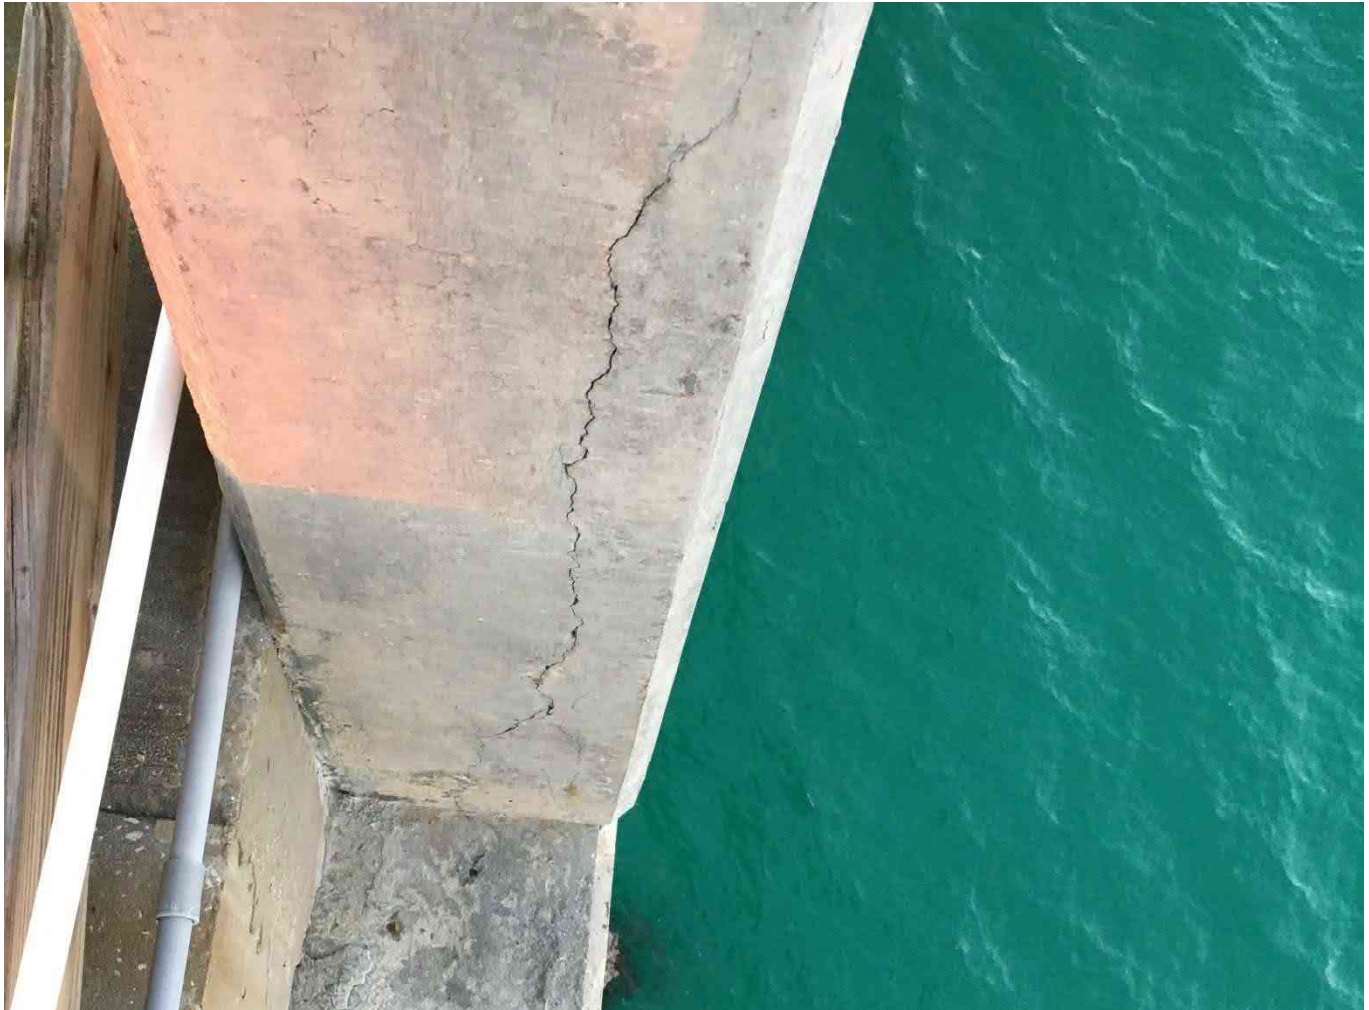
Hurricane Sally likely damaged concrete members through direct water forces, debris impacts, and the movement of the pier under lateral loads. Lateral loading has cracked several light columns as shown in Figure 12 and the cracks must be sealed to prevent continued deterioration.

*Figure 12 – Typical Light Column Cracking*

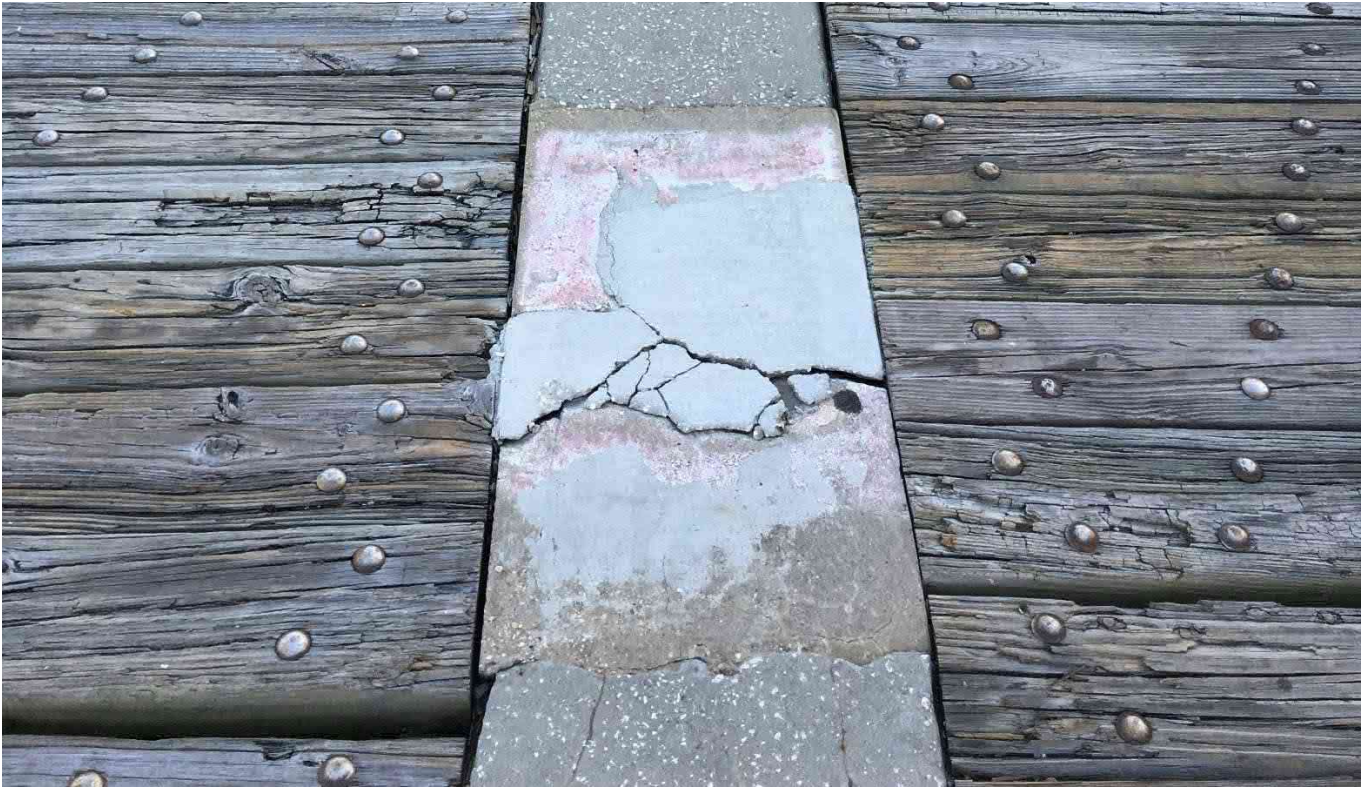
Wave loading produced longitudinal loads which are transmitted along the full length of the pier. These longitudinal forces resulted in compression in the closure pours between beam ends which produced cracks and spalls in several locations. Cracks in closure pours between concrete sections which are still sound and not loose can be repaired by sealing. Large cracks with loose concrete should be treated and repaired as a concrete spall. The previously repaired closure pour shown in Figure 13 was likely cracked during the hurricane. This longitudinal loading has also caused cracking and spalls in the coped beam ends connected by the closure pours.

*Figure 13 – Typical Closure Pour Cracks and Spalls*

3. If timber is used for the railing, revise the design to replace the 2"x2" pickets with a different type of rail panel.
4. Investigate increasing reinforcement in the closure pours with repairs to enable them to transfer higher longitudinal forces without cracks or spalls.

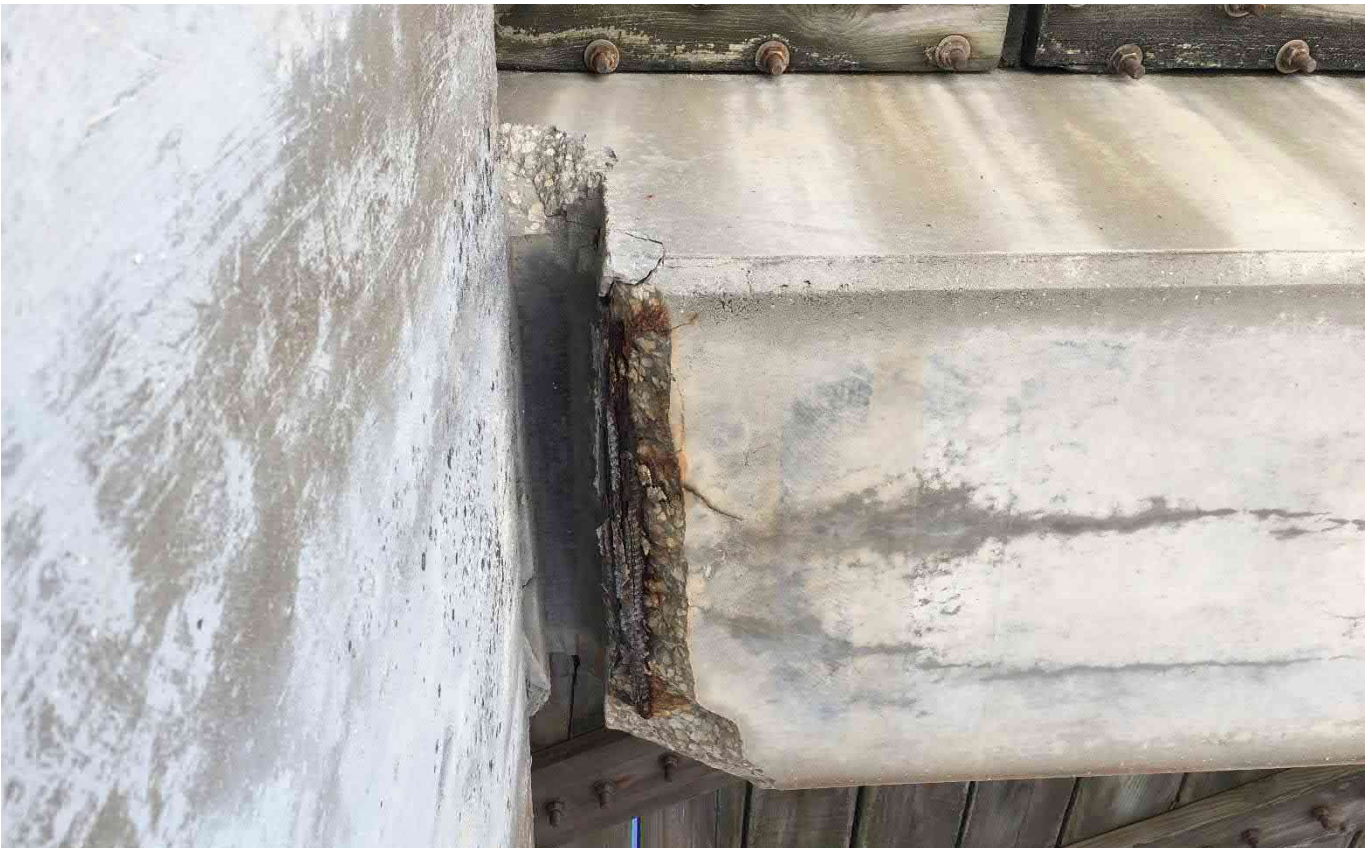
*Figure 14 – Typical Beam End Cracking and Spall*

The concrete beams have deterioration in the form of end cracking and spalls, longitudinal bottom flange cracking, and impact spalls along the top flange. Wave impact forces contribute to the beam end cracking and spalls as shown in Figure 14. Longitudinal cracking along the beam length of the beams was not greatly affected by the hurricane but is a problem that must be addressed to prevent future problems. The top flanges of several beams have spalls, as shown in Figure 15, likely from impacts with timber blowout panels during the storm event.

5. The prestressed beams show signs of longitudinal cracking along with end cracking and spalls. Repair and maintenance of these beams may require the addition of cathodic protection to prevent future premature loss of structural capacity through delamination and spalling along the length of the strands. Beam end repairs must eliminate future corrosion and be able to withstand wave impact forces.

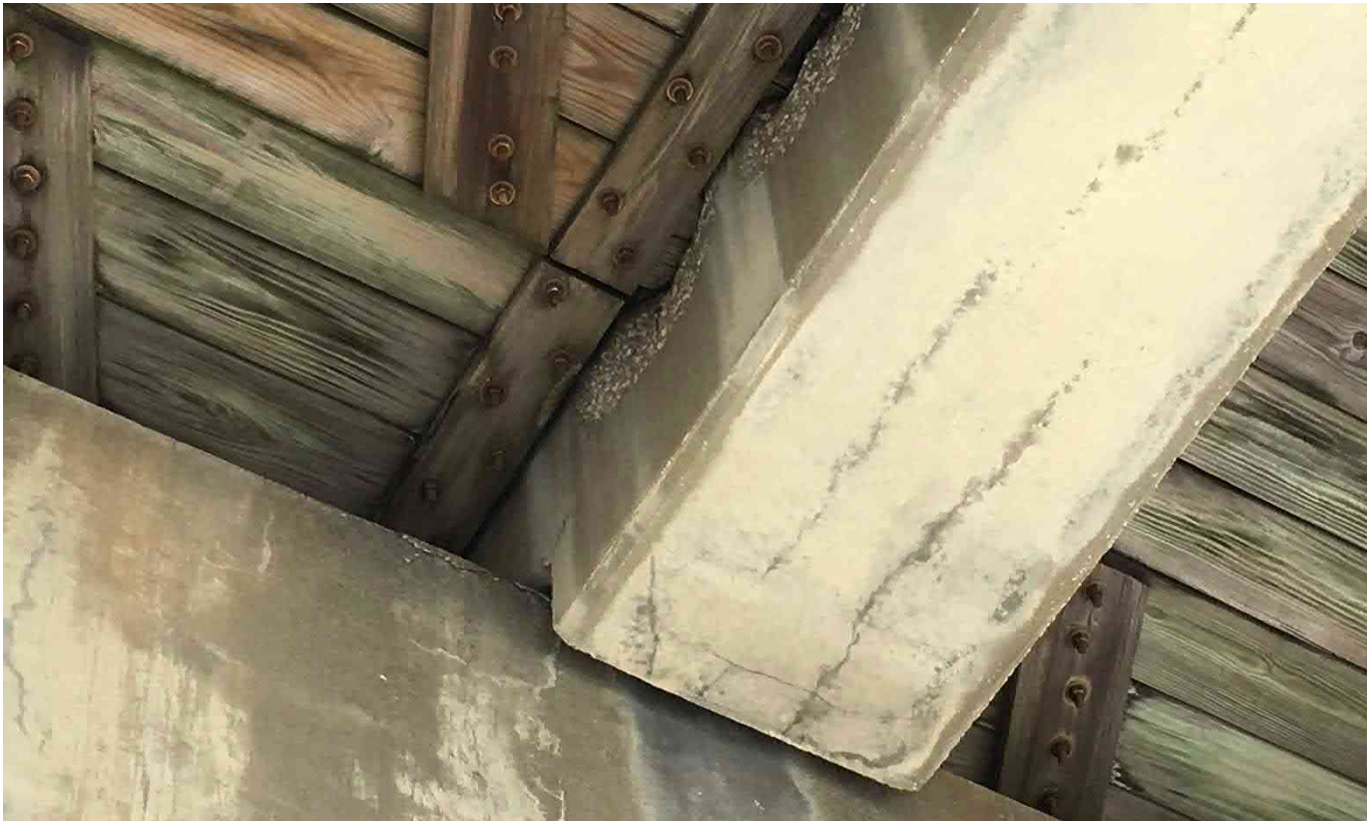
*Figure 15 – Typical Beam Top Flange Spall*

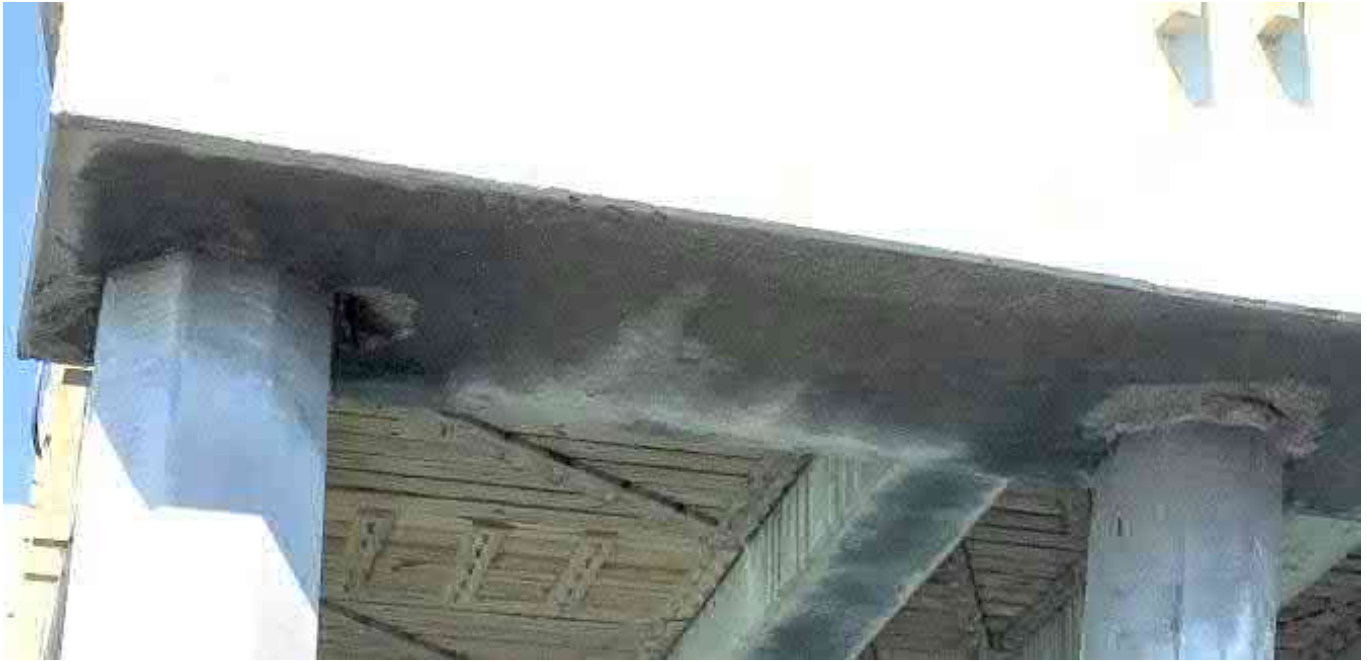
Hurricane Sally likely caused damage to the concrete pile caps in the form of spalls and cracking. Cracking could occur from the moments produced at the pile tops from wave action lateral loads. These moments can cause small cracks which extend along the pile cap face and spalls which occur at the bottom of the pile cap around the pile. Spalling around the piles due to lateral loading is shown in Figure 16. Pile caps may also be damaged by impact from floating debris during a storm event. These impacts can cause spalls such as that shown in Figure 17.

*Figure 16 – Pile Cap Spalls around Piles from Lateral Loading*

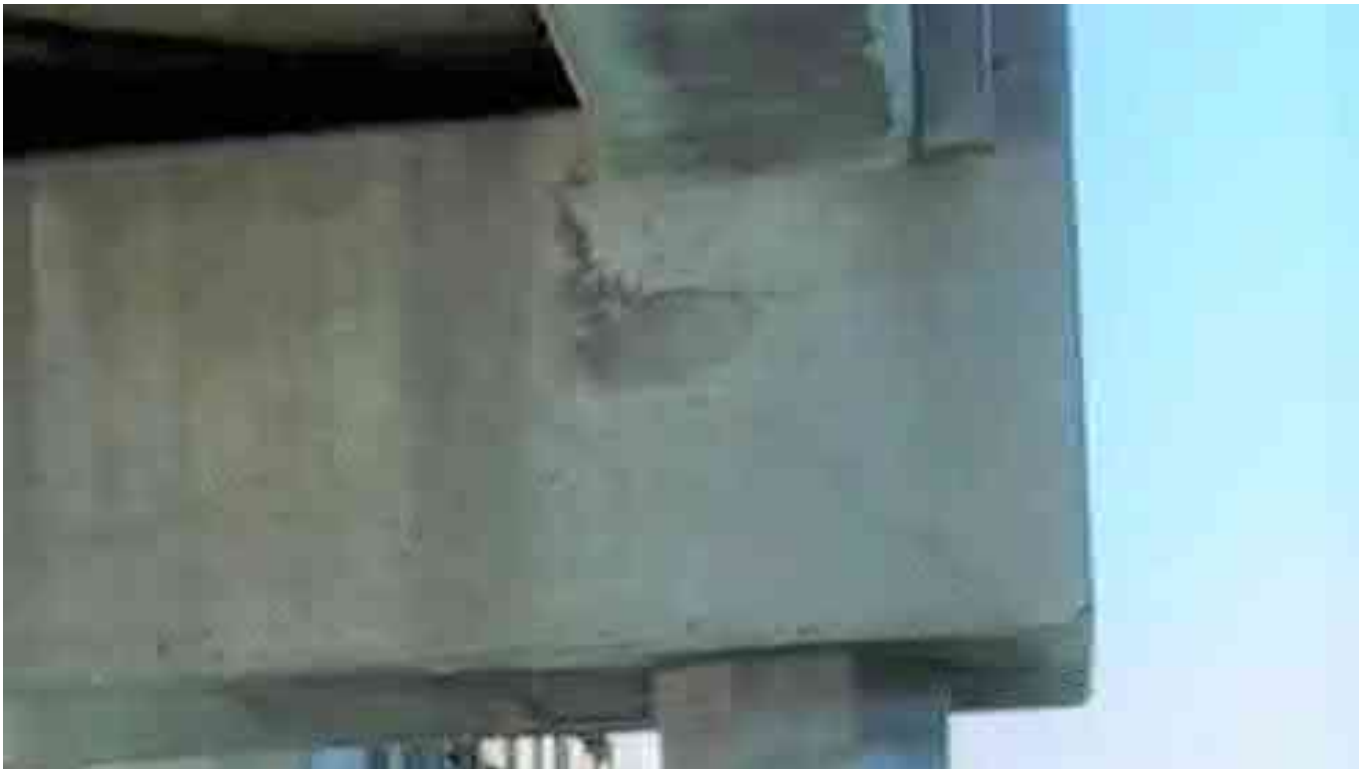
*Figure 17 – Pile Cap Spall from Impact*

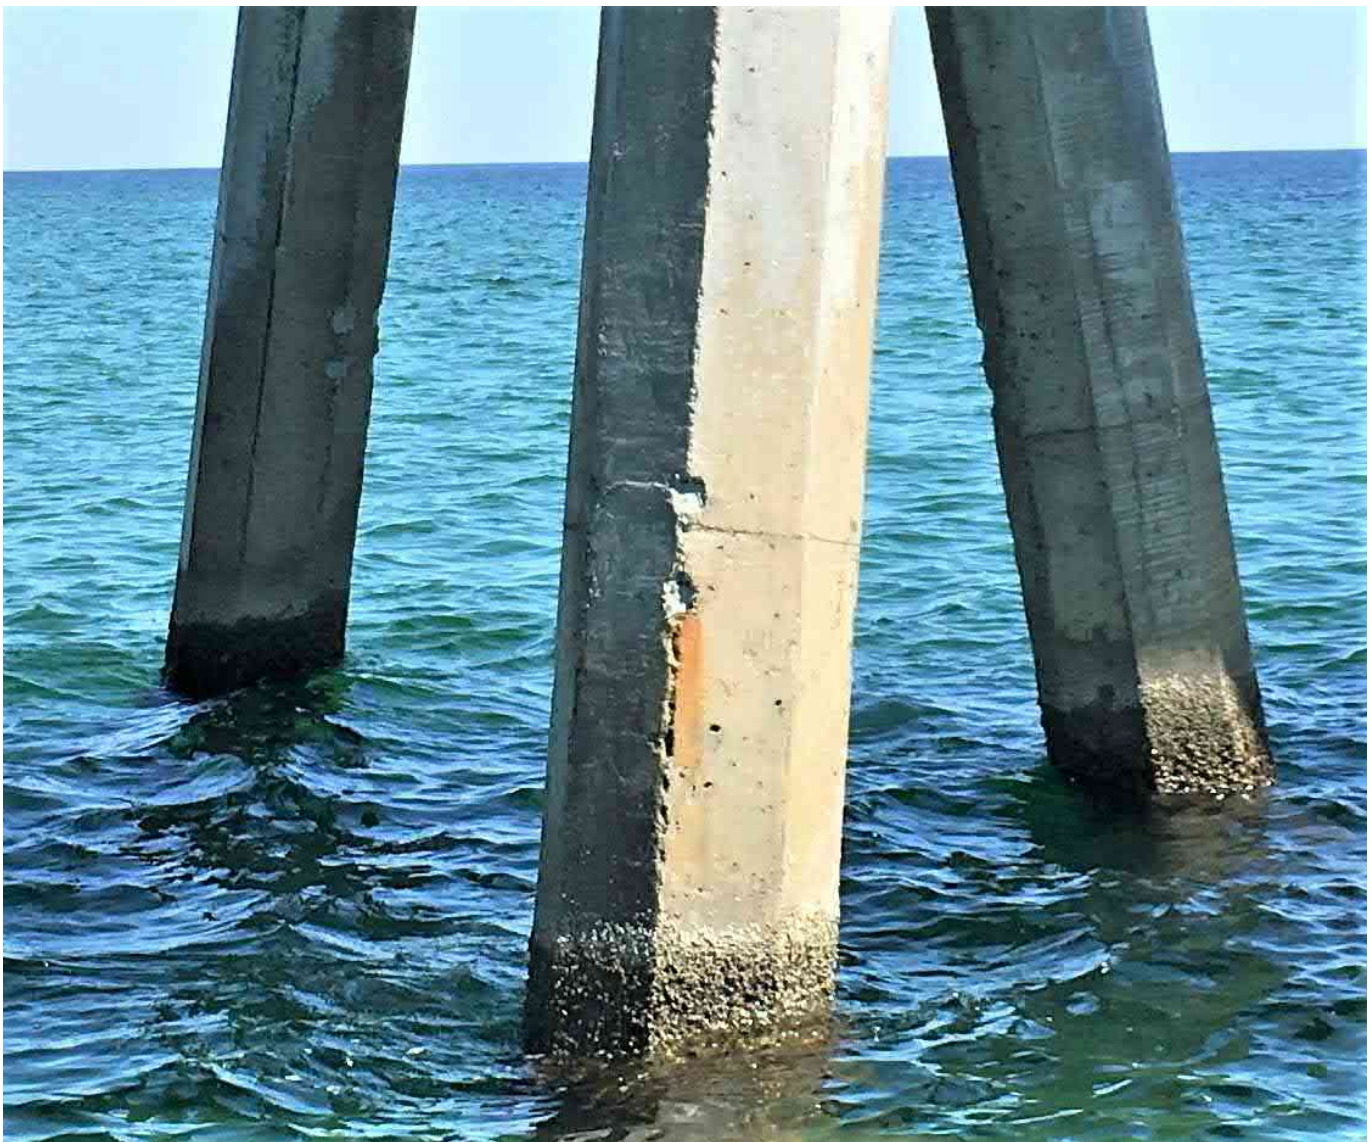
The concrete piles have also been damaged from wave action and direct impact from floating debris. The longer piles have a series of filled holes which may be part of a splicing system. The holes are indicated as spalls in this report because they represent the same type of damage that spalls present. Previous repairs to fill these spalls have been damaged from wave forces which removed portion of the fill as shown in Figure 18. These spalls must be repaired again along with the repair of new spalls to provide proper protection against corrosion. Refer to the Photo Log in Appendix A for photos of all identified damage. A list of identified concrete spall damage for the pier elements is provided in Table 2 and cracking damage is shown in Table 3.

*Figure 18 – Pile Spall Previous Repair Damage*

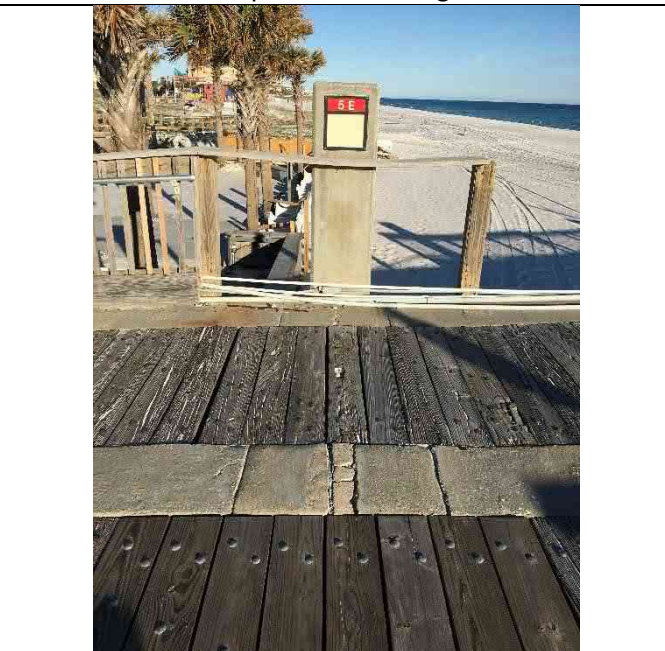
Bent 5E – Closure cracking, missing railing, loose posts

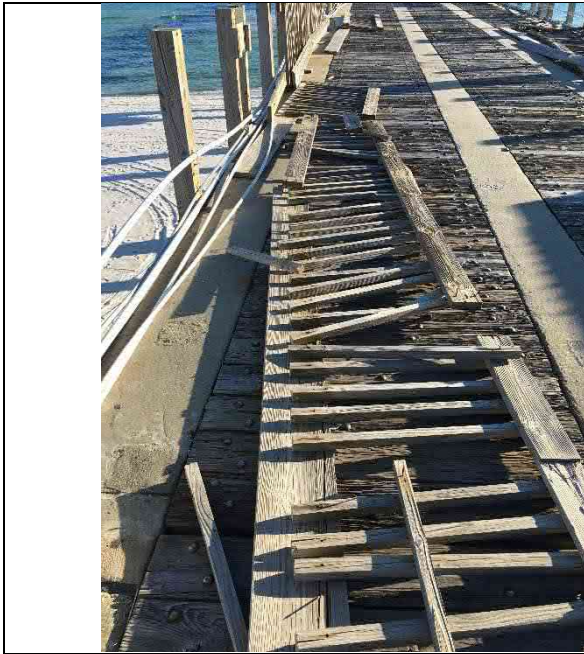
Span 8E Deck, damaged railing and utilities

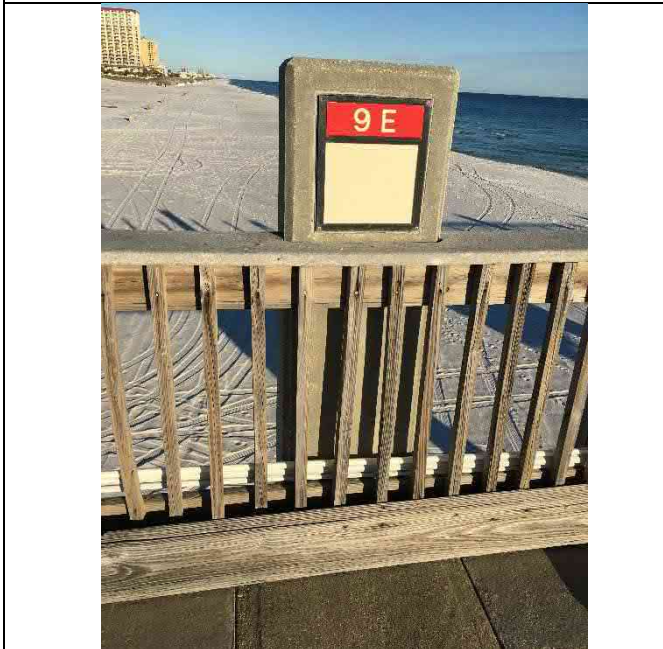
Bent 9E – Loose and damaged railing

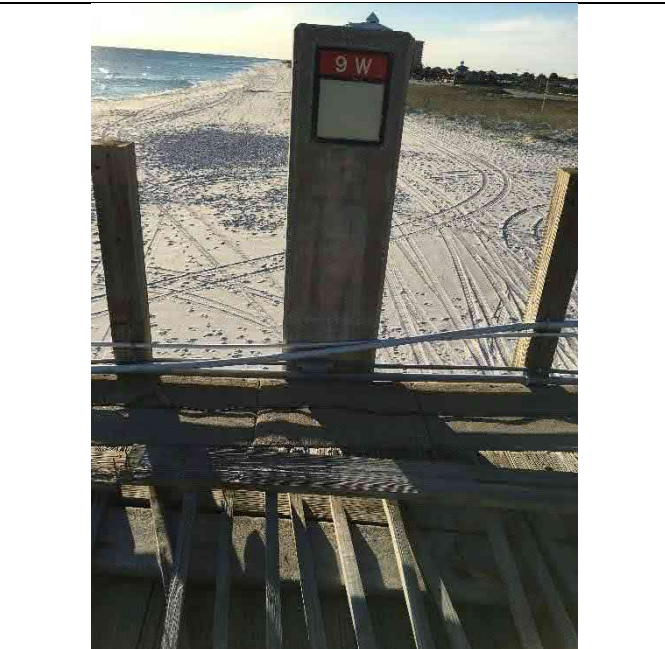
Bent 9W – Damaged railing and utilities

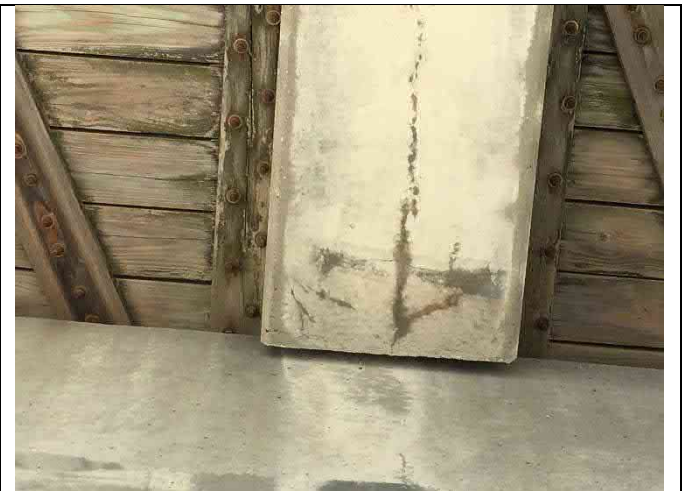
Bent 9 / Span 9	Beam 9-3 North – End cracking

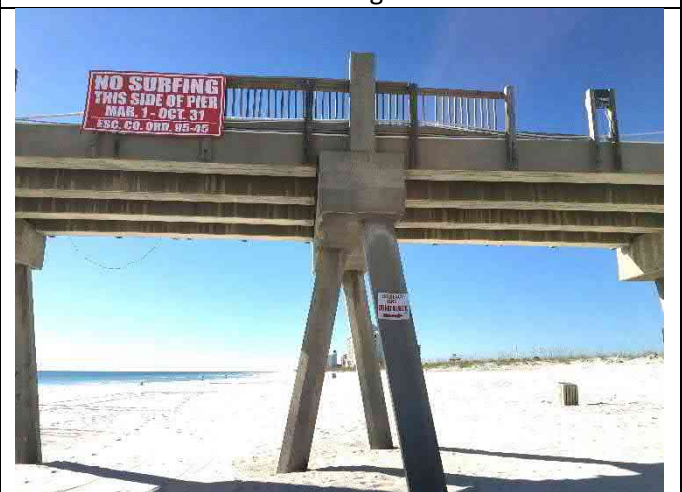
Bent 9W	Bent 9E – Spall Pile 9-1 top 10"x12"x1"

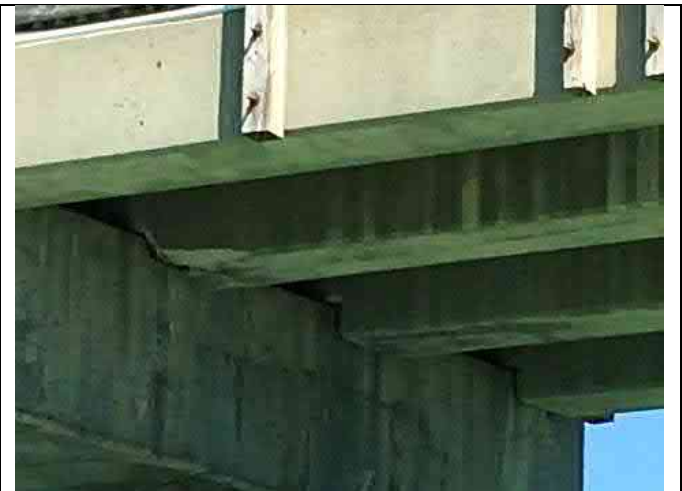
Bent 21 South Face	Beam 21-3 North end cracking and spall 24"x24"x4"

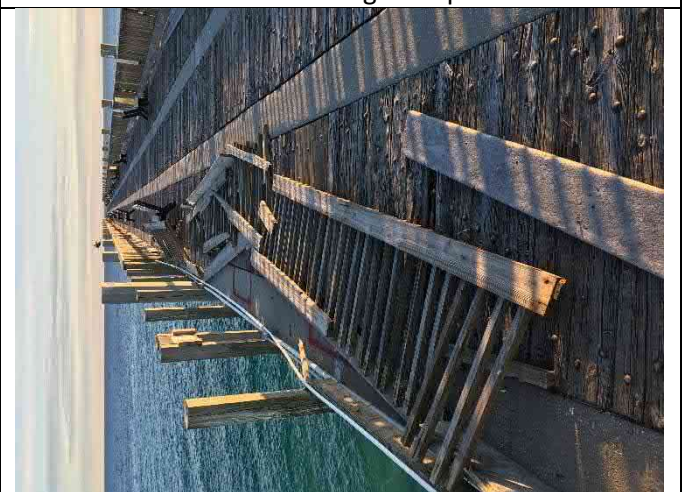
Bent 22E – Damaged light column (existing pre-storm)	Span 22E

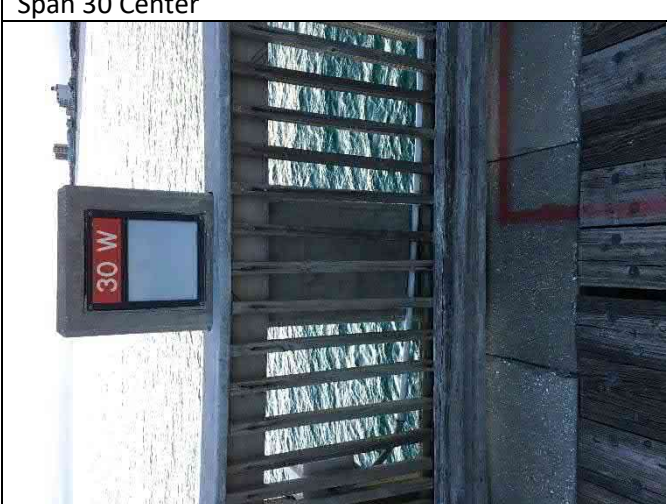
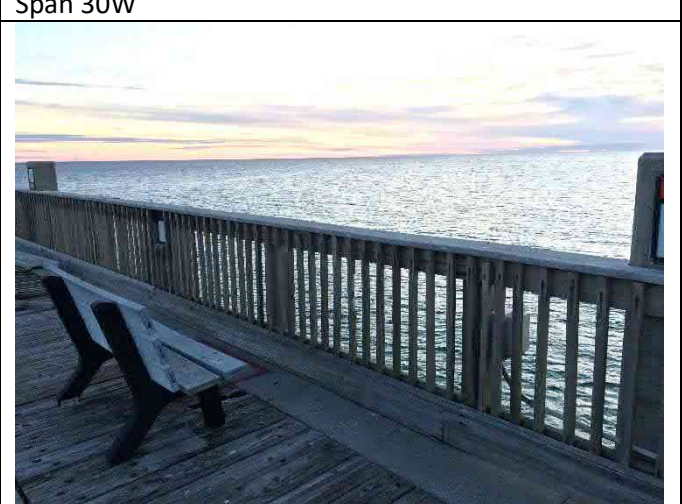
Bent 30W	Span 30W – Railing loose with split wood members

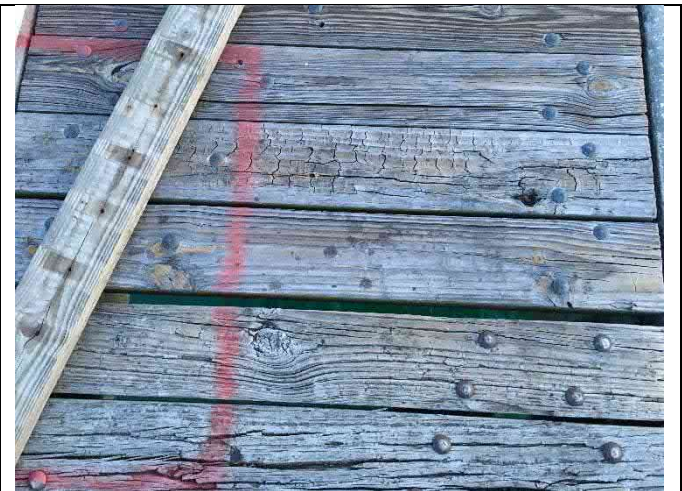
Span 32E – Railing destroyed	Span 32 – Decking damaged with gaps and dips >0.5"

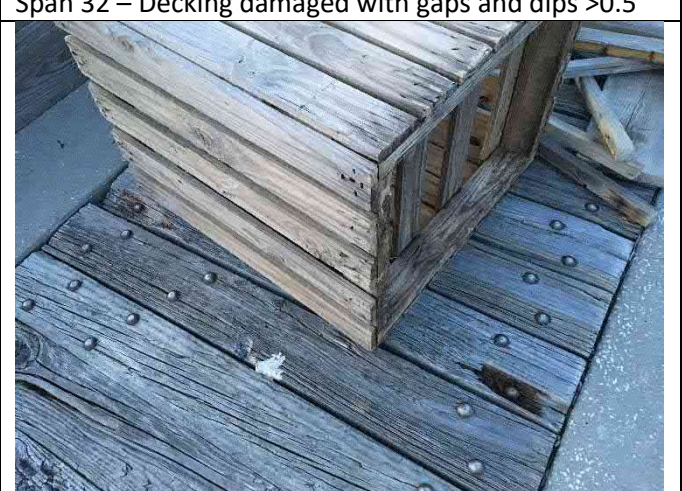
Span 32 – Decking damaged with gaps and dips >0.5"	Span 32 – Decking damaged with gaps and dips >0.5"

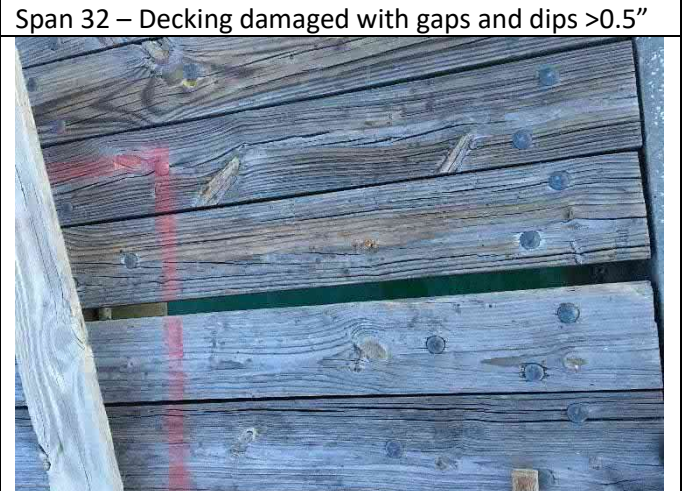
Span 32 – Decking damaged with gaps and dips >0.5"	Span 32 – Decking damaged with gaps and dips >0.5"

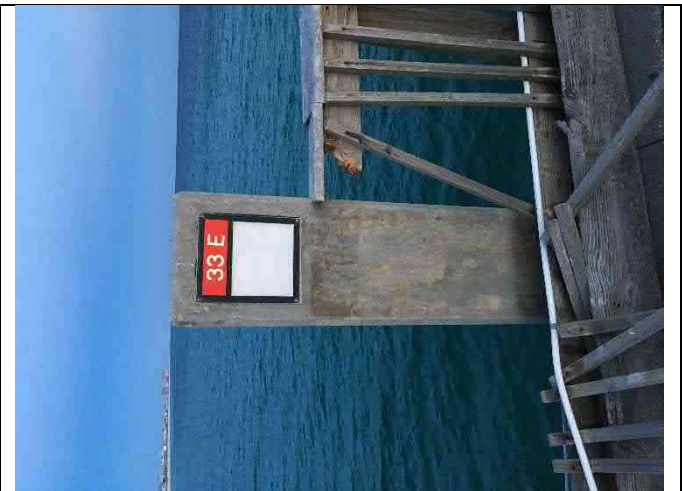
Bent 32W – Previous pile hole/spall repair damaged	Bent 33E

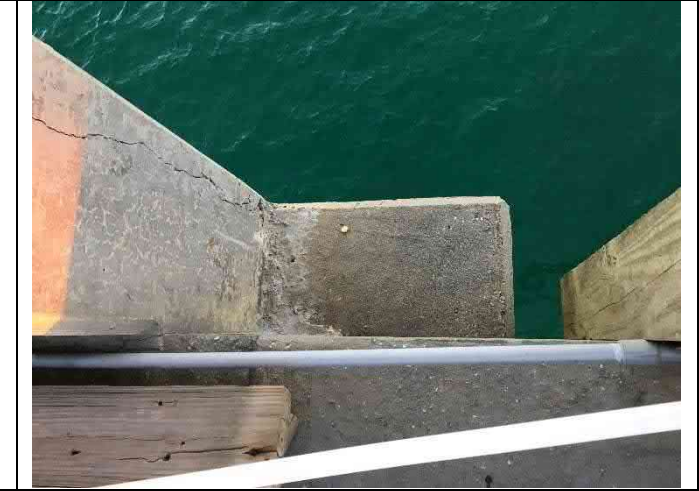
Span 37W	Bent 37E – Light column cracking (8' +/-)
