# **Preliminary Engineering Assessment (PEA)**

## **Pensacola Beach Gulf Pier**

Escambia County, FL

April 5, 2021

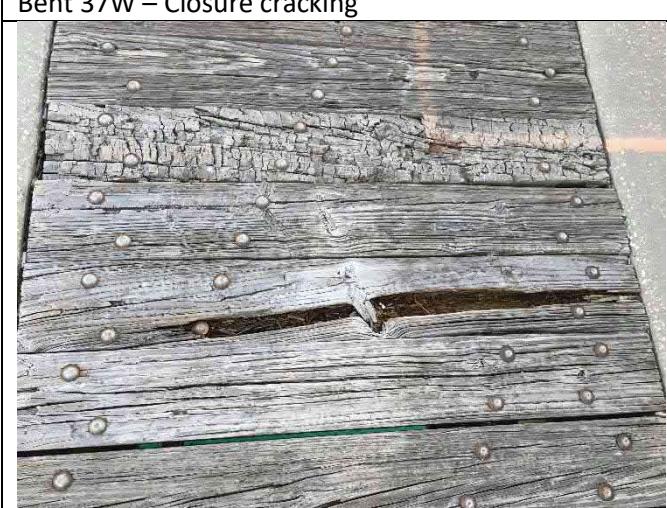
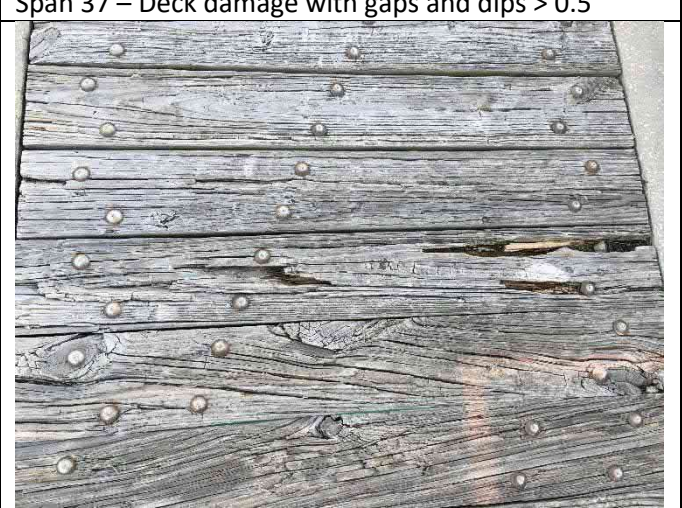
Span 37 – Deck damage with gaps and dips > 0.5"	Span 37 – Deck damage with gaps and dips > 0.5"

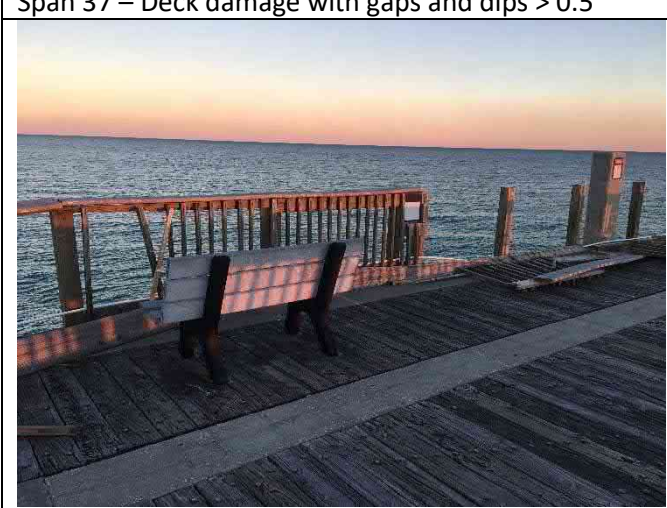
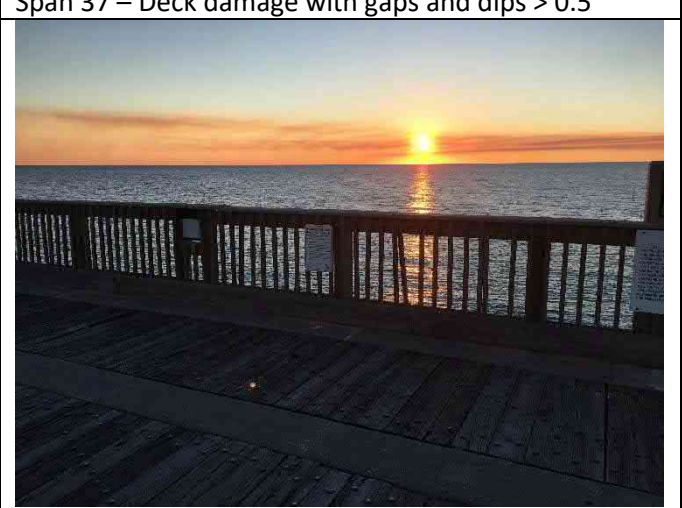
Span 37E – Railing damage	Span 37W – Railing damage

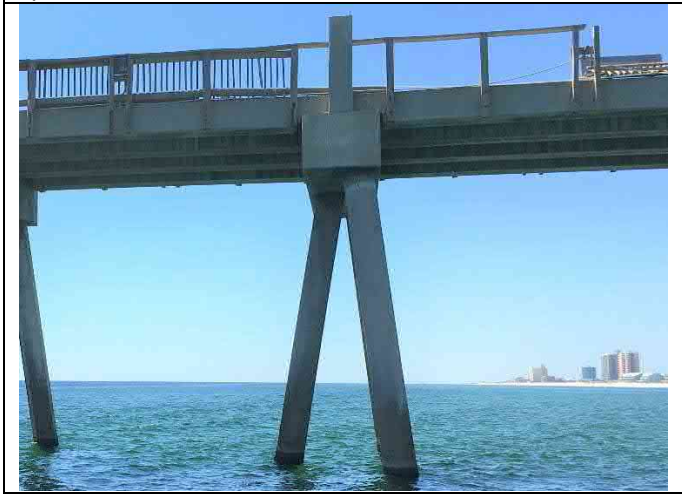
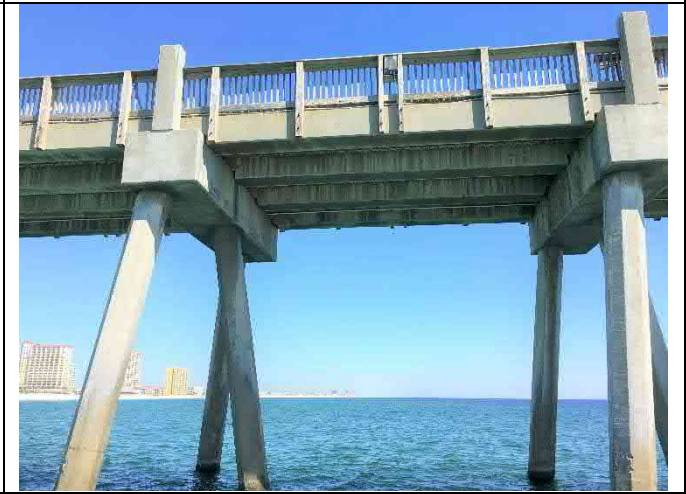
<p>Bent 42E – Pile 42-1 top spall 6"x6"x1"</p>	<p>Bent 42W - Pile spall repair damage 3x4~4"x4"x2"</p>

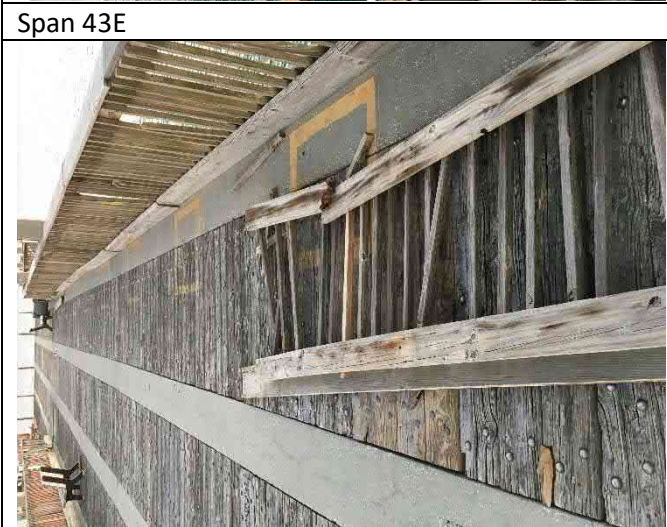
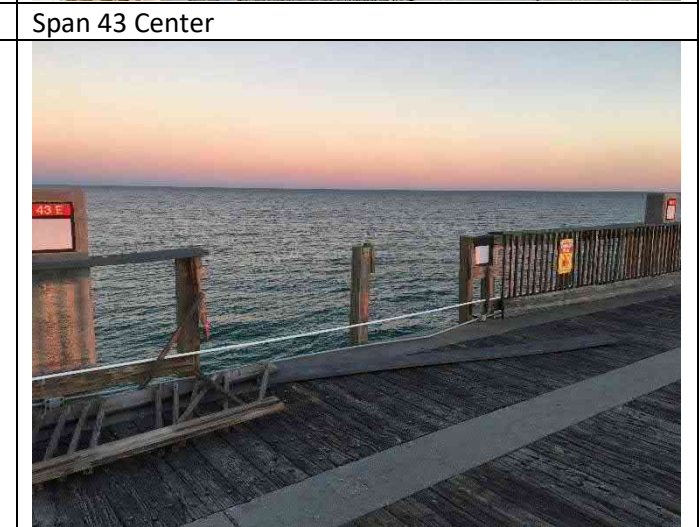
Span 43W	Span 43E – Railing damage

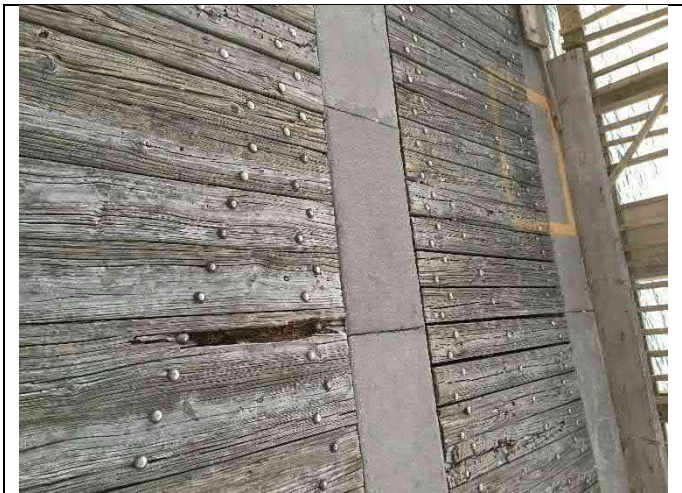
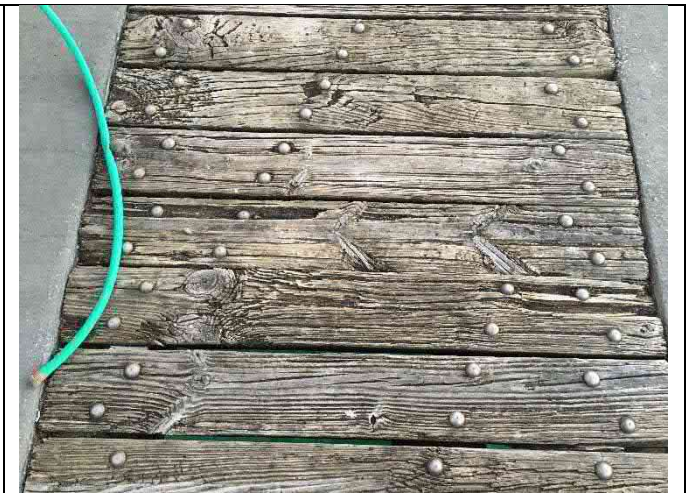
<p>Span 45 – Deck damage with gaps and dips &gt; 0.5"</p>	<p>Span 45 – Deck damage with gaps and dips &gt; 0.5"</p>

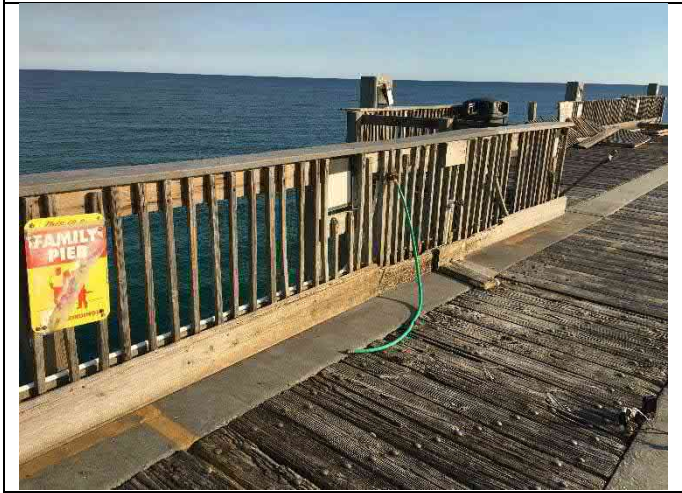
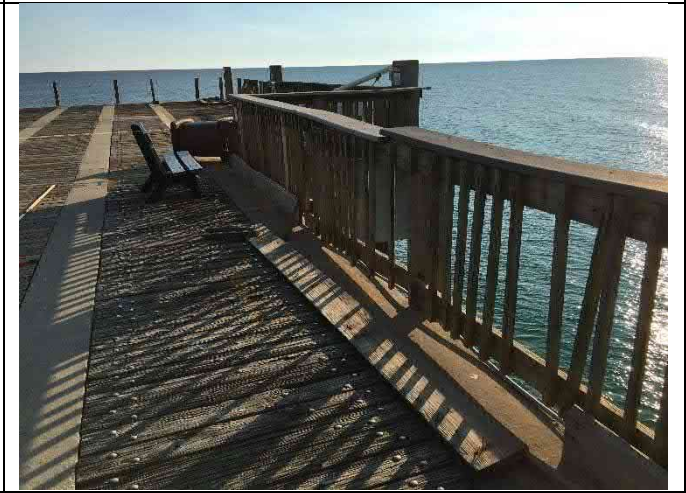
<p>Span 45E – Railing, deck and utility damage</p>	<p>Span 45W – Railing damage</p>

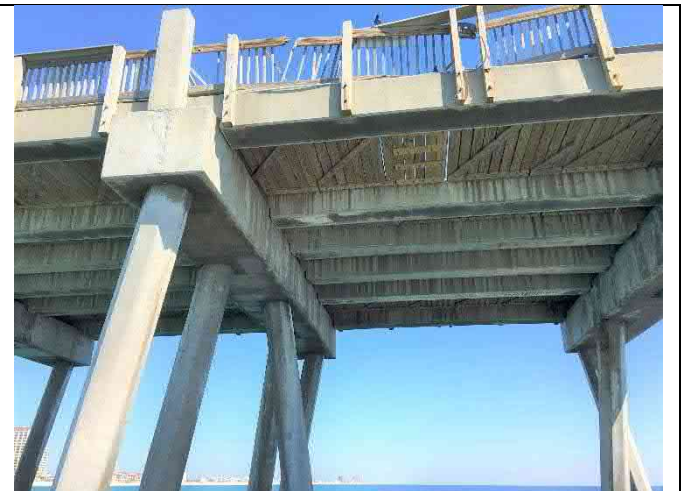
Bent 47W North Face	Bent 47W South Face – Beams shifted north
