WATERSHED ASSESSMENT

HYDROLOGIC & HYDRAULIC ASSESSMENT REPORT

Escambia County
Pensacola, Florida

**CARPENTER CREEK AND BAYOU TEXAR
WATERSHED MANAGEMENT PLAN
HYDROLOGIC & HYDRAULIC (H&H) MODEL
DEVELOPMENT (Task 3.1.1)
& SIMULATION REPORT (Task 3.1.2)
Tasks 3.1 and 3.2**

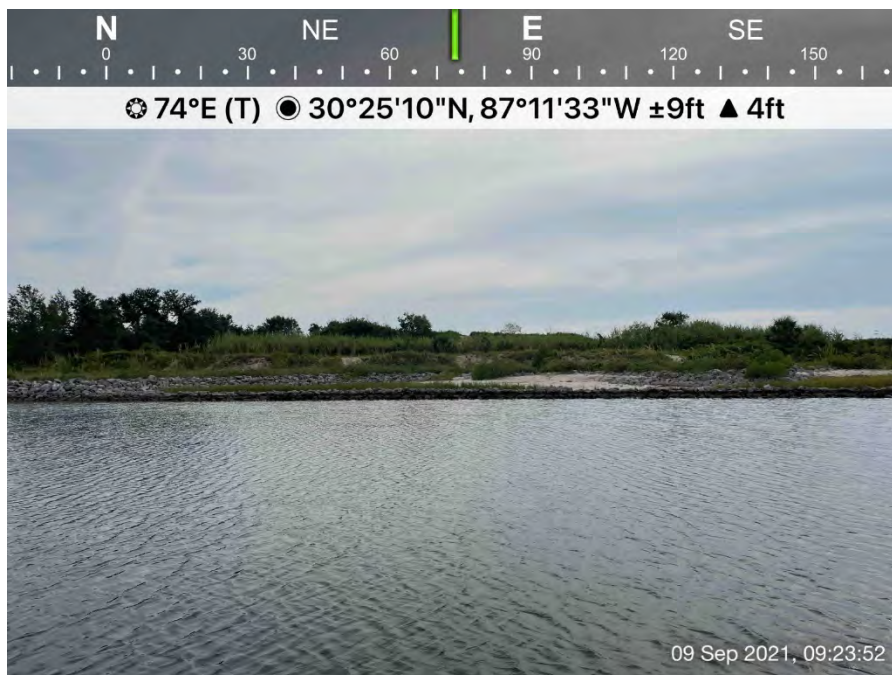
Photograph #6. Condition of east shoreline along the mouth of Bayou Texar just south of the railroad bridge. Shoreline armored with quarried limestone. Upland areas landward of the armored shoreline used as a dredge disposal site so native plant communities are altered.

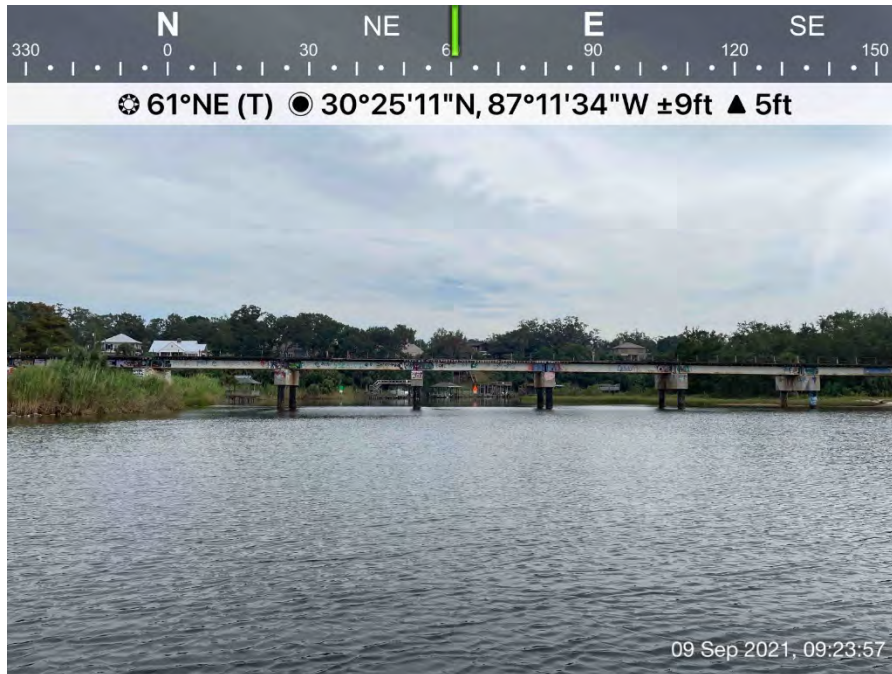
Photograph #7. Railroad bridge that crosses the mouth of Bayou Texar. Structure is supported by steel piles with concrete pile caps.

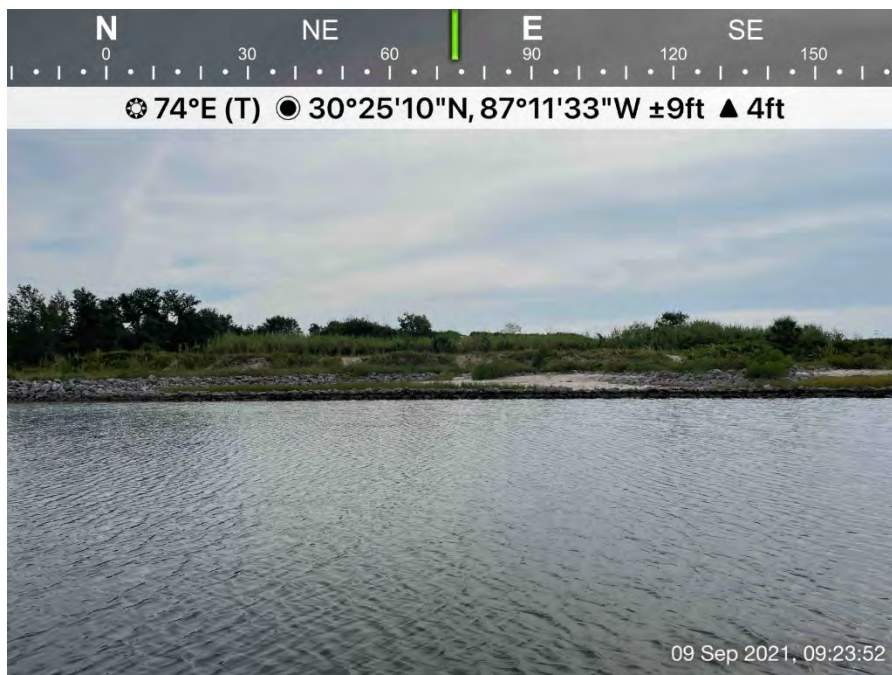
Photograph #6. Condition of east shoreline along the mouth of Bayou Texar just south of the railroad bridge. Shoreline armored with quarried limestone. Upland areas landward of the armored shoreline used as a dredge disposal site so native plant communities are altered.

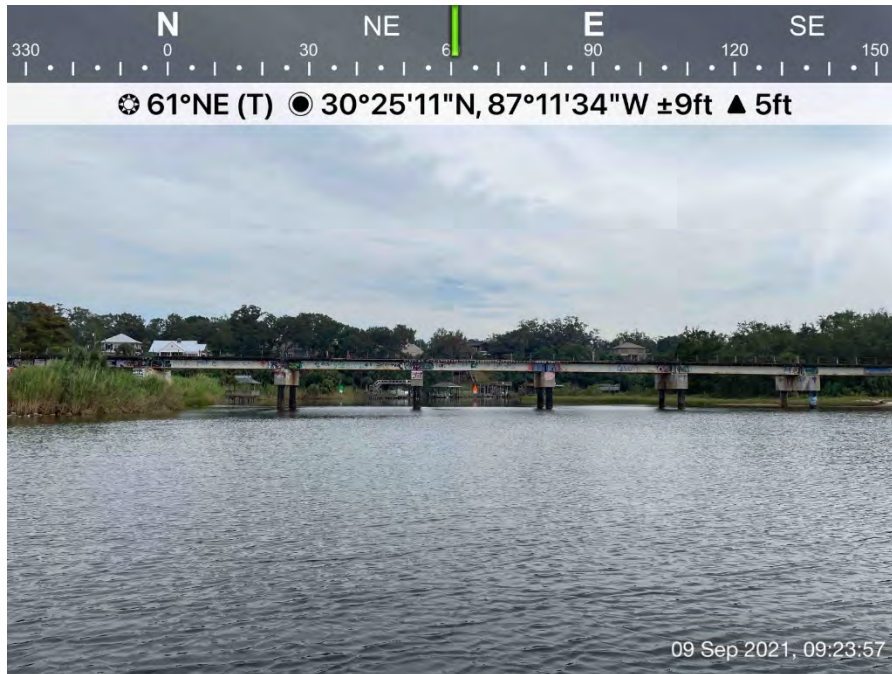
Photograph #7. Railroad bridge that crosses the mouth of Bayou Texar. Structure is supported by steel piles with concrete pile caps.

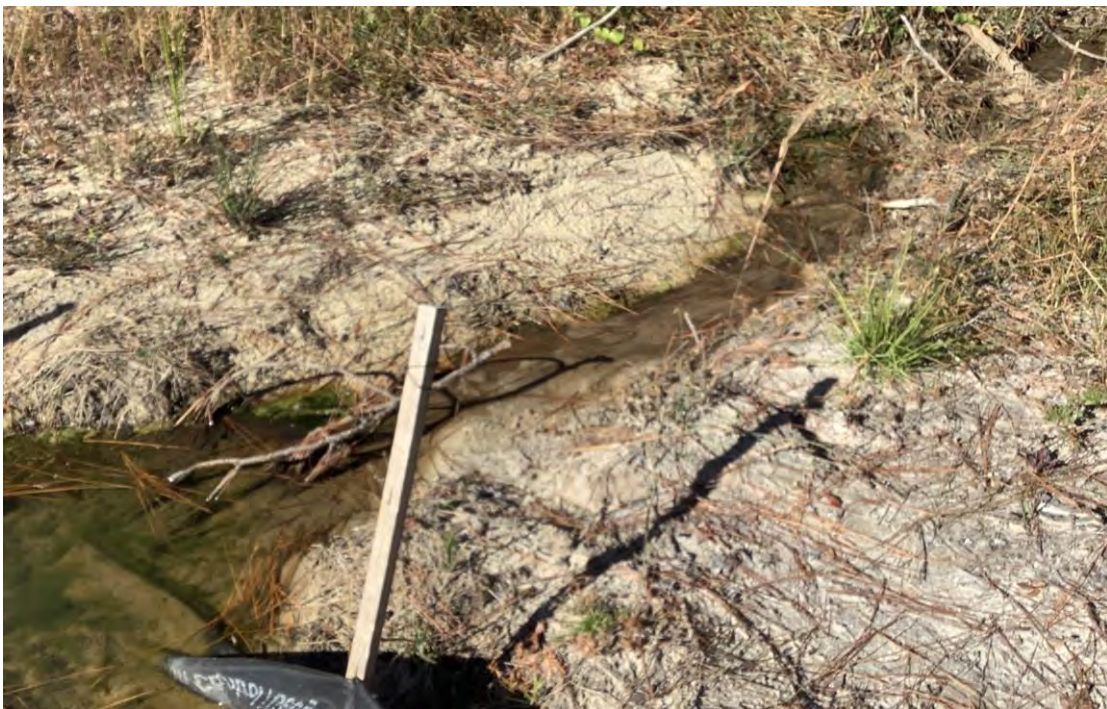
Photograph #10: Site 46 (FPZ 2)
Failing BMP and erosion

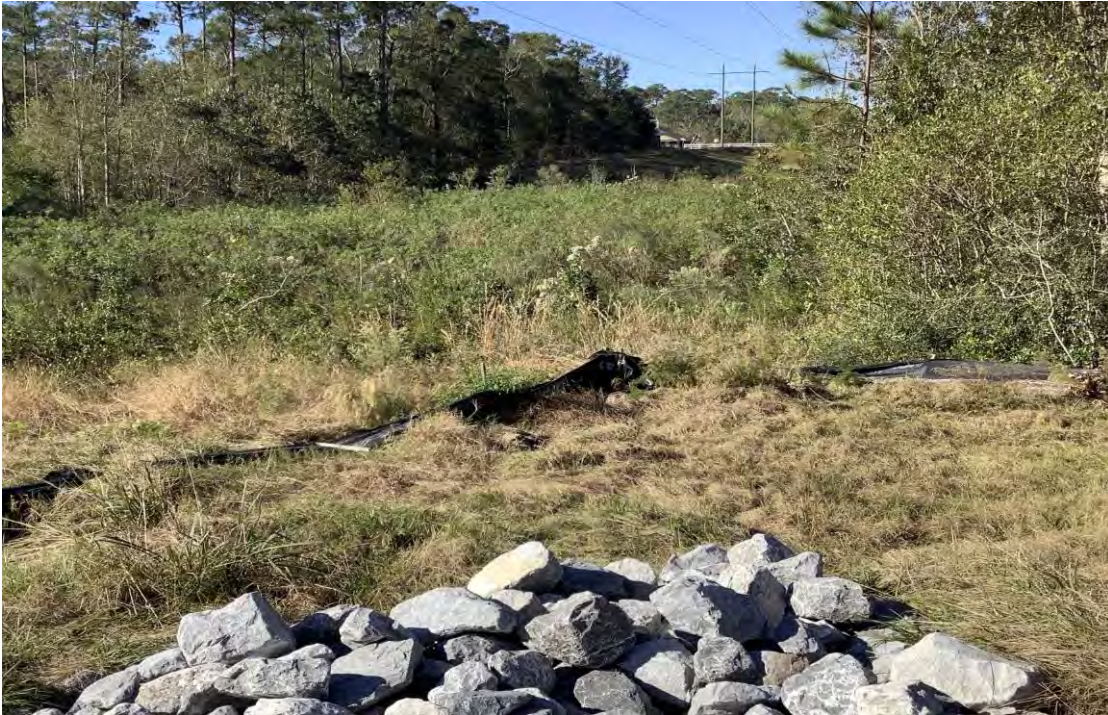
Photograph #11: Site 46 (FPZ 2)
Outfall into powerline easement with steep slopes

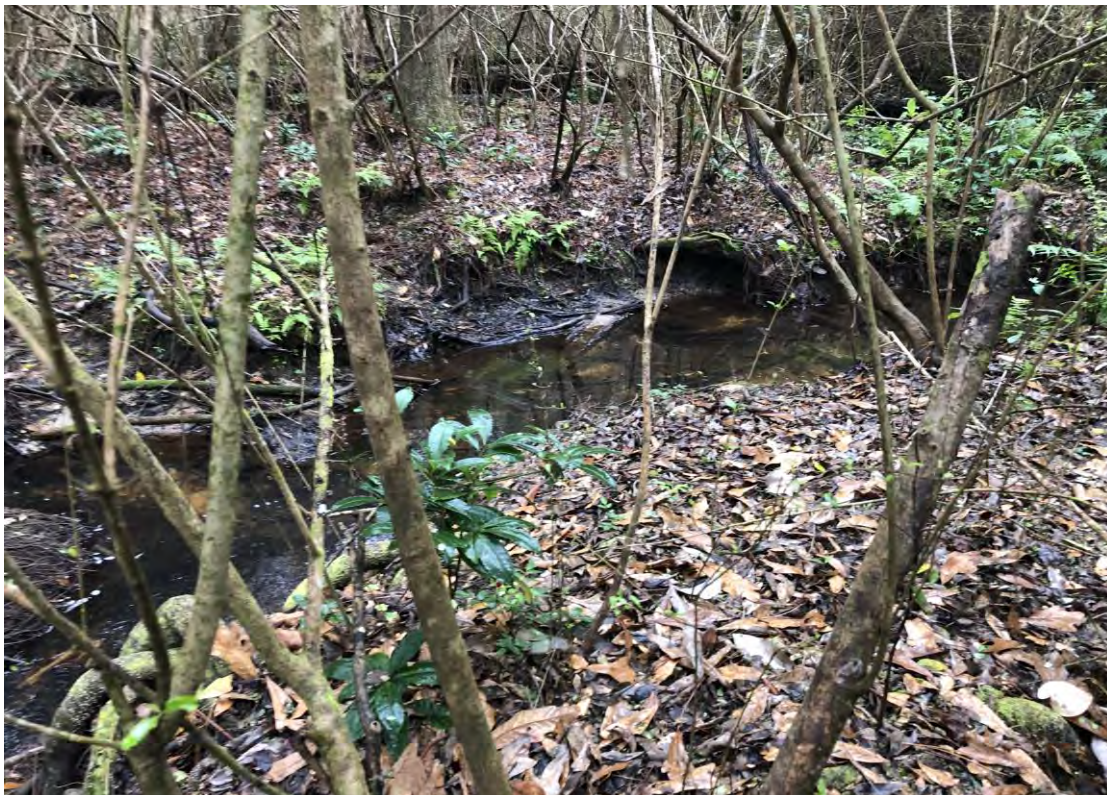
Photograph #48: Site 8 (FPZ 5)
Mid-order stream type with high quality condition

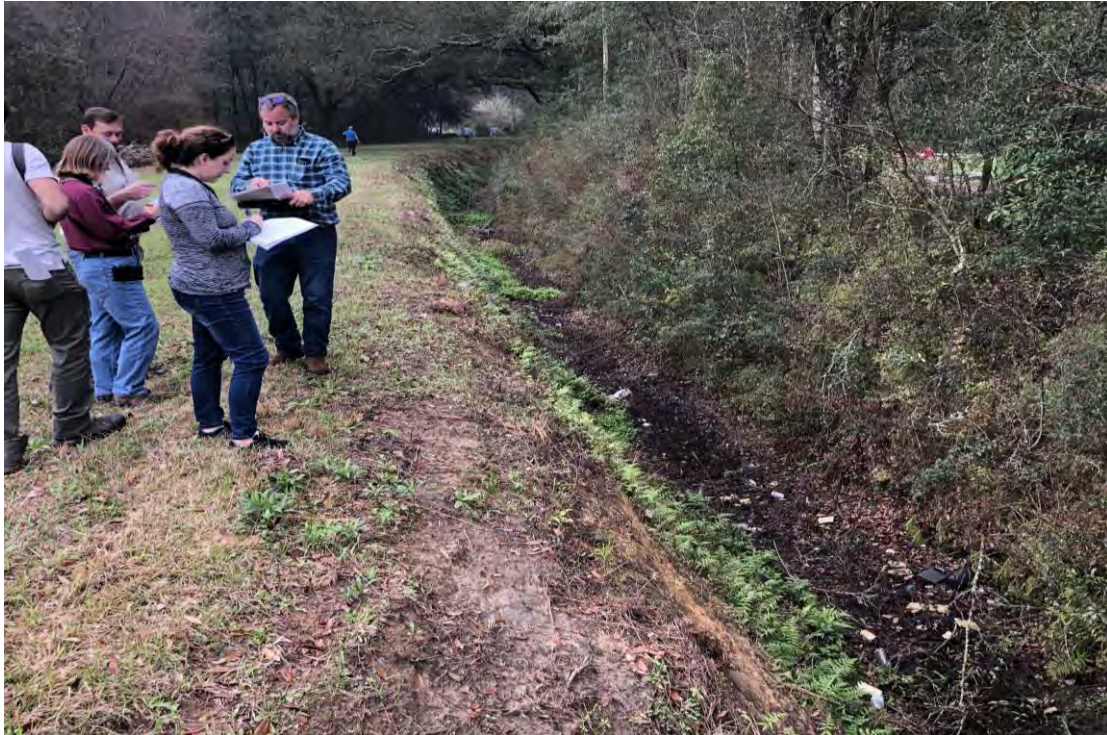
Photograph #49: Site 4 (FPZ 6)
Slot gully, drainage ditch

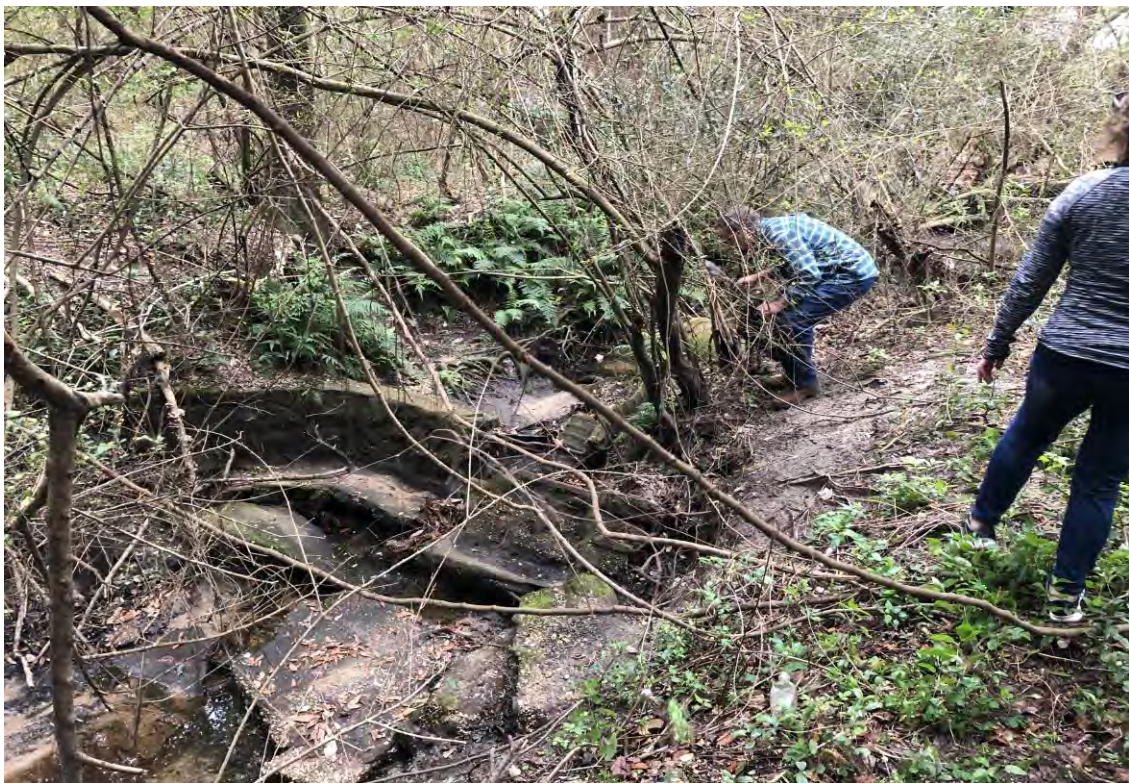
Photograph #72: Site AHI (FPZ 6)
Failing concrete outfall

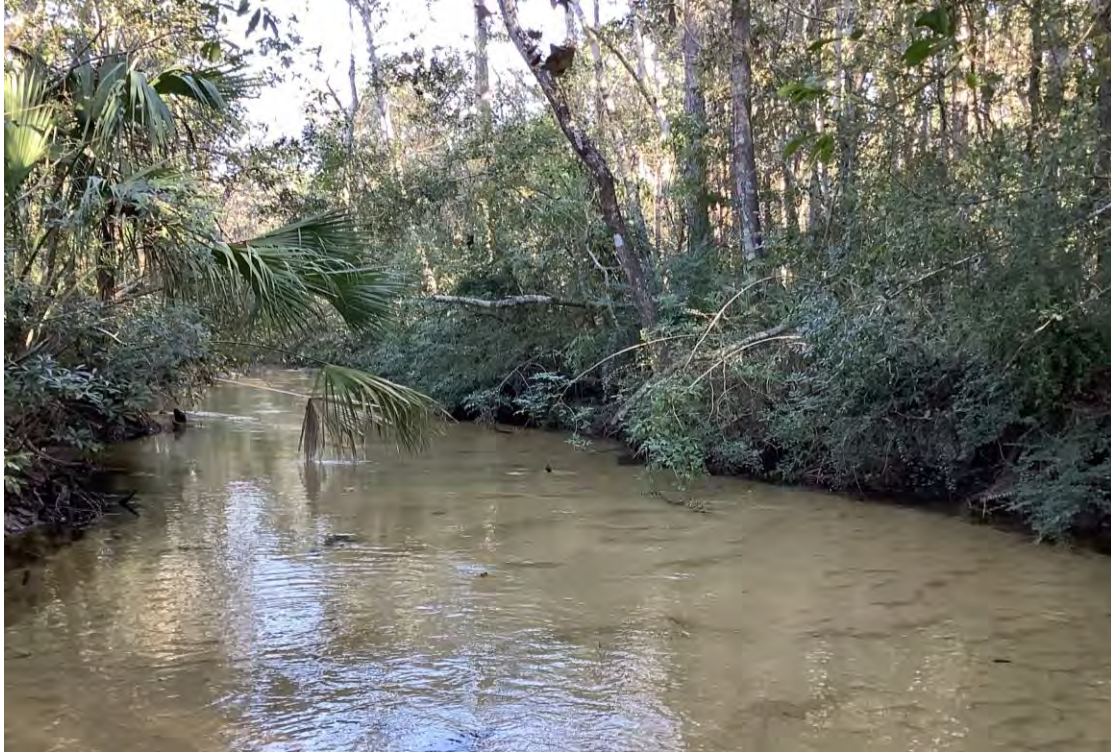
Photograph #73: Site 35 (FPZ 8)
Straightened channel smothered by sand with very wide, accessible floodplain
