ESCAMBIA COUNTY ADA Study of County Facilities and Parks

**FINAL REPORT
2/24/16**

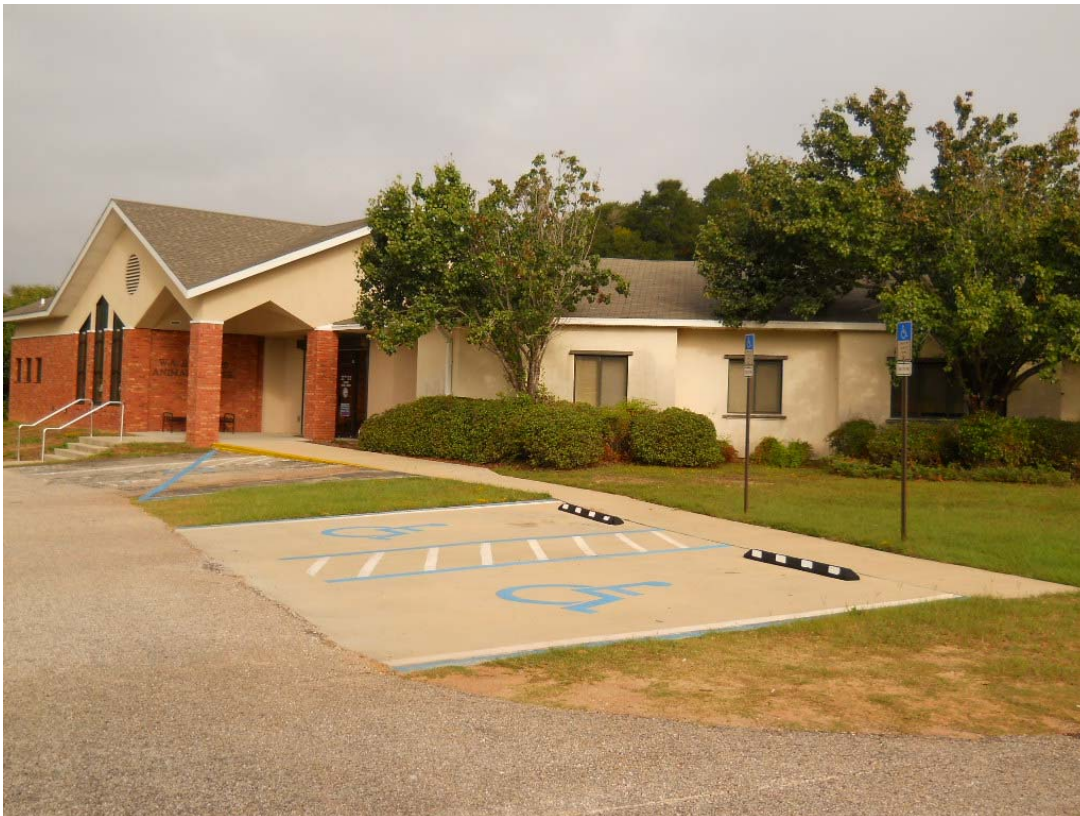
Priority 1 Parking and Sidewalks	Compliance	Notes/Dimensions	Recommended Improvement	Opinion of Cost
Parking				
No handicapped parking at Animal Dropoff Entrance	N	No handicapped space at this location	Construct one (1) new handicapped parking space in existing lot	\$2,700
Sidewalk				
Existing sidewalk does not match new space	N		Construct new section of sidewalk to meet code	\$1,500

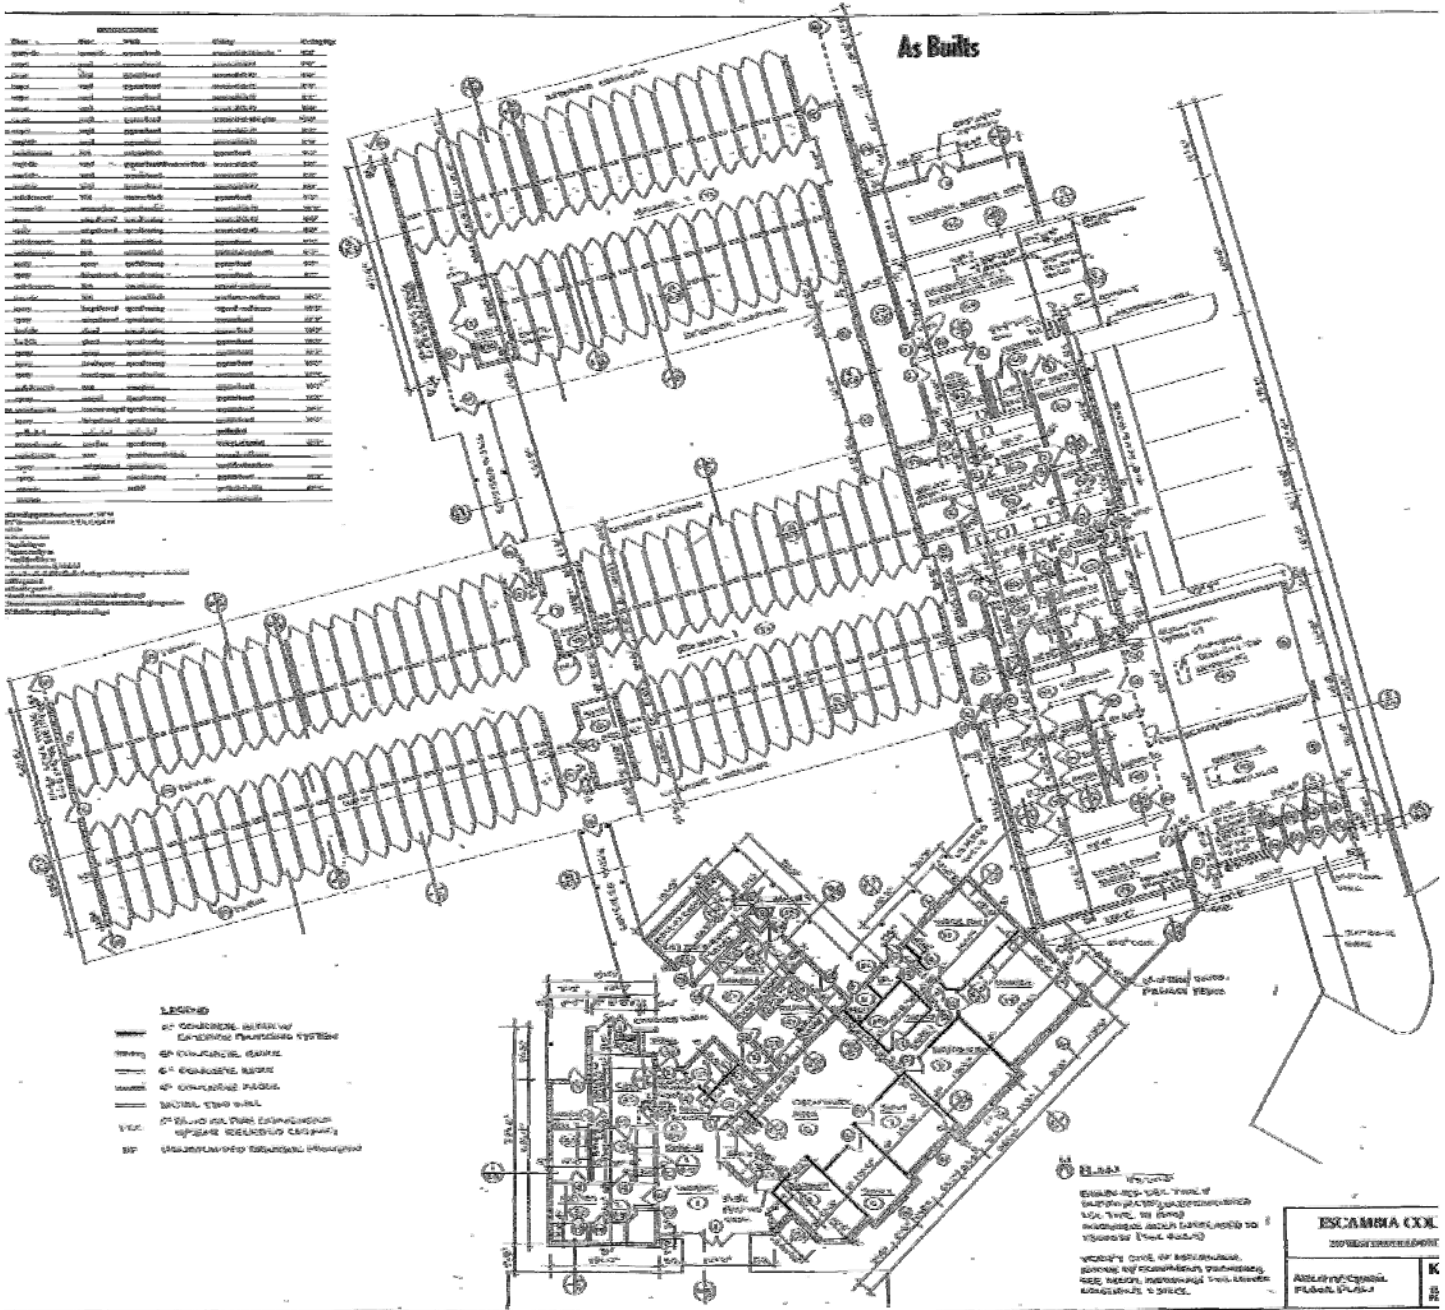
PARTIAL FLOOR PLAN

MEN'S Toilet Room	Compliance	Notes/Dimensions	Recommended Improvement	Opinion of Cost
Is the door equipped with hardware that is operable with one hand and does not require tight grasping, pinching, or twisting of the wrist?	N	Knob	Replace knob with lever.	\$250
Can the door be opened easily 2.26796 kg (5 pounds) maximum force?	N	Catches at threshold and requires 8 lbs.	Adjust closer, and repair door where catching.	\$150
If the mirror is over a lavatory or countertop, is the bottom edge of the reflecting surface no higher than 1016 mm (40 inches) above the floor?	N		Add wall mirror or reinstall existing mirror at ADA compliant height.	\$30
Above lavatories or counters no less than 508 mm (20 inches) and no greater than 635 mm (25 inches) deep: no higher than 1117.6 mm (44 inches) above the floor?	N	48"	Reinstall paper towel dispenser at ADA compliant height.	\$30
Is the centerline of the water closet no less than 406.4 mm (16 inches) and no greater than 457.2 mm (18 inches) from the side wall or partition?	N	18.5"	Furr-out wall as required. Review with Code official.	\$500

WOMEN'S Toilet Room	Compliance	Notes/Dimensions	Recommended Improvement	Opinion of Cost
With clear floor space beyond the arc of the door swing between the closed position and 45-degree open position, at least 457.2 x 457.2 mm (18 x 18 inches) centered on the tactile characters?	N	Drinking fountain is in required clear space.	Relocate drinking fountain.	\$850
If there is a front approach to the pull side of the door is there at least 457.2 mm (18 inches) of maneuvering clearance beyond the latch side plus 1524 mm (60 inches) clear depth?	N	Drinking fountain is in required clear space.	Relocate drinking fountain.	See above.
Is the centerline of the water closet no less than 406.4 mm (16 inches) and no greater than 457.2 mm (18 inches) from the side wall or partition?	N	18.5"	Furr-out wall as required.	\$500
Is there at least 38.1 mm (1½ inches) clearance between the grab bar and projecting objects below?	N		Reinstall grab bar at ADA Compliant height.	\$30

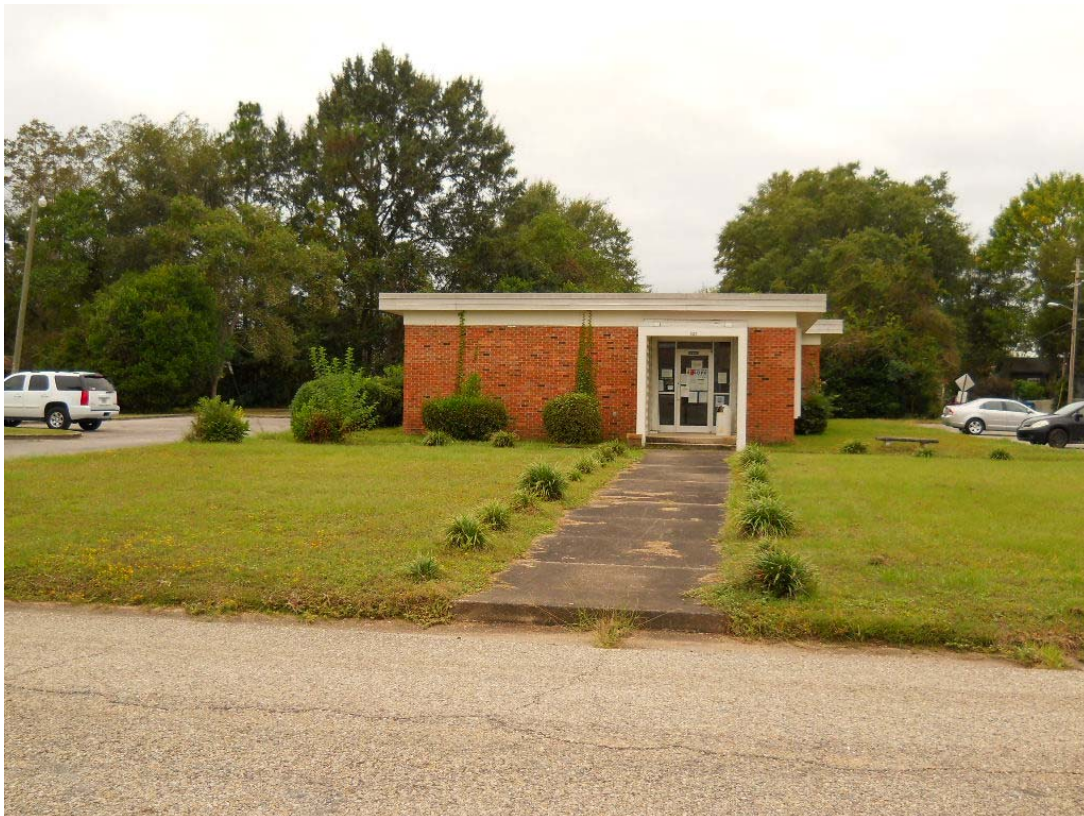
Priority 1 Parking and Sidewalks	Compliance	Notes/Dimensions	Recommended Improvement	Opinion of Cost
Parking				
Parking at Entrance - No handicapped parking at main entrance	N	Existing handicapped parking is at rear of building for entrance in back door	Construct two (2) new handicapped parking spaces in existing lot	\$5,400
Sidewalk				
No existing handicapped access to front door	N	Steps to door	Construct new section of sidewalk and ramp to meet code	\$1,200

CONSTRUCT TWO HANDICAP SPACES (ONE VAN ACCESSIBLE)

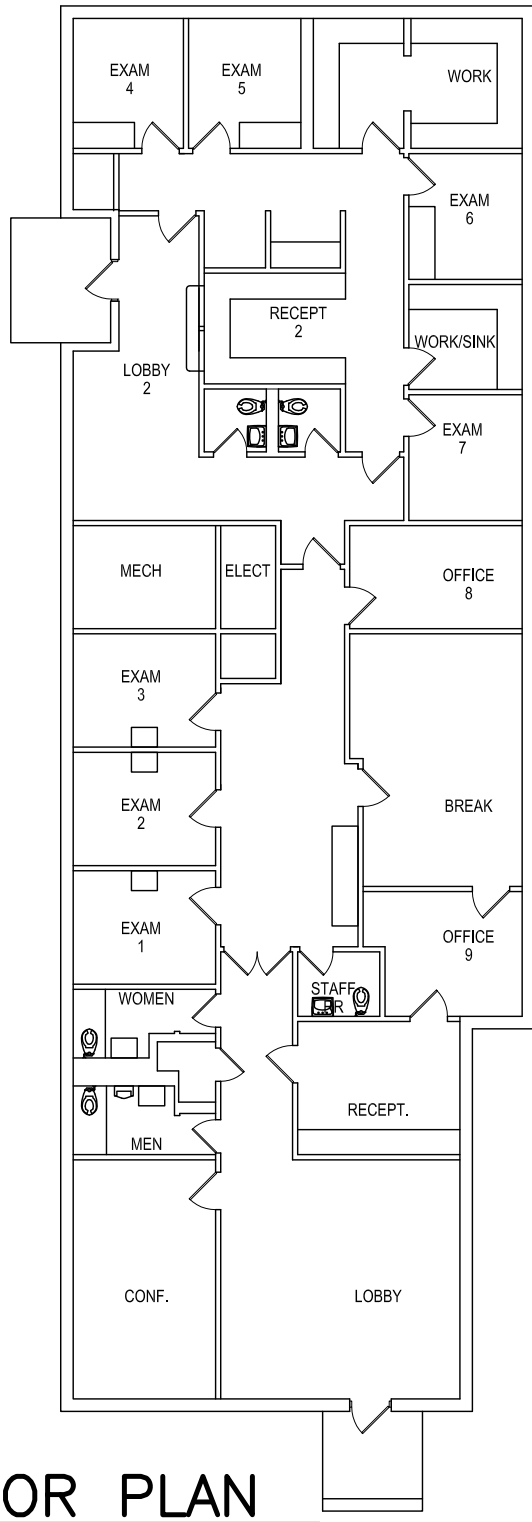
PARTIAL FLOOR PLAN

Compliance	Notes/Dimensions	Recommended Improvement	Opinion of Cost
Of the total parking spaces, are the accessible spaces located on the closest accessible route to the accessible entrance(s)?	N		See Fabre's report	Fabre
Is the main entrance accessible?	N		See Fabre's report	Fabre
Can the alternative accessible entrance be used independently and during the same hours as the main entrance?	N	Depends on staff policies.		
Do all inaccessible entrances have signs indicating the location of the nearest accessible entrance?	N		Provide Signs directing to accessible entrance, or add ramp to main entrance.	\$100, See Fabre's report for ramp cost
If not all entrances are accessible, is there a sign at the accessible entrance with the International Symbol of Accessibility?	N		See above	
If the door has a closer, does it take at least 5 seconds to close from an open position of 90 degrees to a position of 12 degrees from the latch?	N	Too fast	Adjust closers at front and rear exterior doors, and interior doors with closers	\$150

Are all public spaces on at least one accessible route?	N	Double doors are 32" wide each. All exam rooms are not accessible.	Replace double door with a 48" wide door. Determine how many exam rooms are required to be accessible. 1 is currently out of 6.	\$1,500
Do text characters contrast with their backgrounds?	N	One exam room has a sign on the door, it is not accessible.	Provide accessible signage at Exam Rooms.	\$300
Are text characters raised?	N		See above	
Is there Braille?	N		See above	
On the wall on the latch side of the door?	N		See above	
If there is a front approach to the pull side of the door, is there at least 457.2 mm (18 inches) of maneuvering clearance beyond the latch side plus at least 1524 mm (60 inches) clear depth?	N	Exam Room 2 is the only room with correct door clearances.	Provide accessible signage at handicapped accessible Exam Room.	See above
Are the operable parts no higher than 1219.2 mm (48 inches) above the floor?*	N	light switches are at 50", 54" allowed by 1991 ADA standards	No work required.

Compliance	Notes/Dimensions	Recommended Improvement	Opinion of Cost
Restrooms	N	Restrooms are not in accordance with 1991 ADA standards.	Redesign /add a unisex restroom. Recommended location depends on where the accessible entrance is located.	\$15,000
If toilet rooms are available to the public, is at least one toilet room accessible? (Either one for each sex, or one unisex.)	N			
Do text characters contrast with their backgrounds?	N	No signs	Provide accessible restroom sign at accessible toilet room.	
Is the door opening width at least 812.8 mm (32 inches) clear, between the face of the door and the stop, when the door is open 90 degrees?	N	32" Door	See above.	
If there is a front approach to the pull side of the door is there at least 457.2 mm (18 inches) of maneuvering clearance beyond the latch side plus 1524 mm (60 inches) clear depth?	N		See above.	
If there is a privacy wall and the door swings in, is there at least 609.6 mm (24 inches) of maneuvering clearance beyond the door latch side and at least 1219.2 mm (48 inches) to the privacy wall if there is no door closer or at least 1371.6 mm (54 inches) if there is a door closer?	N		See above.

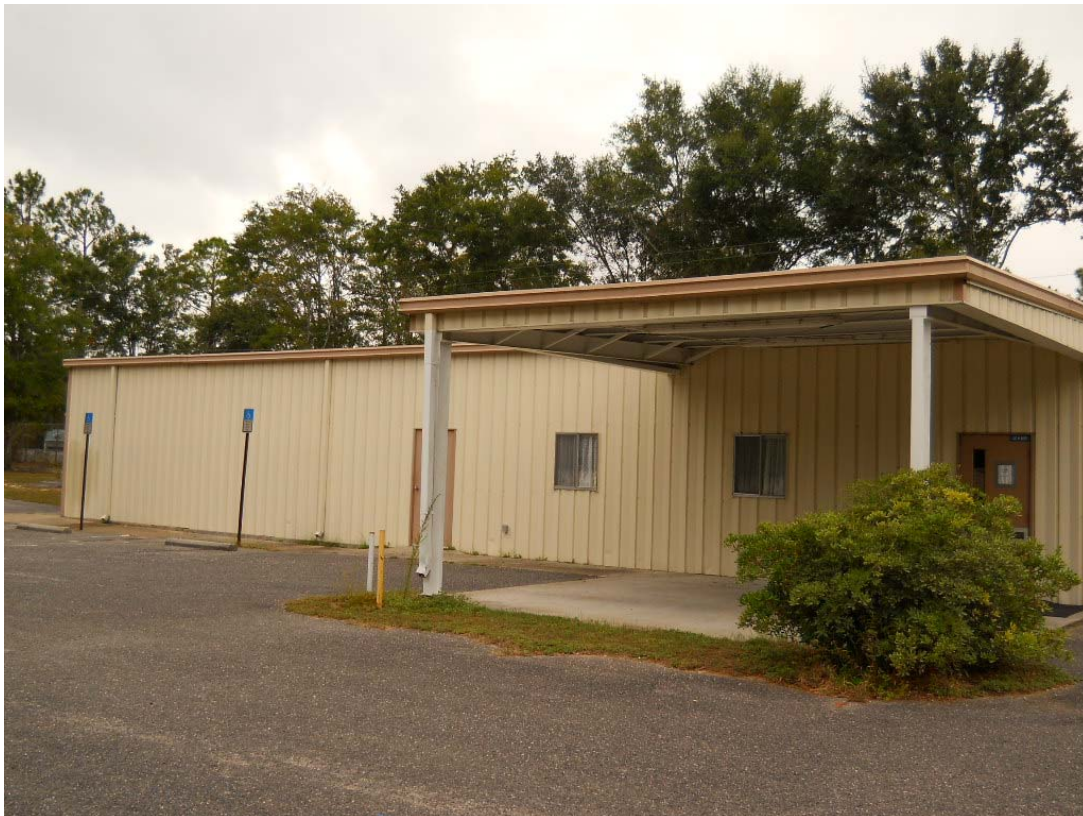
Priority 1 Parking and Sidewalks	Compliance	Notes/Dimensions	Recommended Improvement	Opinion of Cost
Parking				
Parking at Entrance - Existing parking is adequate	Y	Paint on spaces has faded	Repaint existing handicapped spaces	\$400

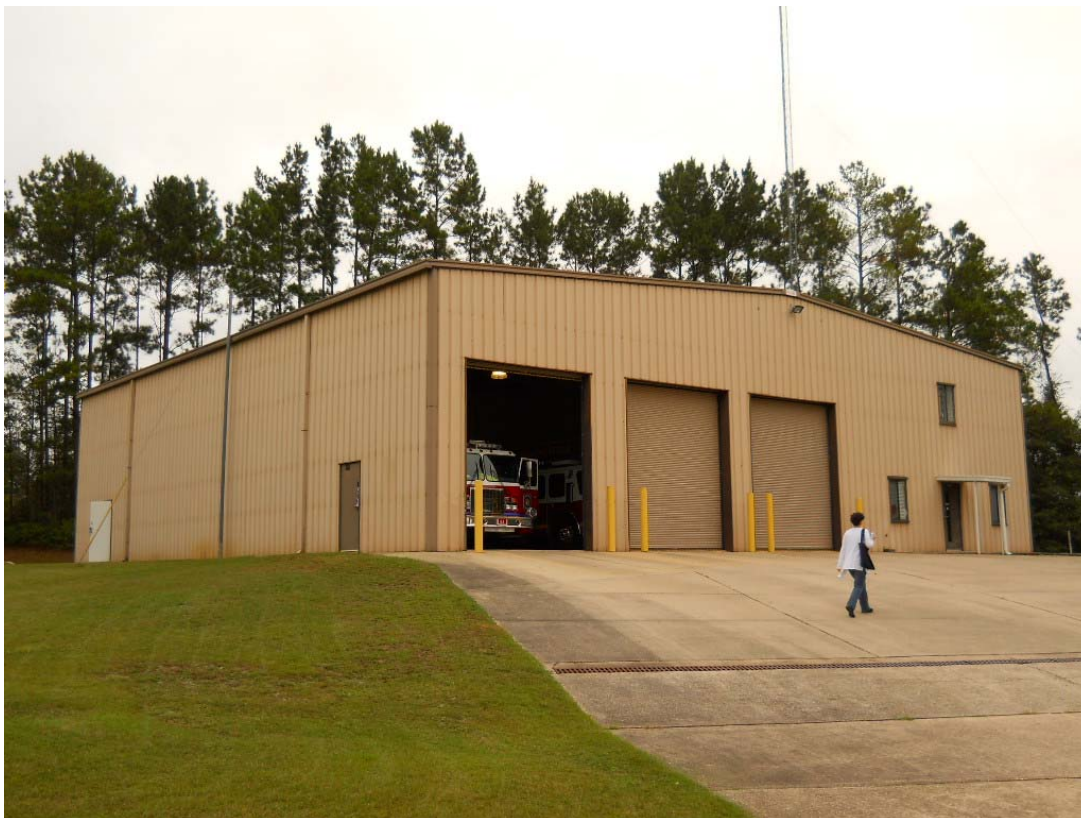
If the Century Volunteer Fire Department building provides school tours, is used as an election polling place, or is used for other community activities, then it is required to be accessible. The handicapped parking access and the restroom design is not in accordance with 1991 ADA standards. Alterations would be required to meet 2010 ADA Standards. If the showers are not used by the public, they may be able to remain as they are. This would need to be reviewed with the local building official. The existing building is separated mixed occupancy. Some existing fire rated doors do not have closers. Closers may be required and will need to meet ADA requirements for closing speed and pressure. Fire rated door requirements may need to be reviewed with the local building official. This is outside of the scope of this project, but may be required if alterations are made at this facility, and should be addressed. As an alternate to renovating both existing restrooms, an accessible unisex toilet room could be added.

REMOVE AND REPLACE
ONE HANDICAP SPACE

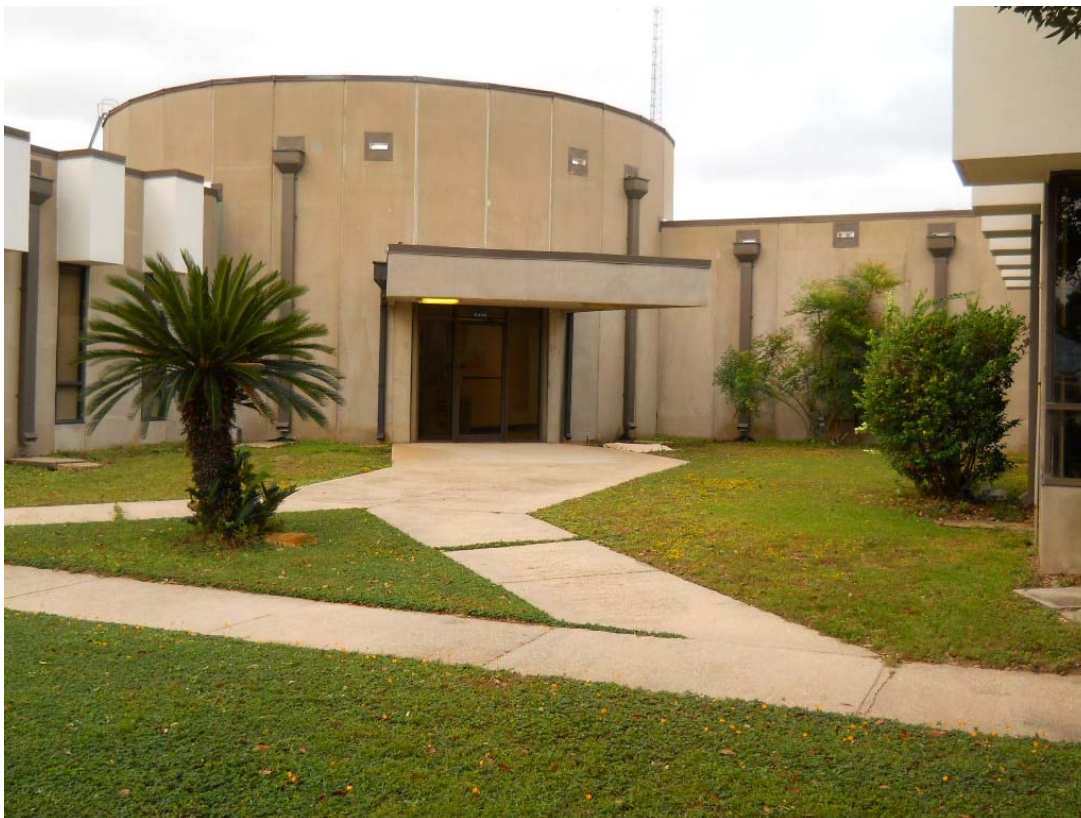
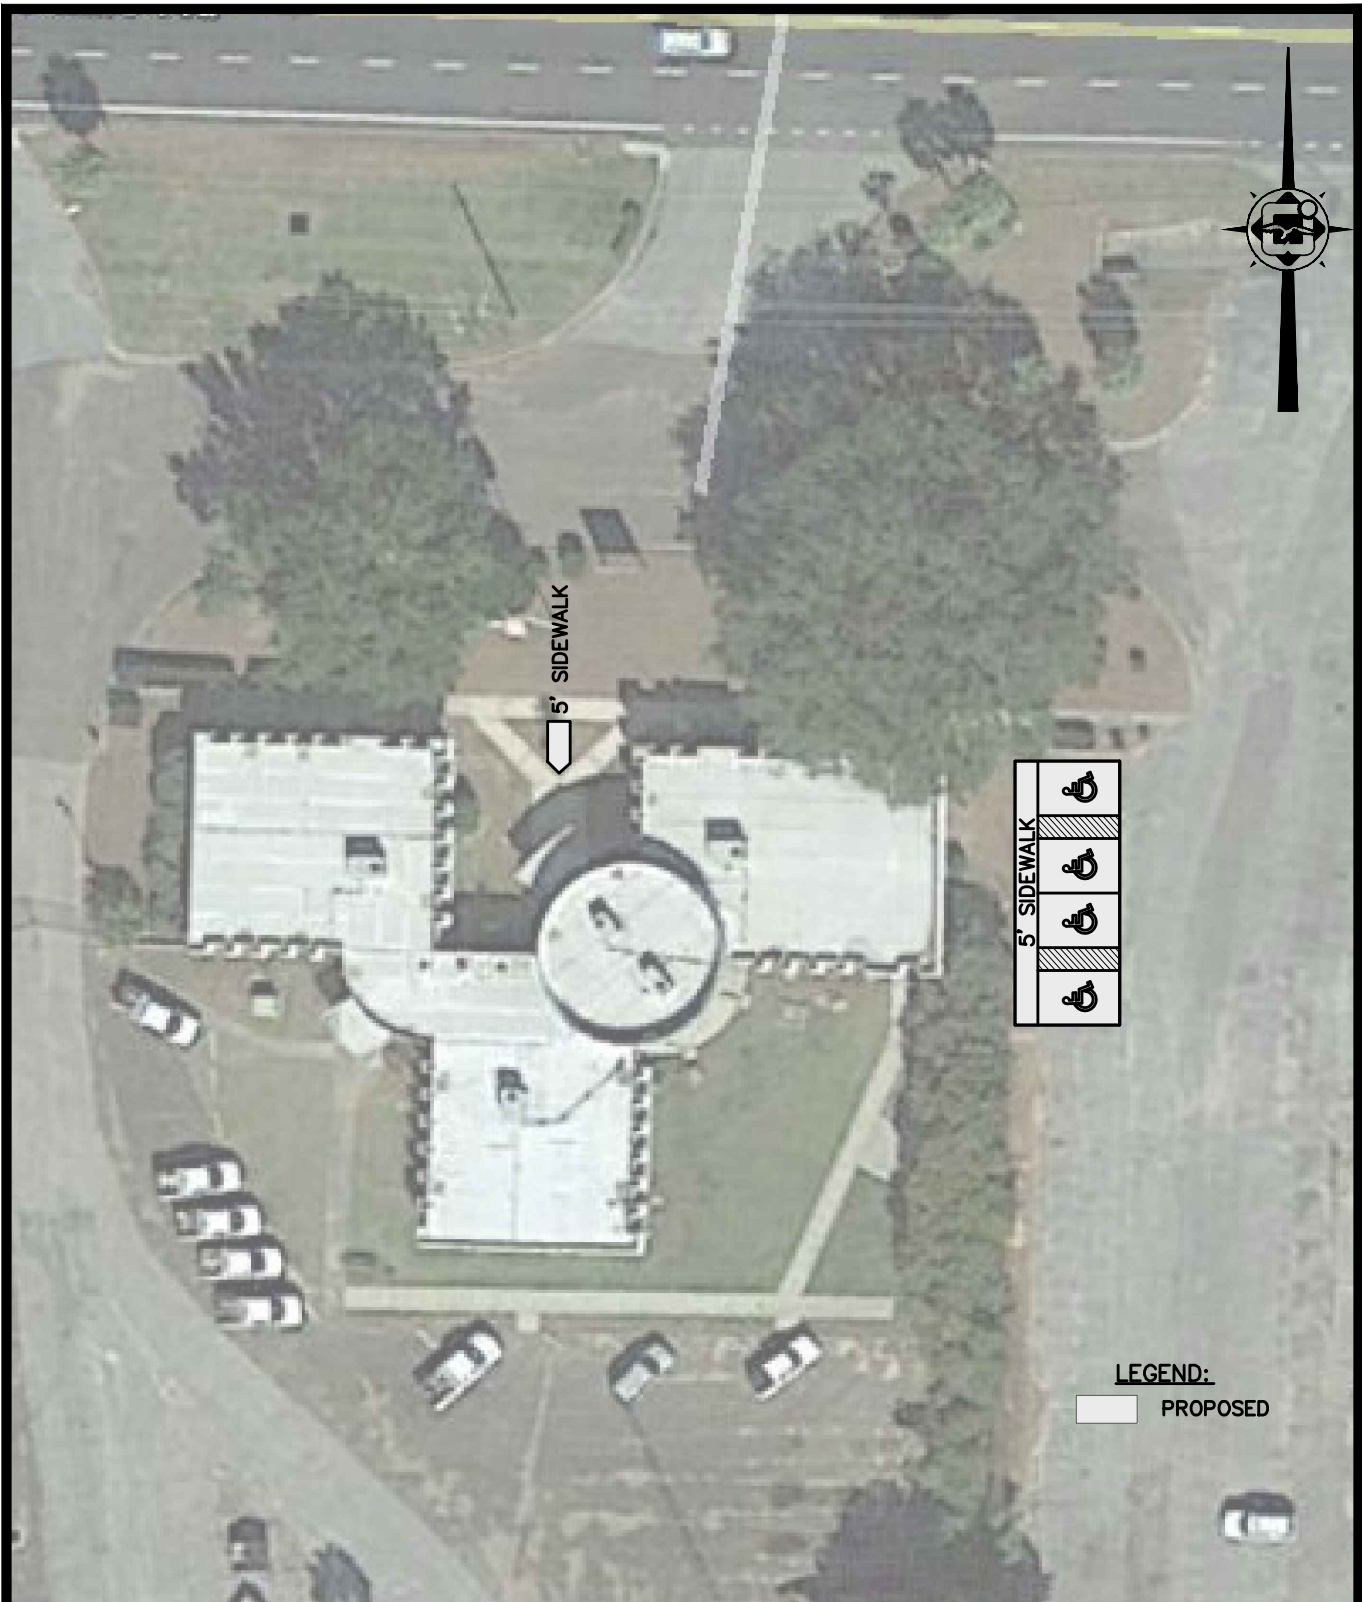
This building is a County office for Parks and Recreation and Roads. It has limited public visitors. The main entrance, restrooms, conference room and Administration area were reviewed for accessibility. Restrooms were not originally designed in accordance with 1991 ADA Standards. Restrooms should be reconfigured to meet 2010 ADA Standards. Note that hot water piping is surface mounted in the Women’s restroom and hot water is not provided in the Men’s restroom. The front sidewalk would need to be reconstructed to provide access and three new parking spaces would need to be built and a sidewalk to connect to the existing sidewalk.

CONSTRUCT A RAMP AT THE MAIN ENTRANCE AND A 5.0' SIDEWALK TO MEET ADA REQUIREMENTS.

CONSTRUCT ONE HANDICAP SPACE WITH A 5.0' SIDEWALK TO MEET ADA REQUIRED SLOPES.

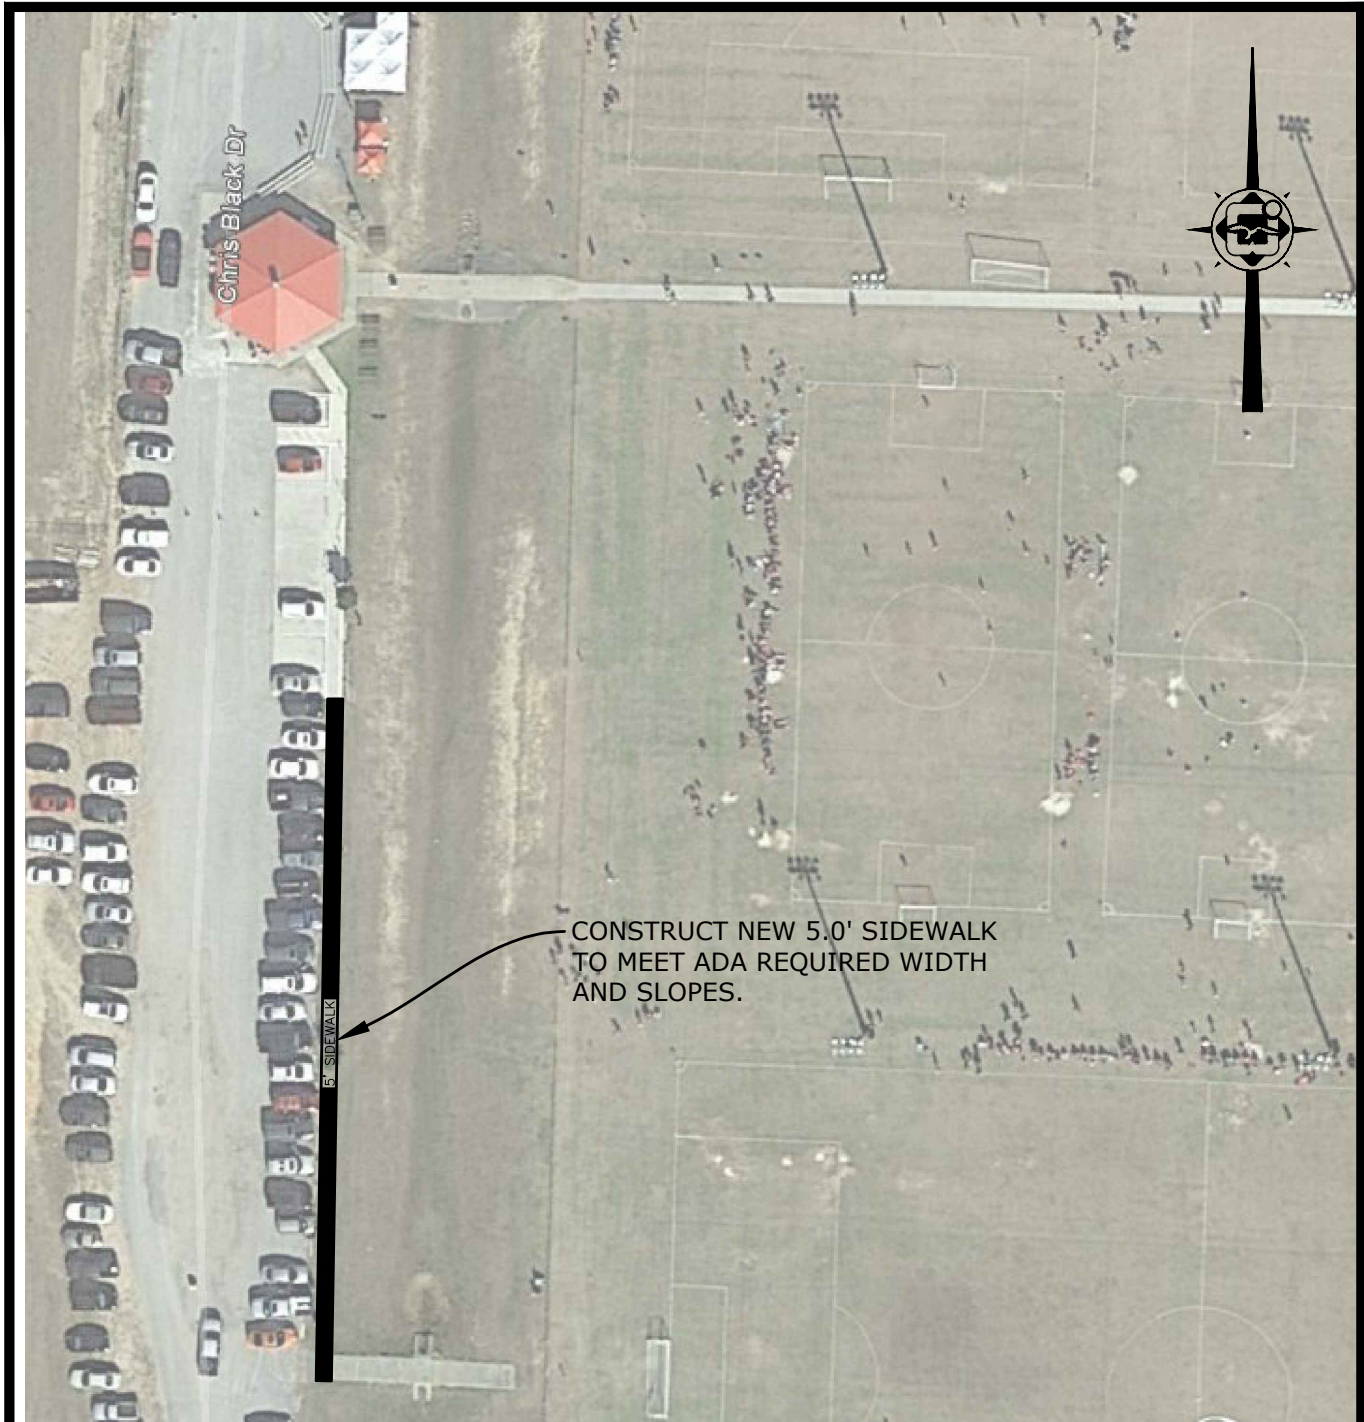
Site Area 2-3- Sidewalk between Building 1 and Building 2 - Running slope is too steep. Recommend regrading. Recommend adding guard rails on portion of sidewalk crossing culvert. Multiple cracks in sidewalk must be repaired.

Site Area 4- Paved handicap parking space and appropriate signage must be installed at field across from Building 1 to provide access.

Site Area 5- Paved handicap parking space and appropriate signage must be installed at field to provide access to field on west side of Chris Black Dr.

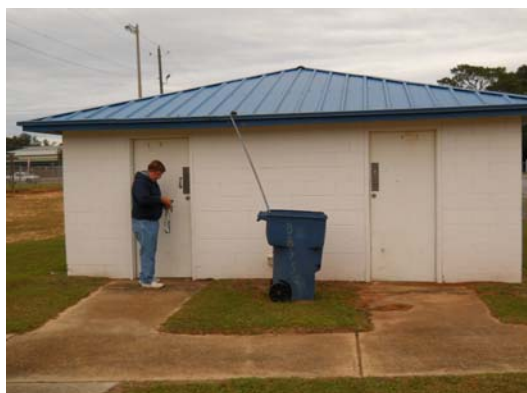
Building 3 Restrooms & Concession

Building 3 Concessions & Restrooms -Privacy wall and entrance door configuration are not in accordance with 1991 ADA Standards. This area will have to be reconfigured. Other minor corrections are required to meet ADA standards.
