**HAZARDOUS MATERIALS ABATEMENT AND  
DEMOLITION PLAN**

**New Escambia County Correctional Facility Site**  
3030 & 3080 North Pace Boulevard  
Pensacola, Escambia County, Florida

**Intertek-PSI Project Number – 07832209**

**May 01, 2017**

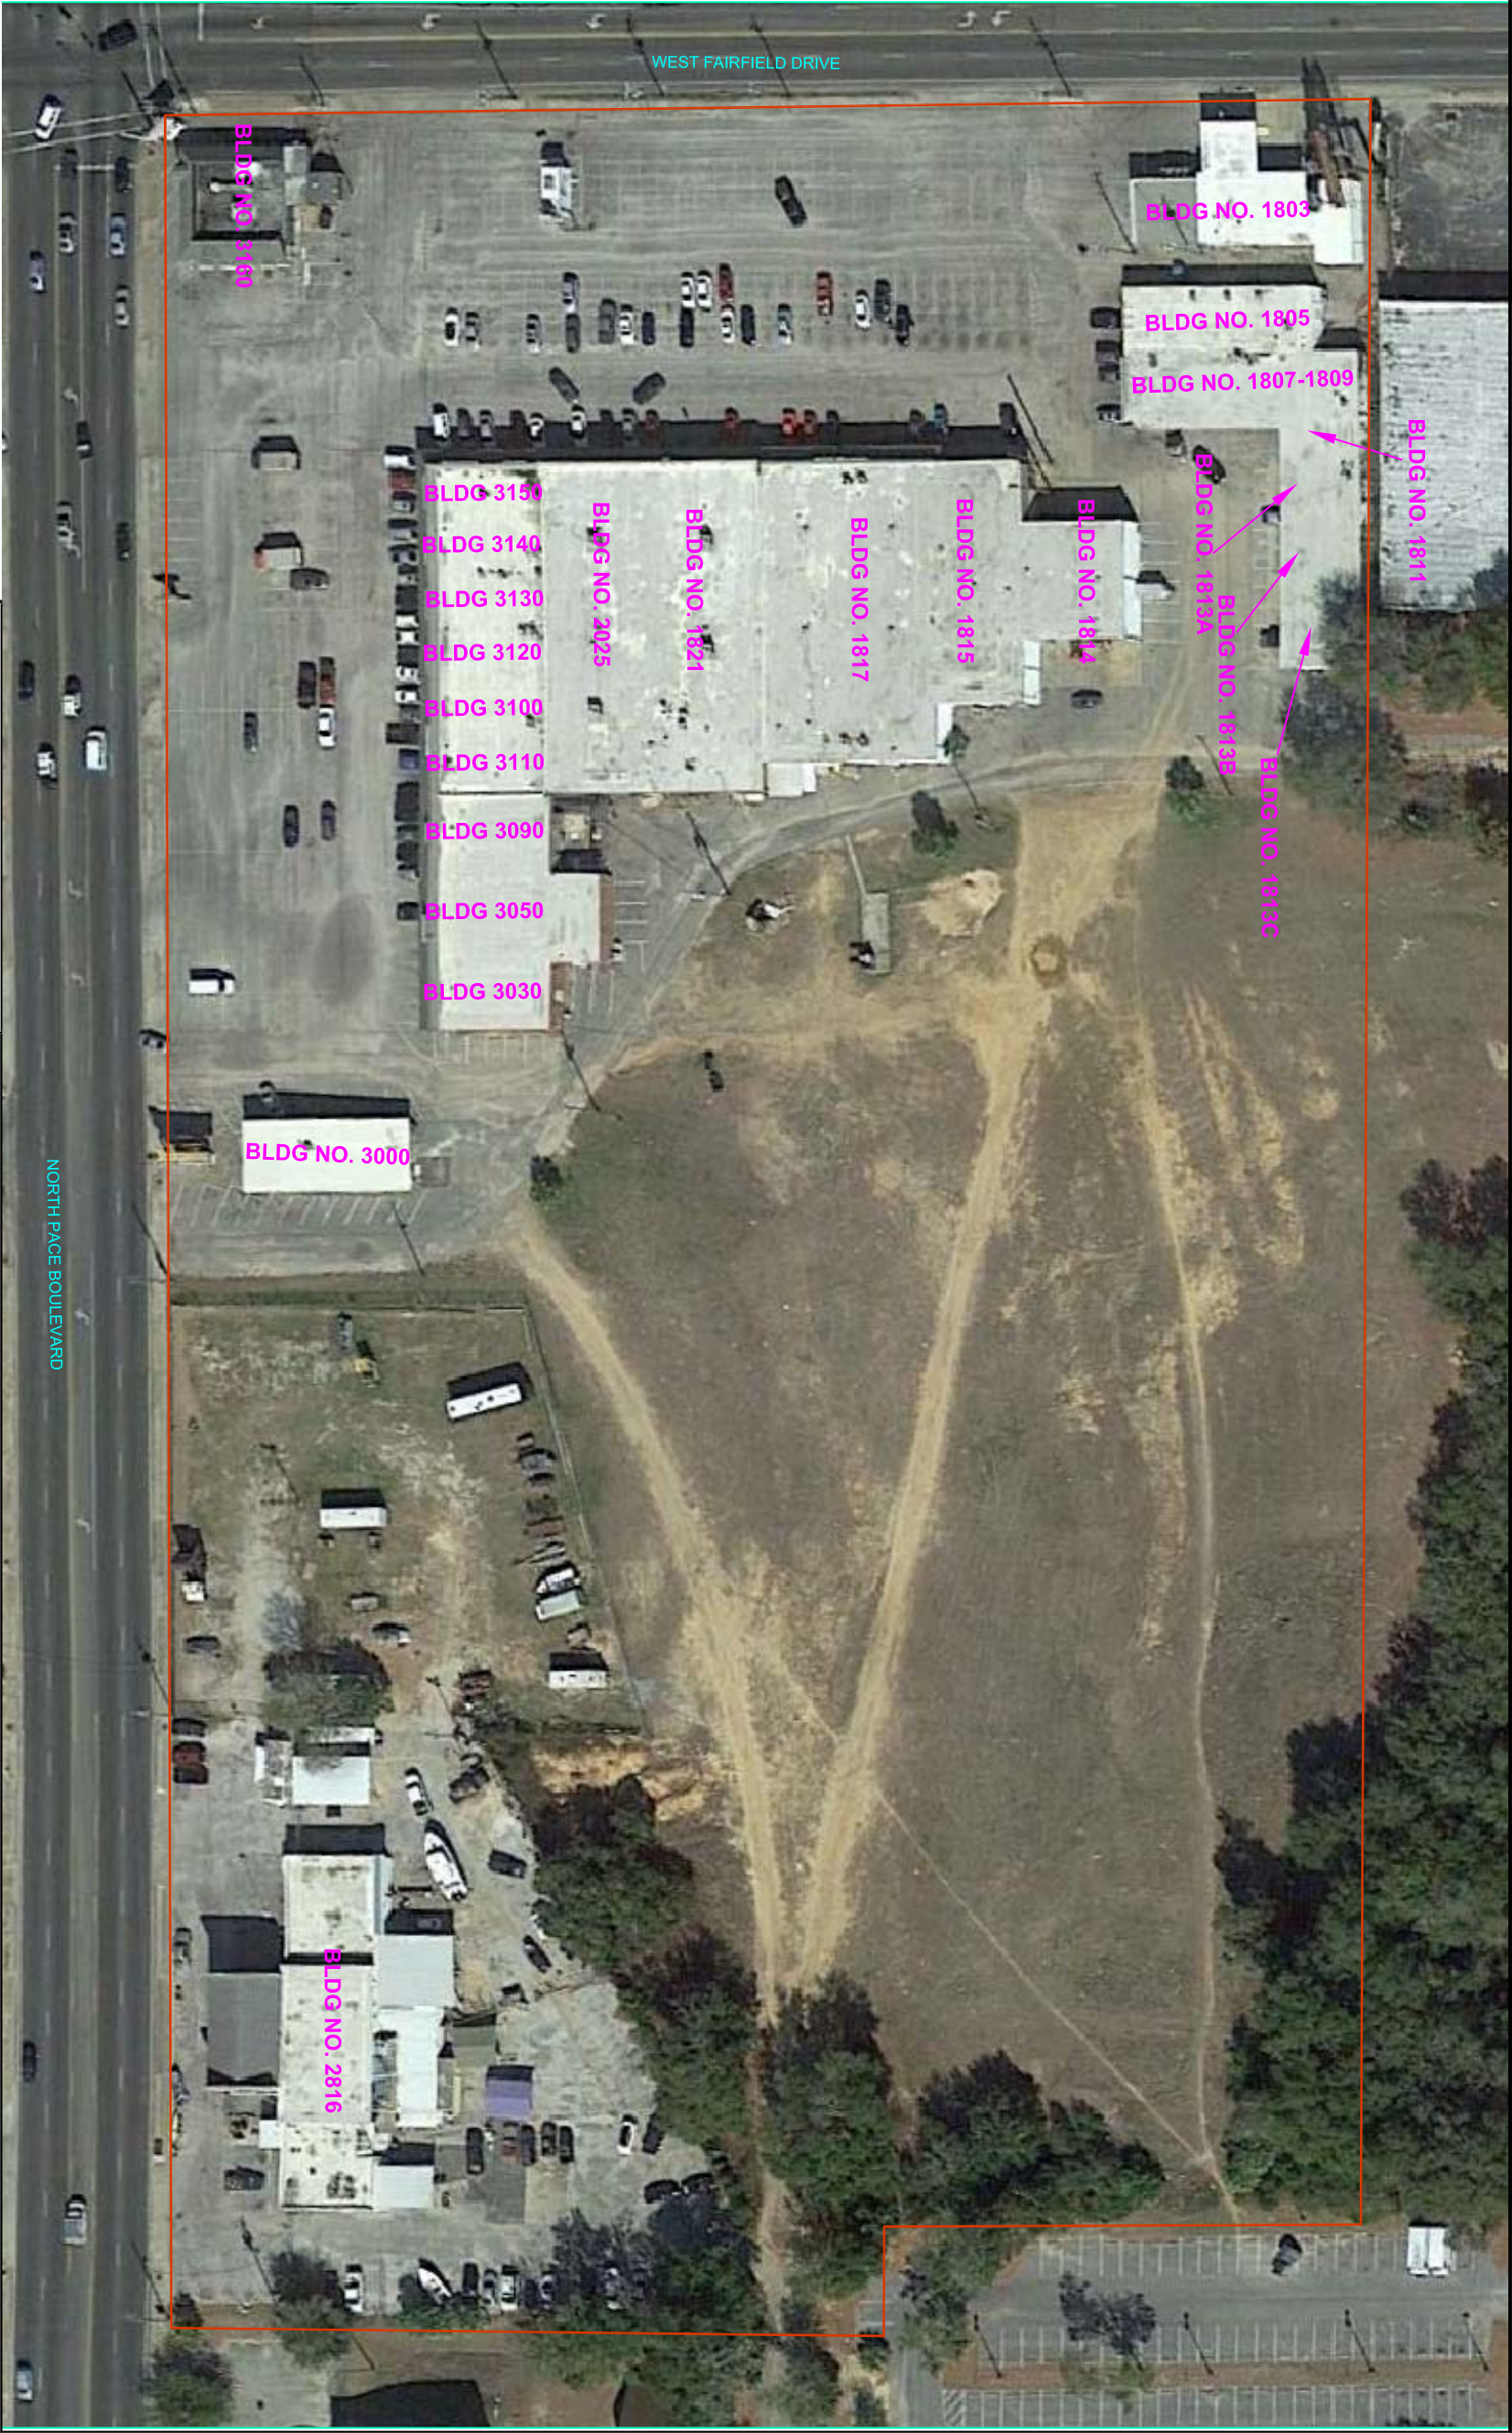
FIGURE 1  
SITE MAP  
MCDONALD SHOPPING CENTER  
3030 AND 3080 NORTH PACE BLVD.  
PENSACOLA, ESCAMBIA COUNTY, FLORIDA

Approximate Project Boundary

- **Base Bid** - Demolition of the “Outbuildings” defined as Building Nos. 1803, 1805, 1813A, 1813B, 1813C, 3160, 3000, and 2816. Figure 1, provided as Appendix A, shows the approximate locations of these structures on the property.
- **Additive (Add.) Alternate 1** - Demolition of the “Outbuildings” defined as Building Nos. 1803, 1805, 1813A, 1813B, 1813C, 3160, 3000, and 2816, the “Main Building” defined as Building Nos. 1814, 1815, 1817, 1821, 2025, 3150, 3140, 3130, 3120, 3100, 3110; and

the “Building Extension” defined as Building Nos. 3090, 3030, 3030. Figure 1, provided as Appendix A, shows the approximate locations of these structures on the property.

- **Additive (Add.) Alternate 2** – Demolition of the “Outbuildings” defined as Building Nos. 1803, 1805, 1813A, 1813B, 1813C, 3160, 3000, and 2816; and the “Building Extension” defined as Building Nos. 3090, 3050, 3030. Figure 1, provided as Appendix A, shows the approximate locations of these structures on the property.

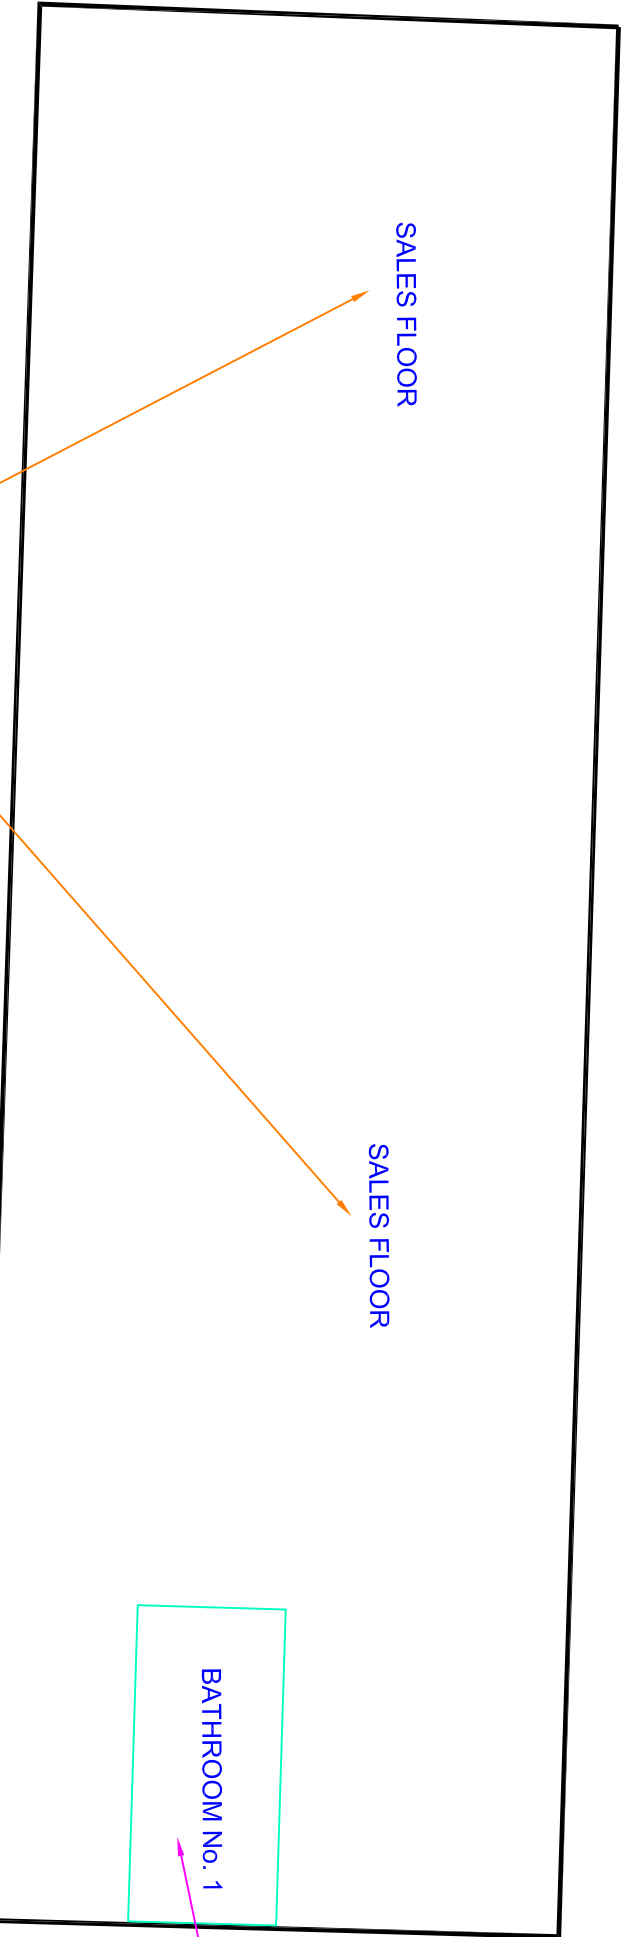
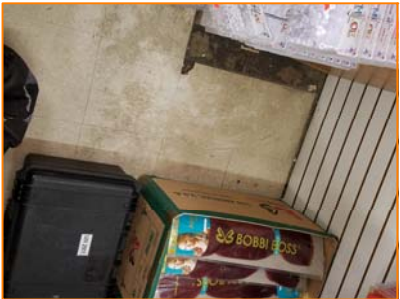
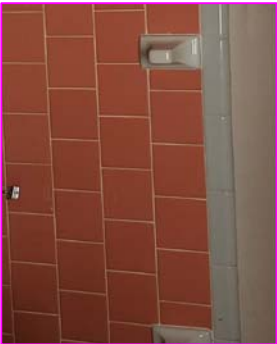
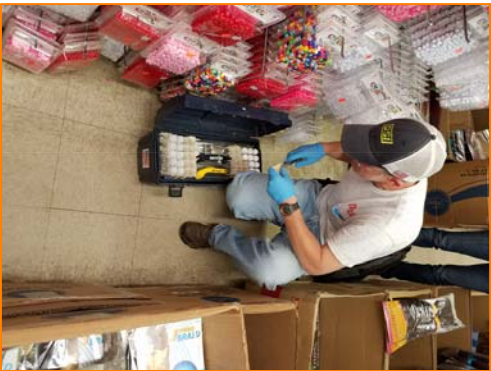
Orange = Approximate Location of Asbestos Containing Materials.  
Magenta = Approximate Location of Materials Coated in Lead Based Paint

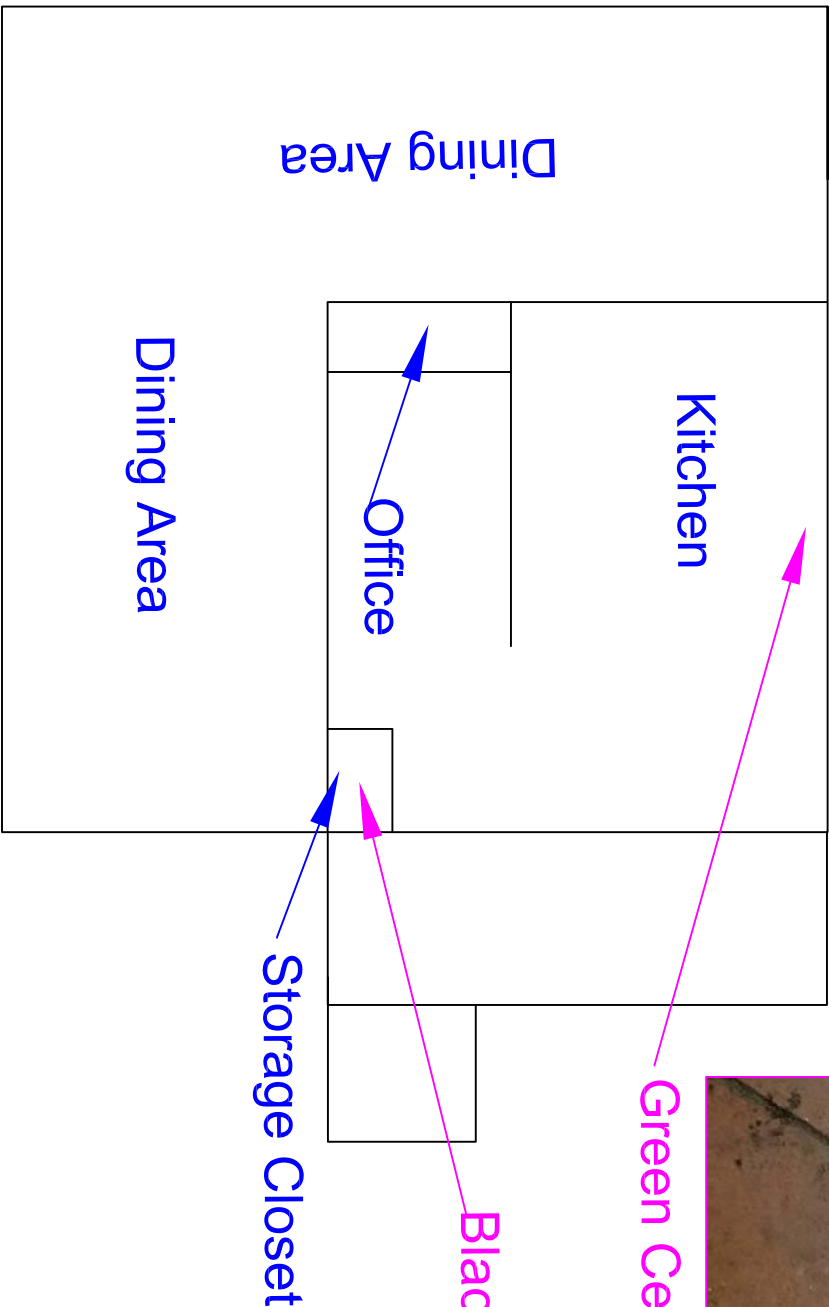
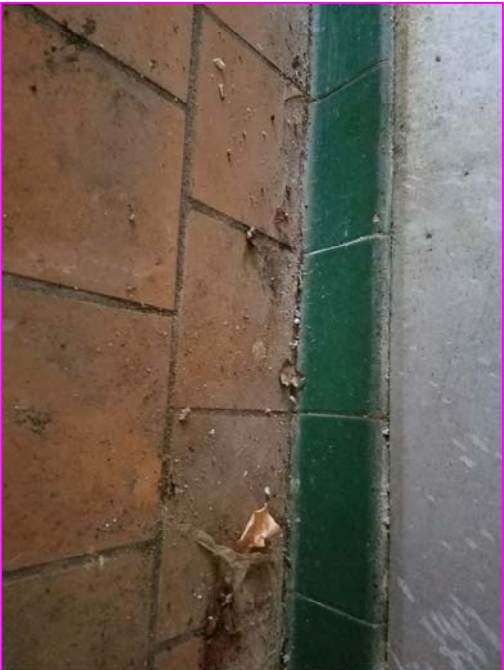
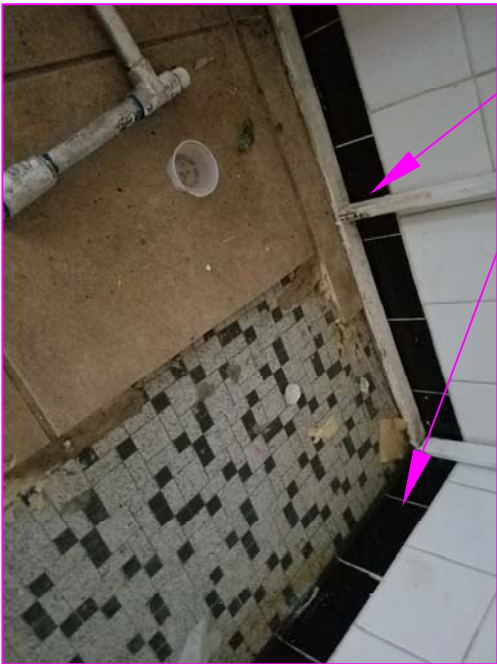
FIGURE 2F  
LEAD BASED PAINT LOCATIONS  
BUILDING 3160  
FORMER HOMESTEAD KITCHEN  
THE MCDONALD SHOPPING CENTER  
PENSACOLA, ESCAMBIA COUNTY, FLORIDA

- Orange = Approximate Location of Asbestos Containing Materials.
- Magenta = Approximate Location of Materials Coated in Lead Based Paint

Green Ceramic Tile

Black Ceramic Tile
