# **Preliminary Engineering Assessment (PEA)**

## **Pensacola Beach Gulf Pier**

Escambia County, FL

April 5, 2021

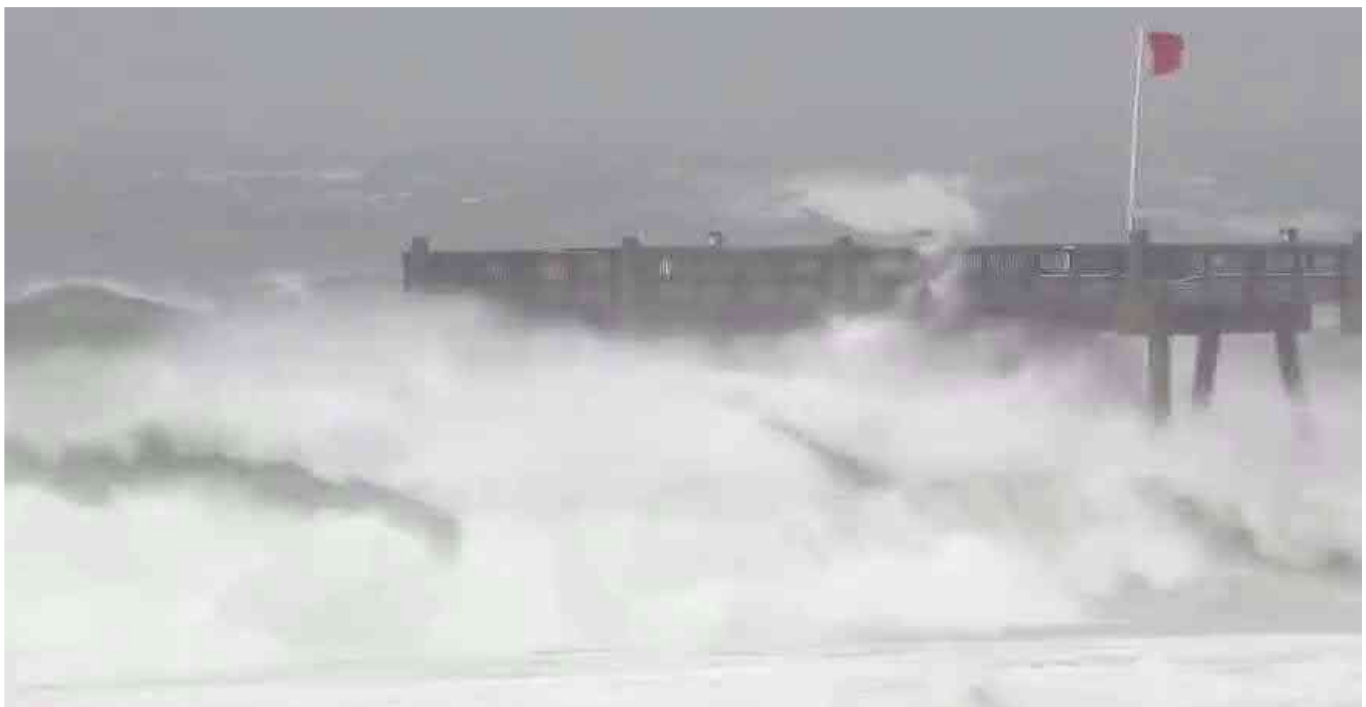
The Pensacola Beach Gulf Pier, also known as the Casino Beach Fishing Pier, was subjected to high winds and wave impacts which caused extensive damage in several areas. The hydraulic forces from wave action dislodged multiple timber deck blowout panels, damaging the timber deck members and shifting the panels. High winds and wave loading destroyed the timber pedestrian railing along with the attached electrical, lighting and water utilities. In addition, concrete damage to piling, pile caps and beams occurred from water forces, debris impacts and the movement of the pier under lateral loads. Mott MacDonald visited the pier on multiple occasions from 10/01/2020 to 12/18/2020 to assess the damage documented in this report. Observations were limited to visual identification above water and does not document damage that may have occurred to piling below the waterline. Plans and a previous comprehensive condition report are not available for the pier. Escambia County indicated that damage from previous storms had been repaired prior to Hurricane Sally. This report identifies damage that was likely caused by Hurricane Sally. Damage identified that was not likely caused by Hurricane Sally was not included in the opinion of probable costs for repairs.

*Figure 1 – Pensacola Beach Gulf Pier, 09/14/20*

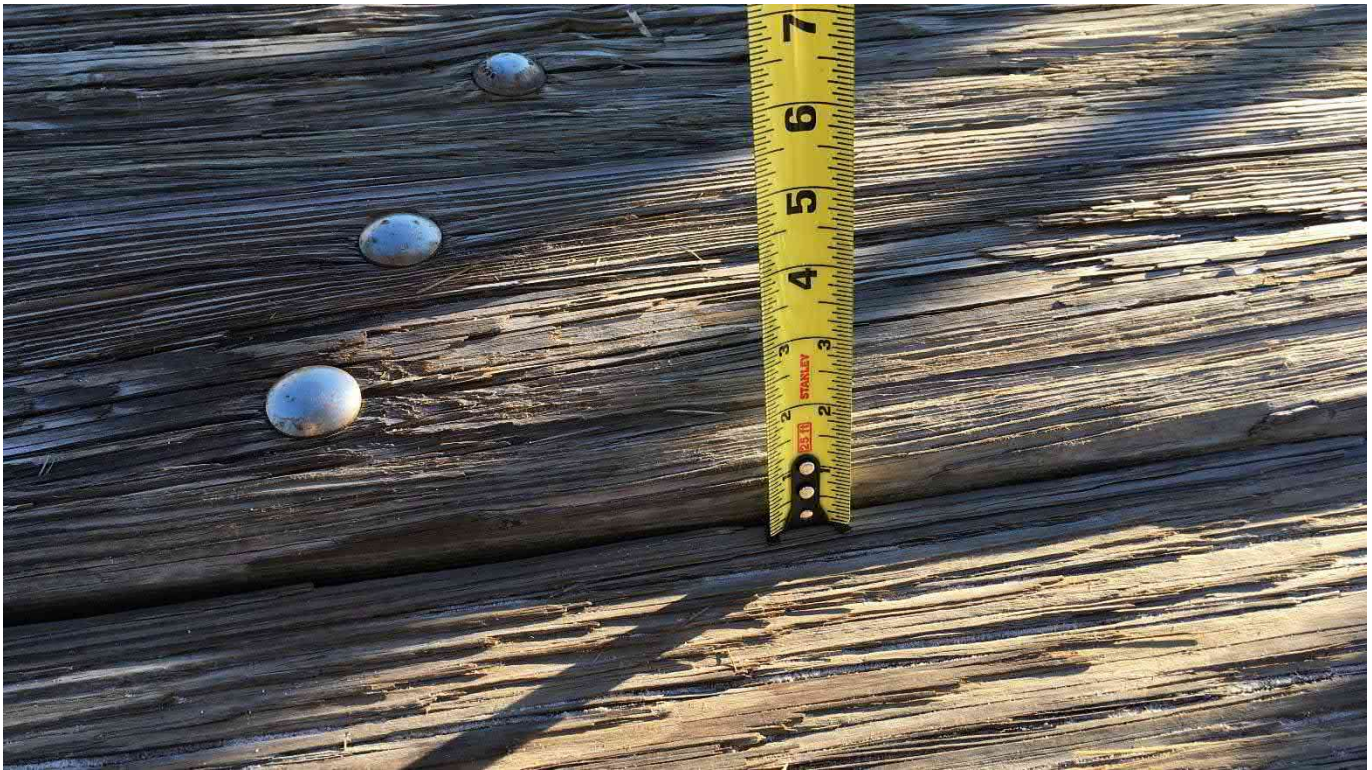
Without additional repairs, replacing blown out panels following a hurricane will not restore the deck to its pre-storm condition. Damaged or warped timbers result in a deck condition with gaps and dips that exceed the Americans with Disabilities Act Guidelines (ADA). ADA Section 302.3 limits the openings between deck members or timber gaps to 0.5" maximum. ADA Section 303.3 requires that changes in level between 0.25" and 0.5" high be beveled with a slope not steeper than 1:2. ADA Section 303.4 requires that changes in level greater than 0.5" high be ramped. Replacement of blown out panels requires replacement of any warped or damaged timbers, repairing concrete spalls, adjusting the spacing of all panels in the span and beveling edges to produce a deck surface that meets ADA Section 303 guidelines. Figures 5 and 6 show typical gaps and dips between blowout panels that exceed 0.5" and do not meet ADA guidelines.

Figure 5 – Timber Deck Blowout Panel Dip > 0.5"

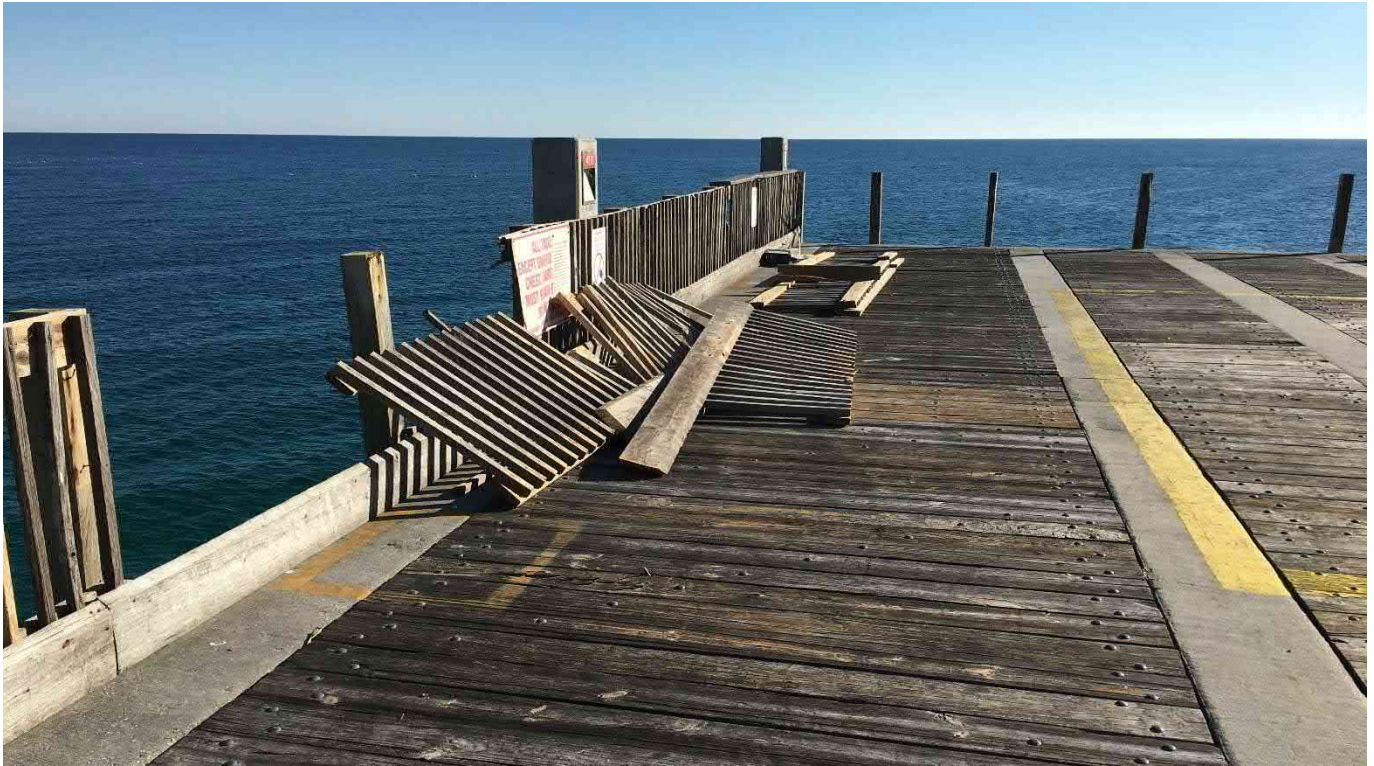
Wind and waves from Hurricane Sally severely damaged the pedestrian railing along the full length of the pier. Figure 7 shows a typical section of railing which has been completely blown out with only the posts remaining. Remaining posts have been loosened and the timber surface has been damaged where attachments have been ripped away. Also shown in Figure 7 is the damage to a water line and the pier lighting system which included railing lights at mid-span. Where sections of railing remain standing as shown in Figure 8, the railing is loose with timber members damaged and splitting. Typical damaged timber members are shown more closely in Figure 9 where the wood has split. These damaged members cannot be brought back to a condition that meets the building code strength requirements without using epoxy repairs which exceed the cost of the timber. Because it is not economically feasible to salvage the remaining pedestrian railing, the entire railing must be replaced to restore the structure to its pre-storm condition. Replacement of the railing will also require replacement of the attached utilities including electrical, lighting, and water as well as the signage located along the full length of the pier. A damaged viewing telescope was also attached to the railing. The flagpole located at Bent 46 was broken during the storm as shown in Figure 10. The storm also destroyed the entrance gate at Bent 7. Refer to the Photo Log in Appendix A for full documentation of the damage.

*Figure 8 – Pedestrian Railing Destroyed End Spans*

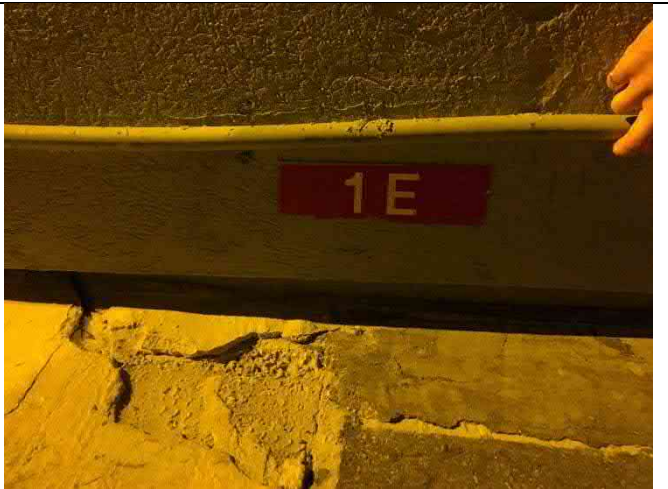
Bent 1E – Closure pour spall 18”x18”x1” (previous)

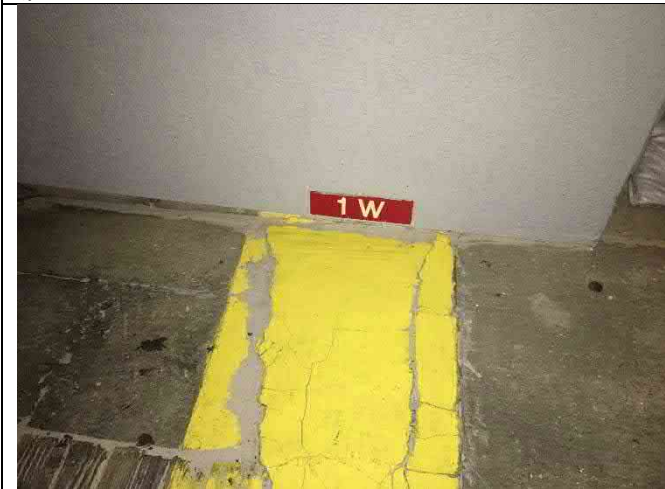
Bent 1W – Closure pour cracking (previous)

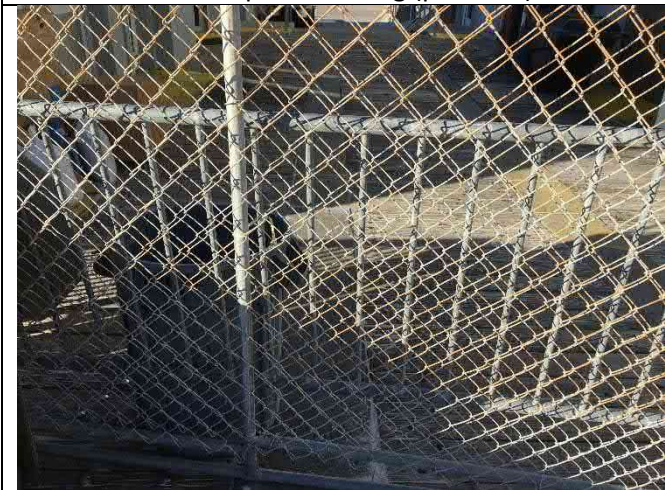
Span 3 - Temporary Fence between B3 and B4

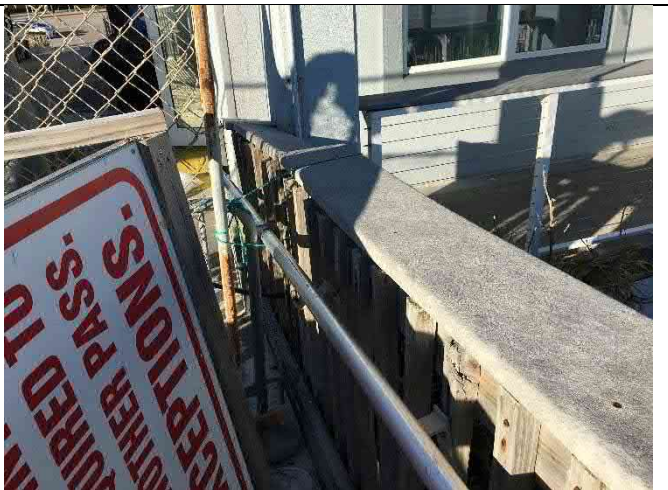
Span 3E – Railing damage (25’ of railing from B4)

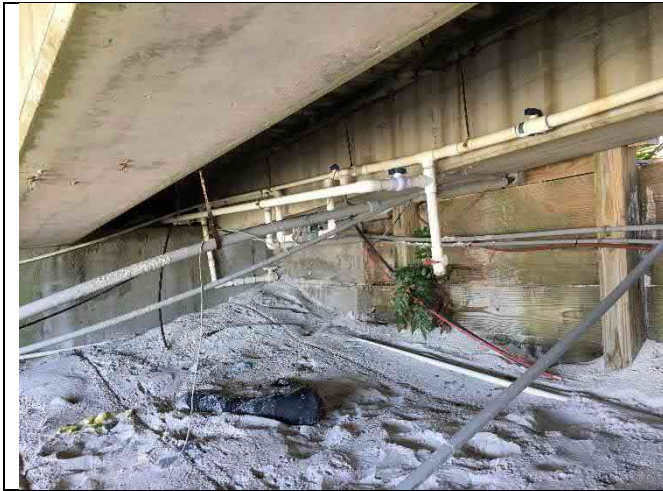
Bent 3E – Water and electrical conduit damage

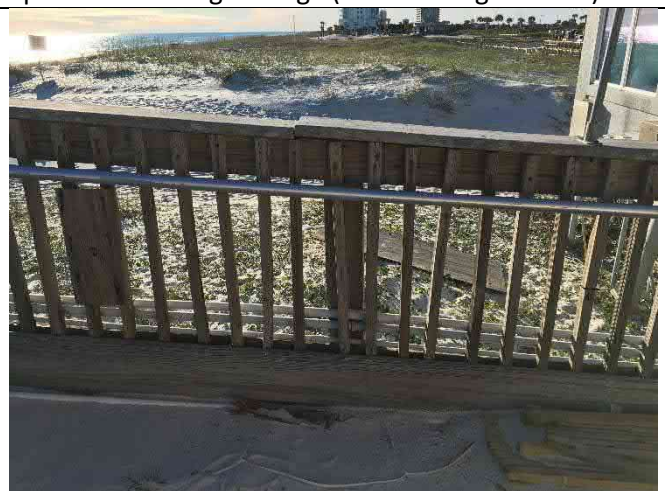
Span 3W – Loose and damaged railing components

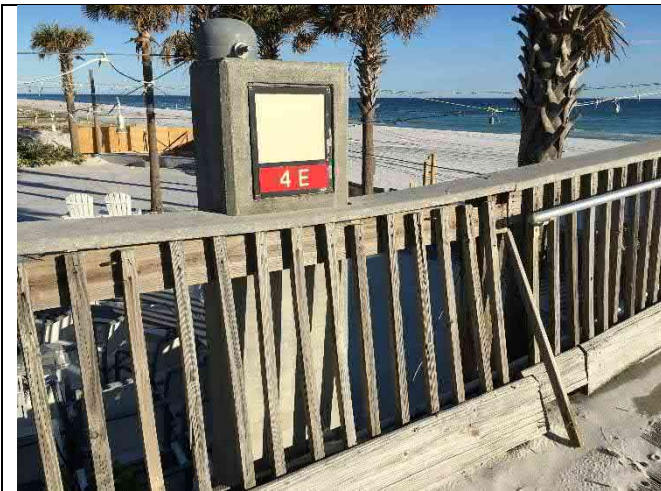
Bent 4E – Railing damage

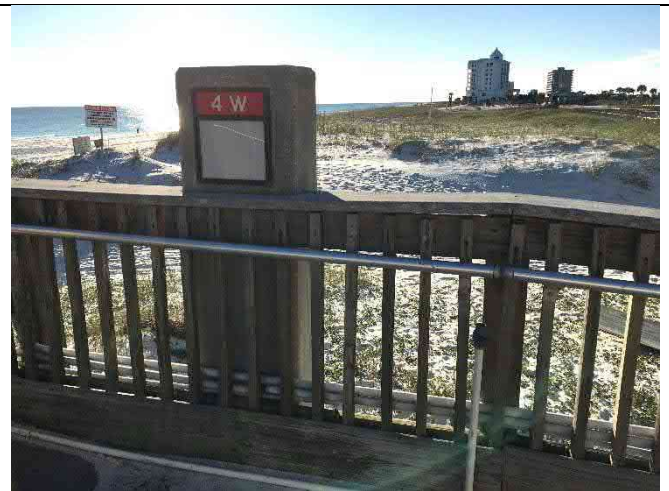
Bent 4W – Loose railing components

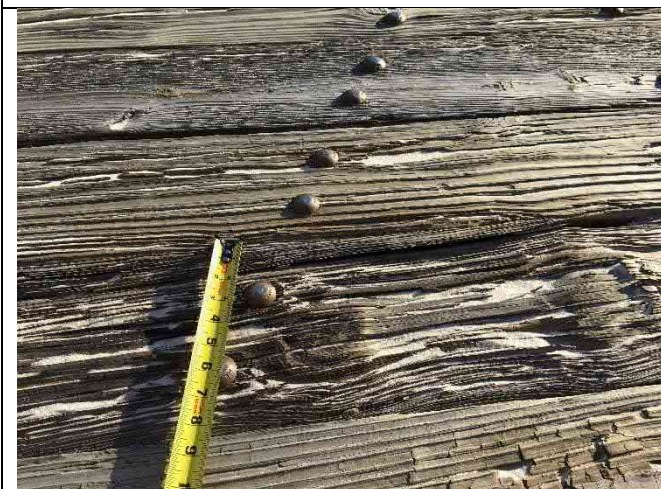
Span 4 – Rough deck surface with changes in elevation between 0.25" and 0.5" without bevel and greater than 0.5" exceeding ADA 4.5.2 limits.

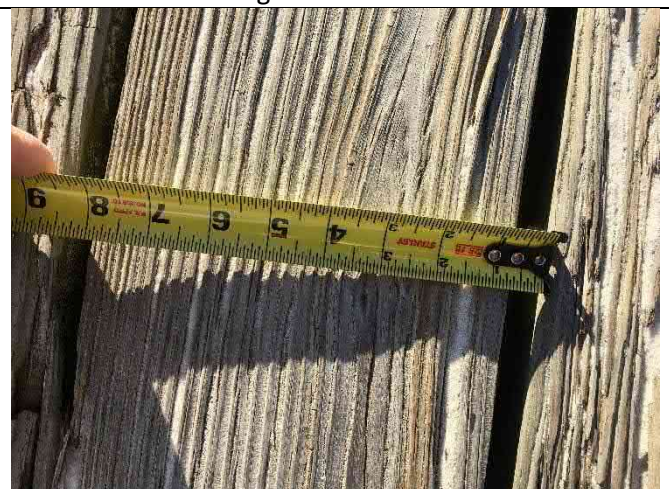
Span 4 – Deck opening greater than 0.5" exceeding ADA 4.5.4 limits.

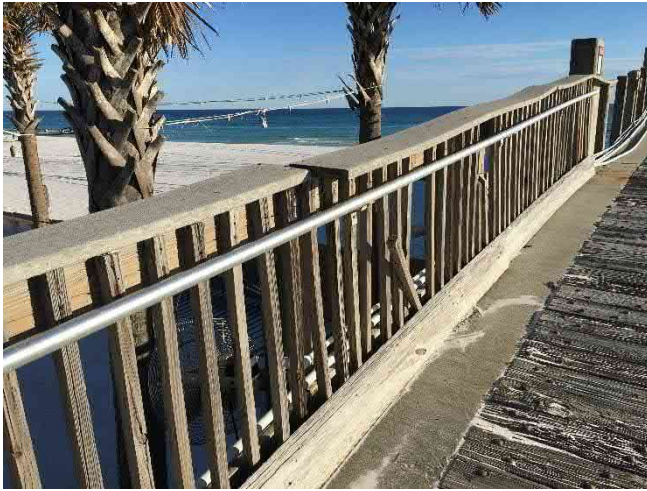
Span 4E – Railing damage and loose components

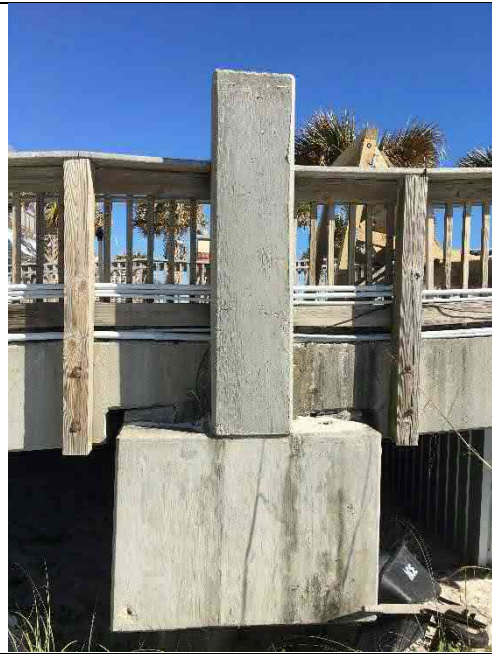
Bent 4W – Pile cap spall and closure cracking, loose railing components

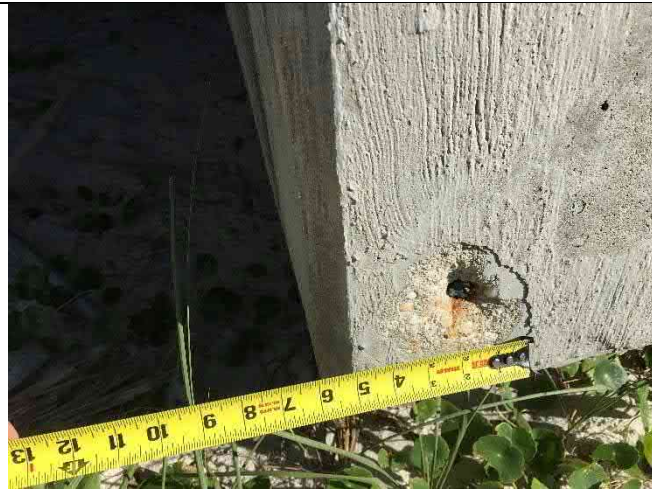
Bent 4W – Pile cap spall 3"x3"x2"

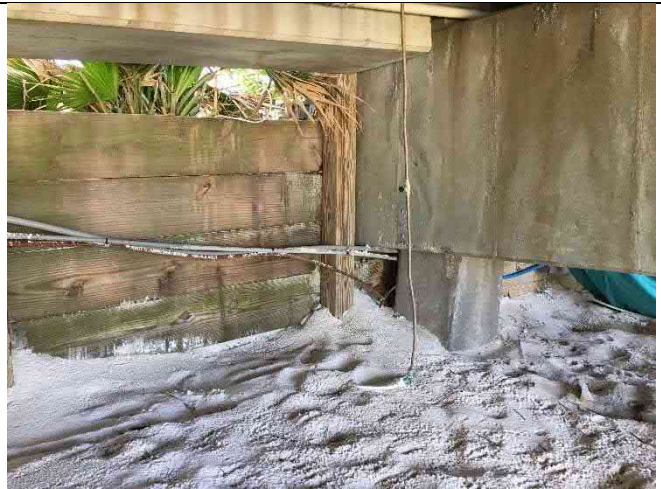
Bent 4E – Pile spall 6"x4"x1"

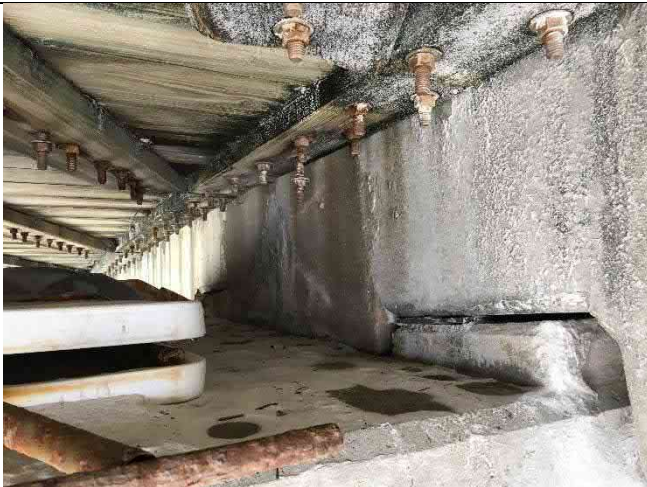
Bent 4 Center – Closure cracking, loose bolts

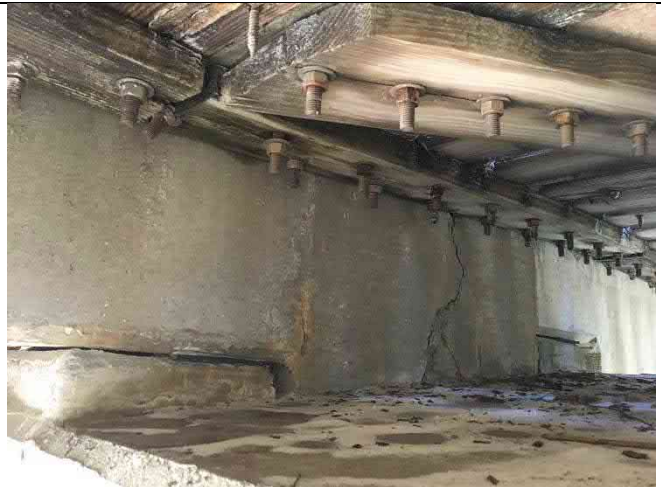
Bent 4W – Closure cracking, loose bolts

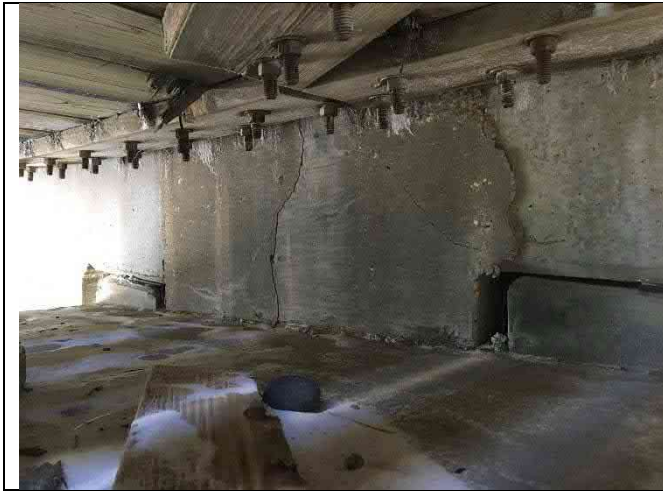
Bent 4 Center – Closure cracking

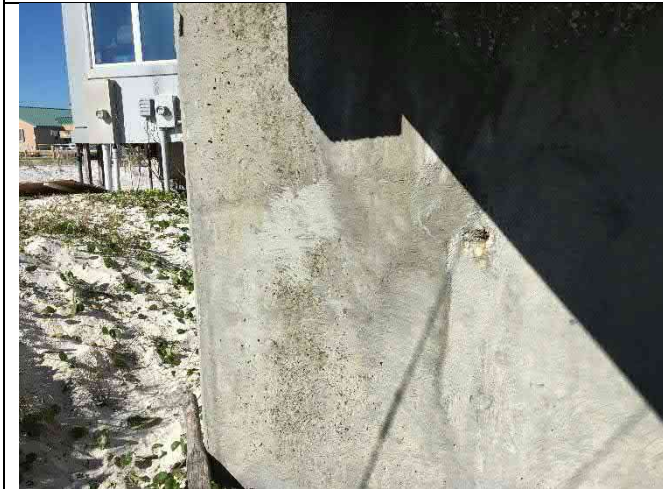
Bent 4W South – Cap spall 2"x2"x1"

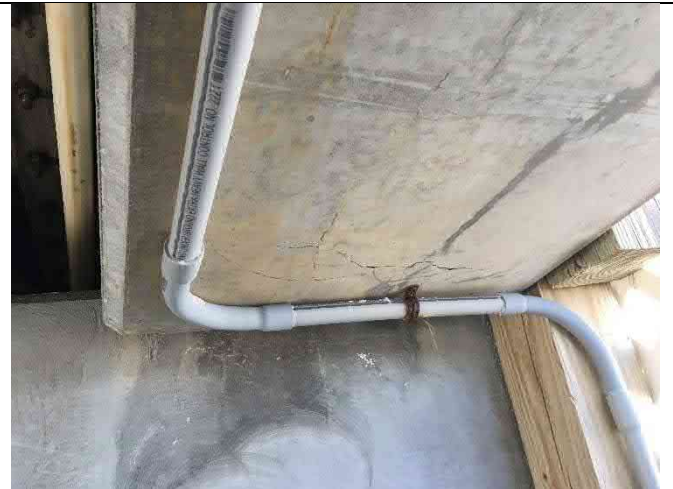
Beam 4-1 North – Bottom flange cracking and spall forming, longitudinal bottom flange cracking

5. The prestressed beams show signs of longitudinal cracking along with end cracking and spalls. Repair and maintenance of these beams may require the addition of cathodic protection to prevent future premature loss of structural capacity through delamination and spalling along the length of the strands. Beam end repairs must eliminate future corrosion and be able to withstand wave impact forces.

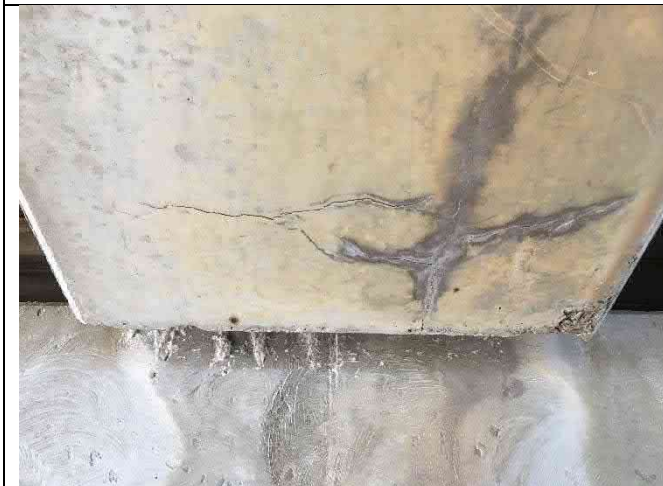
Beam 4-2 North – Bottom flange cracking, spall forming, longitudinal cracking

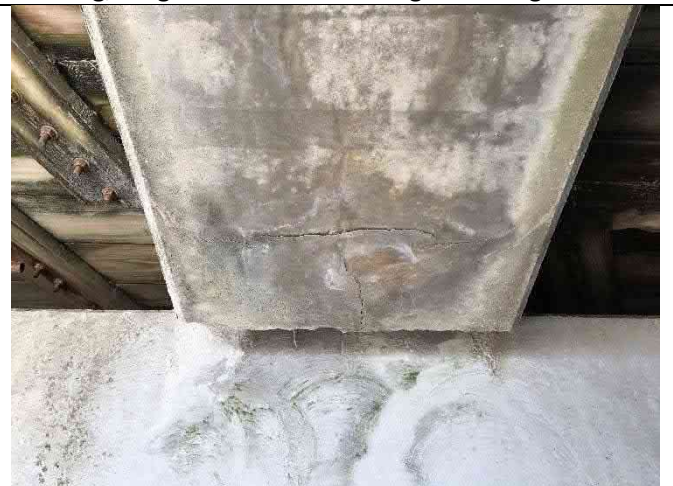
Beam 4-3 North – Bottom flange cracking, spall forming, longitudinal cracking

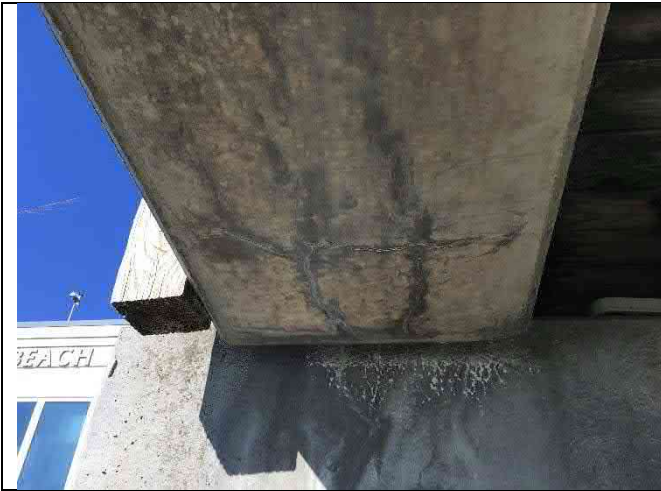
Beam 4-4 North – Bottom flange cracking, spall forming, longitudinal cracking

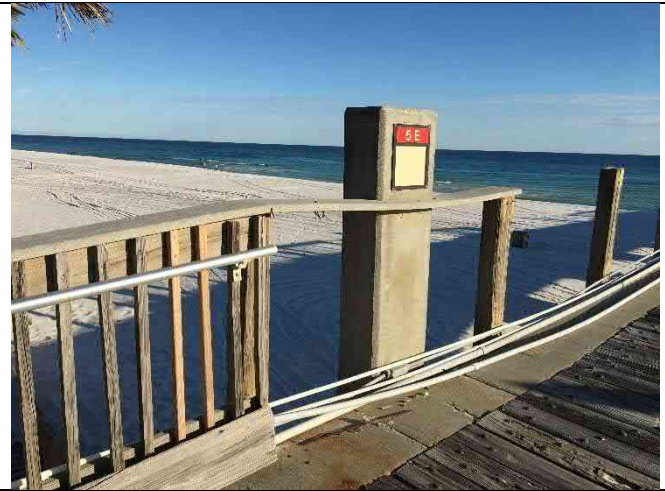
Bent 5E – Railing and conduit damage

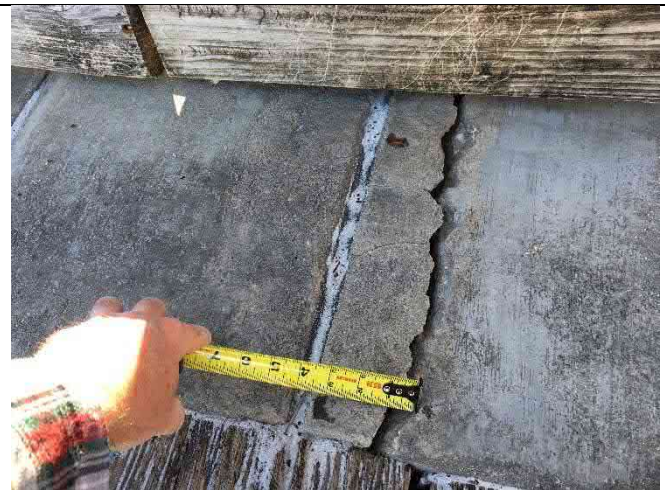
Bent 5W – Railing and conduit damage

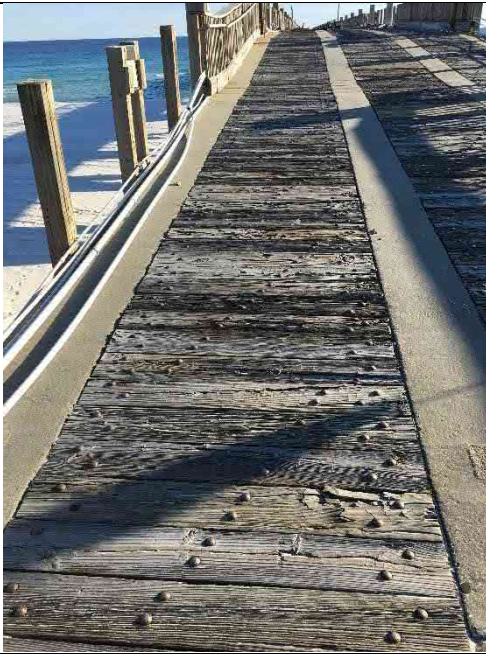
Bent 5E – Closure cracking, missing railing, loose posts

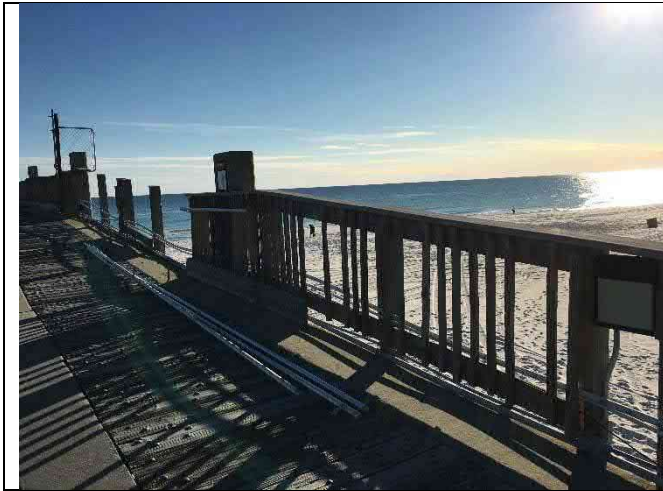
Span 5E – Missing railing (guardrail and handrail)

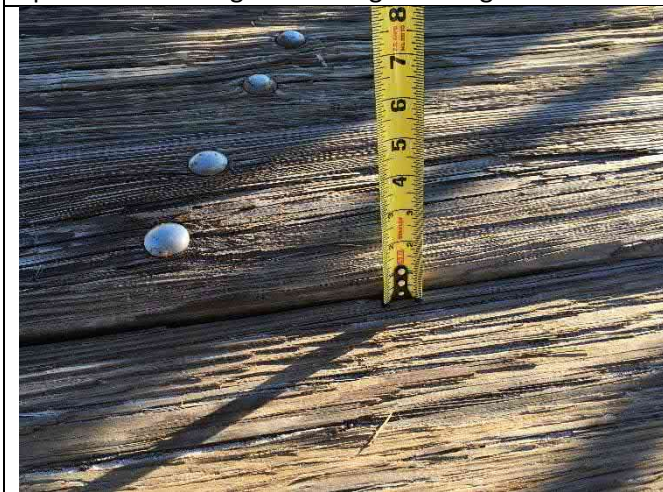
Span 5 - Damaged deck

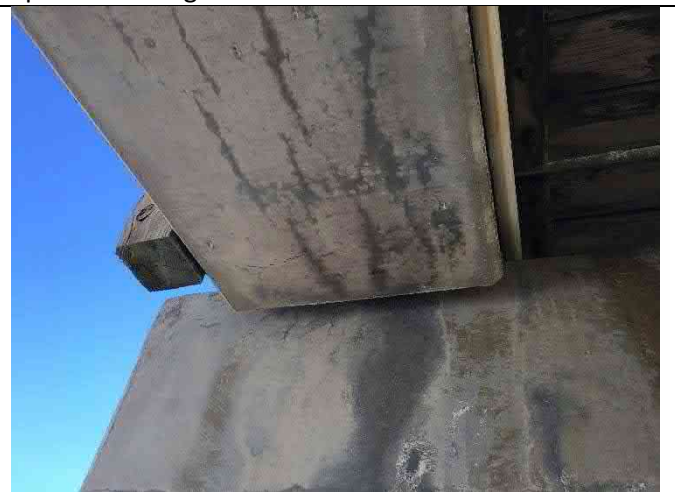
Span 5 Deck – Tripping hazard

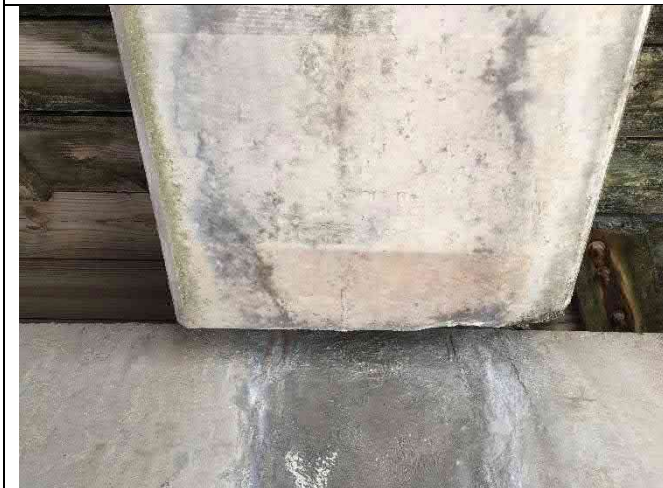
Beam 4-1 South – Bottom flange cracking, end delamination and spall forming, longitudinal cracking

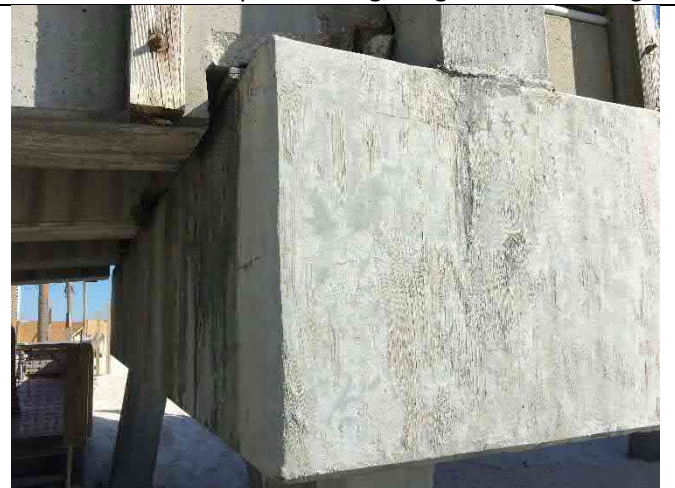
Beam 4-3 South – Bottom flange cracking, end spall and spall forming, longitudinal cracking

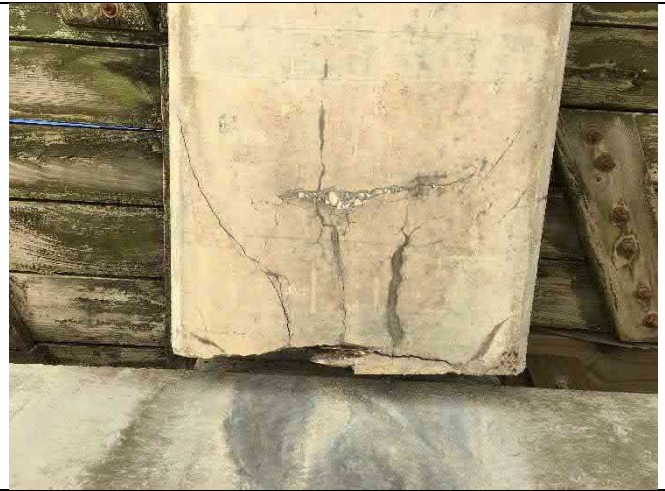
Beam 5-2 North – Cracking and spall 24"x6"x4" bottom flange, longitudinal cracking, spalls on dapped end 16"x8"x1" each side

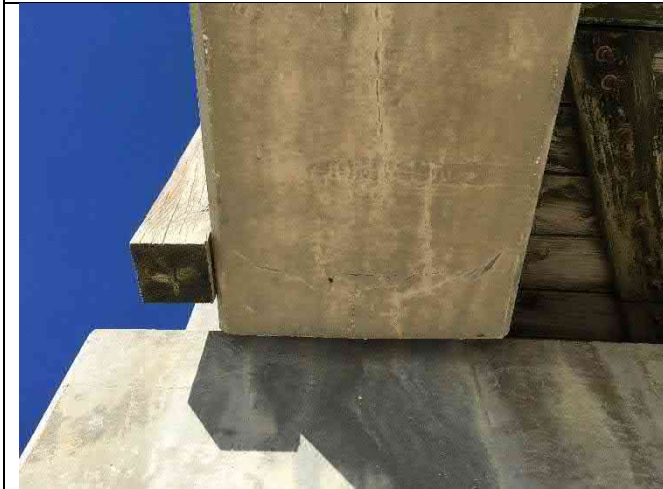
Beam 5-3 North – End cracking, delamination and spall 24"x24"x1", longitudinal cracking

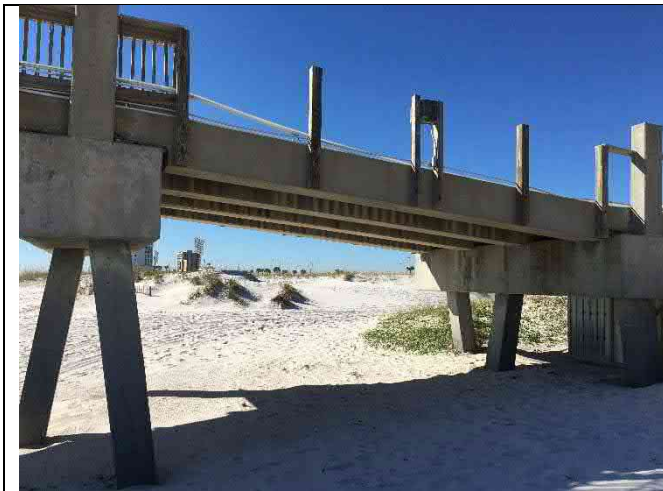
Span 6W Deck	Span 6 Deck – 1.75" Opening > 0.5"

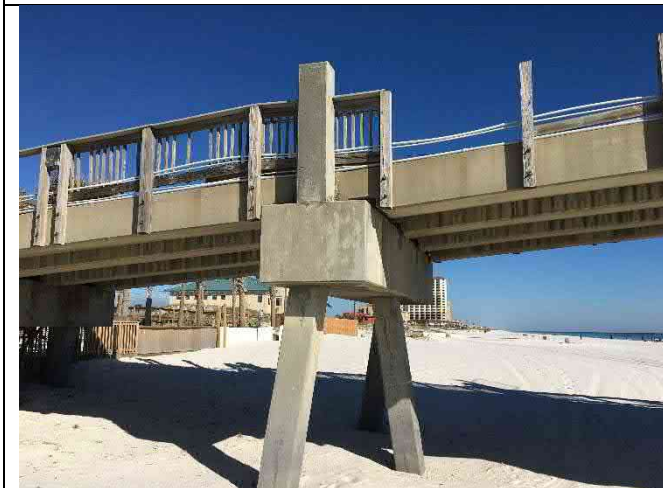
Bent 6E – Minor pile cap cracking (2' +/-), closure cracking end of Beam 5-1

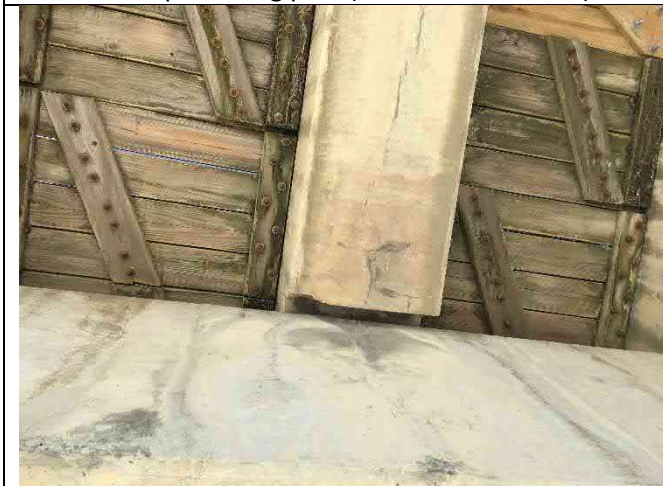
Beam 6-4 North – End spall 24"x6"x4"

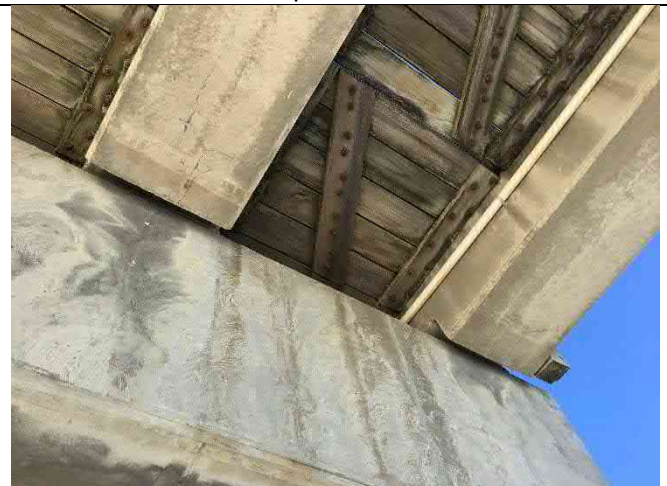
Beam 6-3 North – Small end spall, end cracking and delamination 24"x12", longitudinal cracking

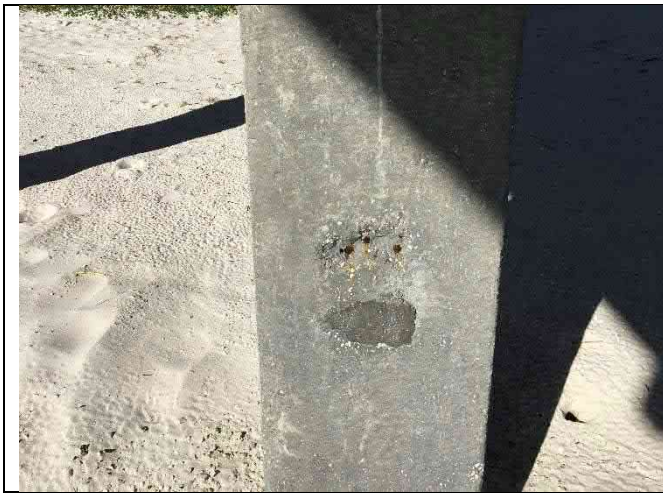
Beams 6-2 and 6-2 North – End cracking and delamination, longitudinal cracking

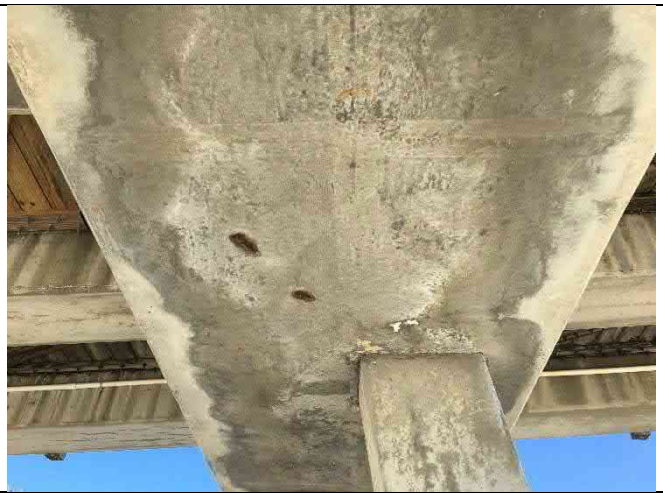
Pile 6-2 – Spall 7"x4"x1"

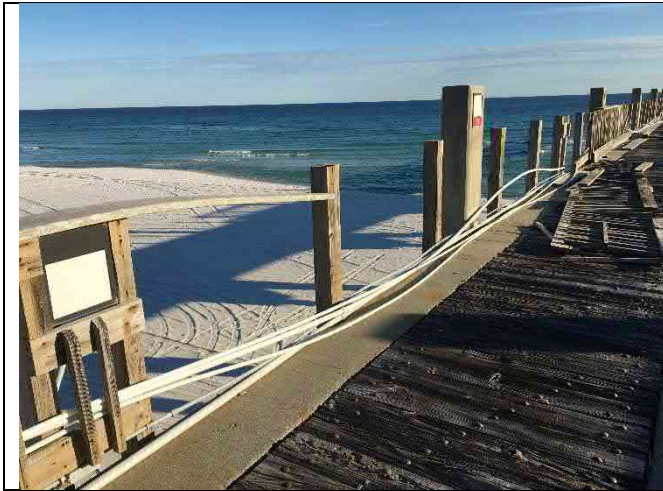
Span 7W Deck	Bent 7 – Missing gate

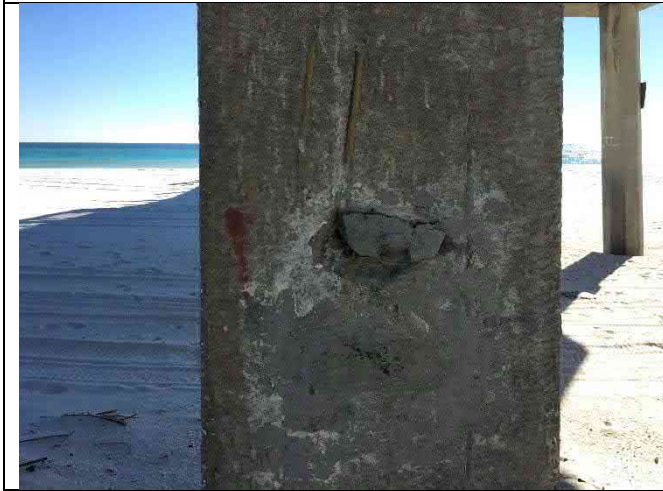
Bent 7 North Face – Spalls piles 7-1 and 7-3,

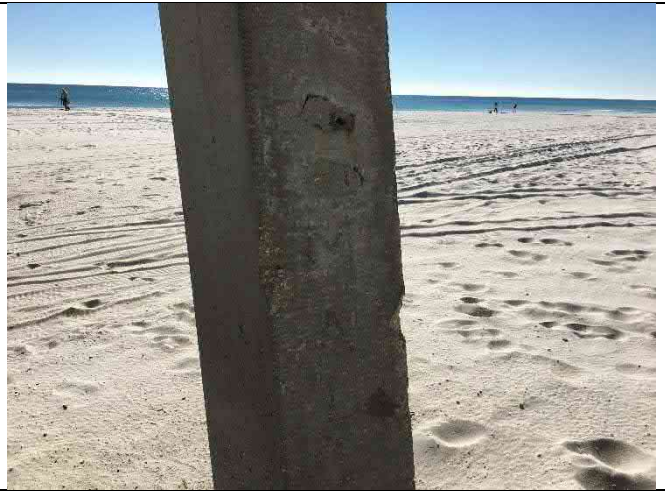
Pile 7-1 – Spall 8"x5"x2"

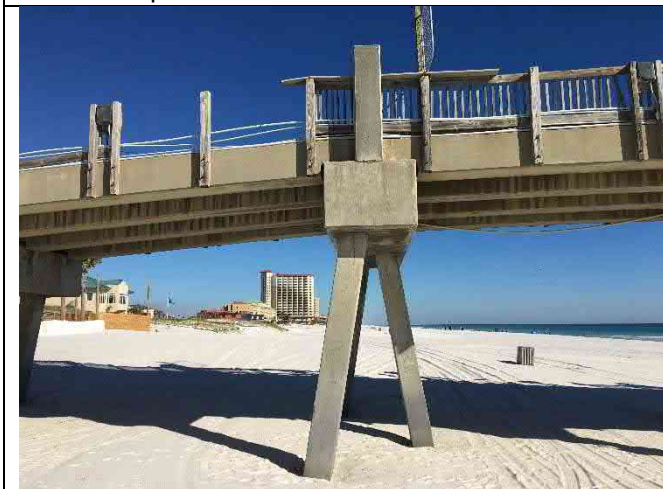
Pile 7-3 – Multiple spalls, 22"x3"x2"

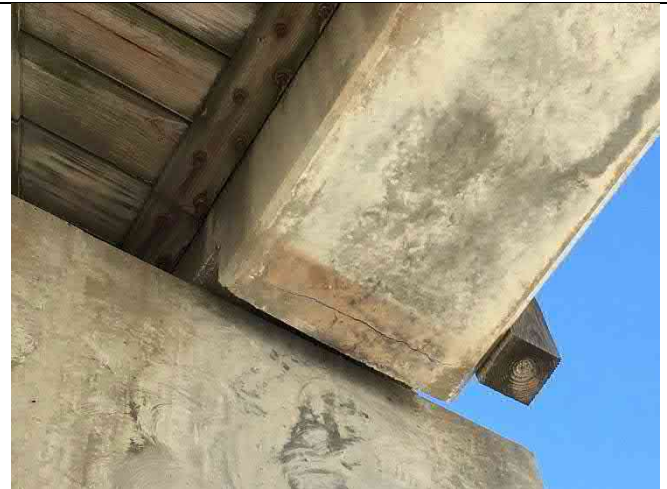
Beam 6-1 South – End cracking and delamination

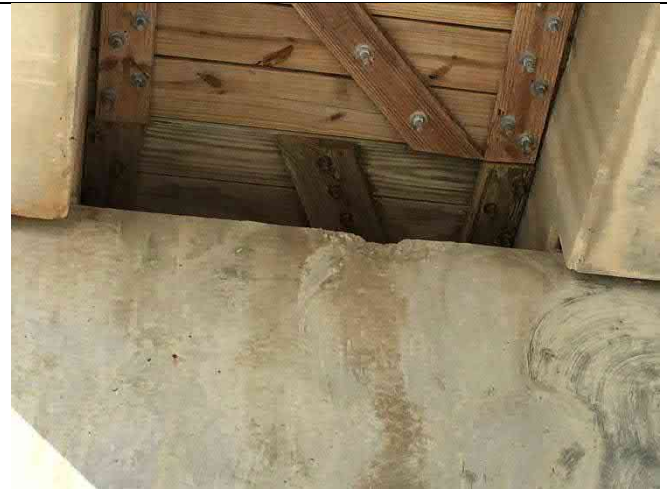
Pile 7-2 – Two spalls 2"x2"x1"

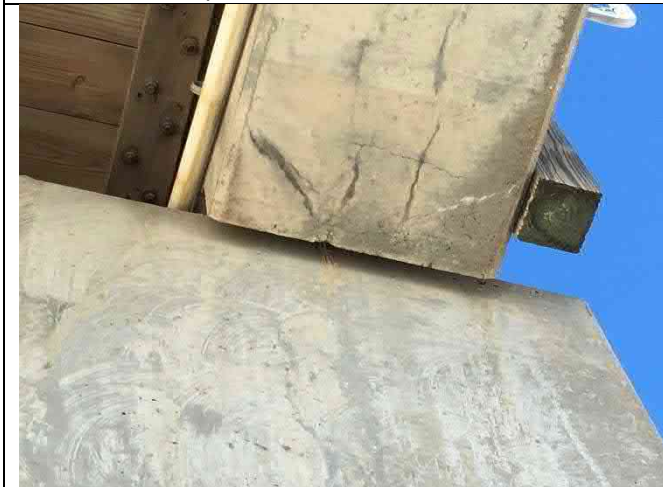
Bent 7 South Face – Spall 8"x4"x2"

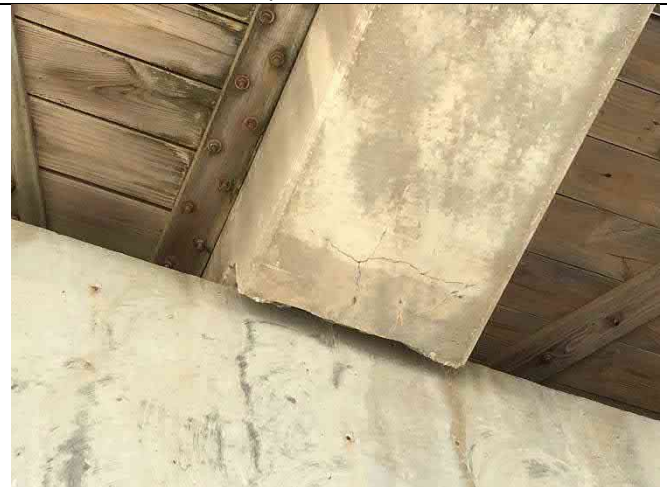
Beam 7-1 North – End cracking and delamination, longitudinal cracking

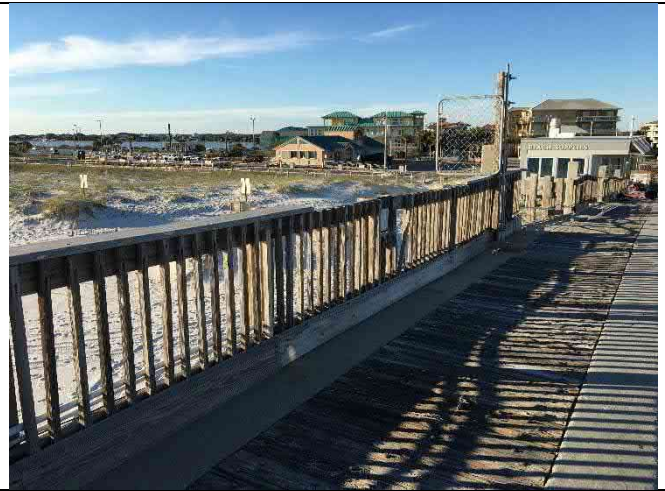
Span 7E – Railing damage

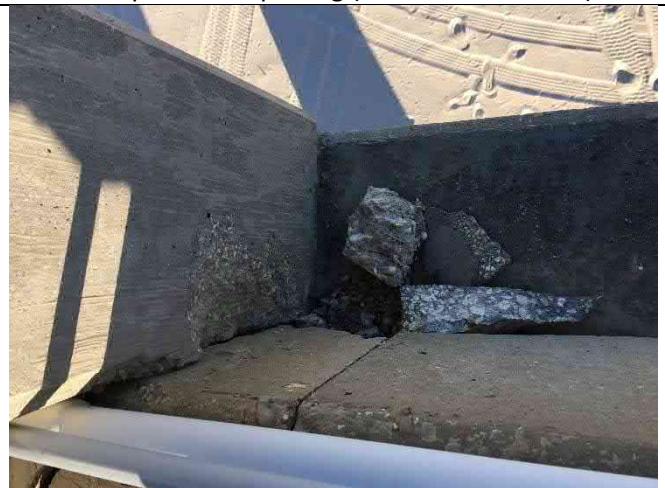
Bent 8E – Railing damage, closure cracking

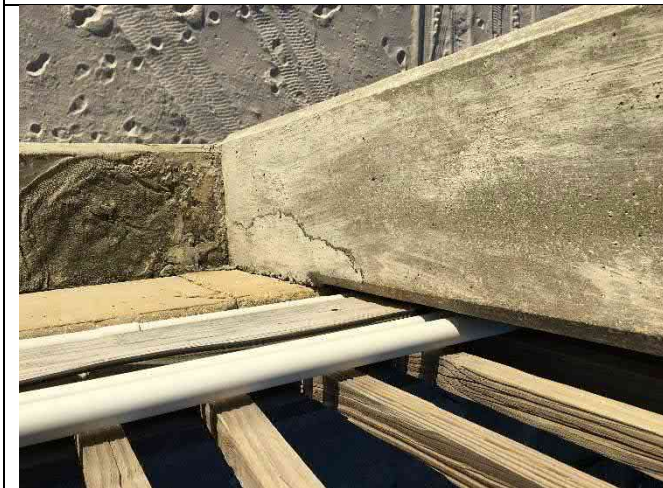
Bent 8E – Light column spall 12"x8"x2", closure spall 12"x6"x4"

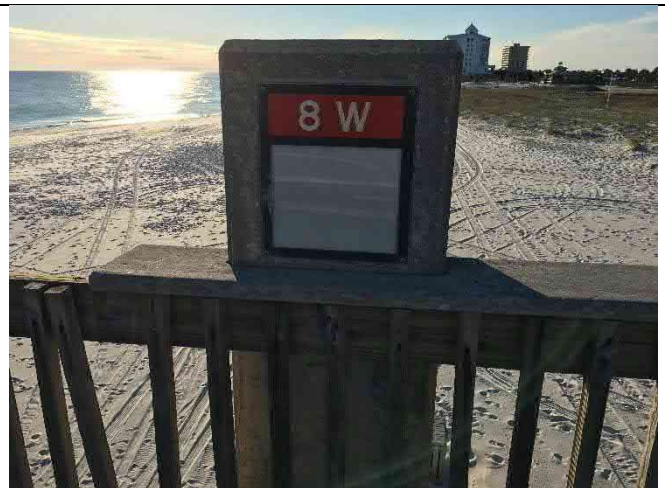
Bent 8W – Previous light column repair good

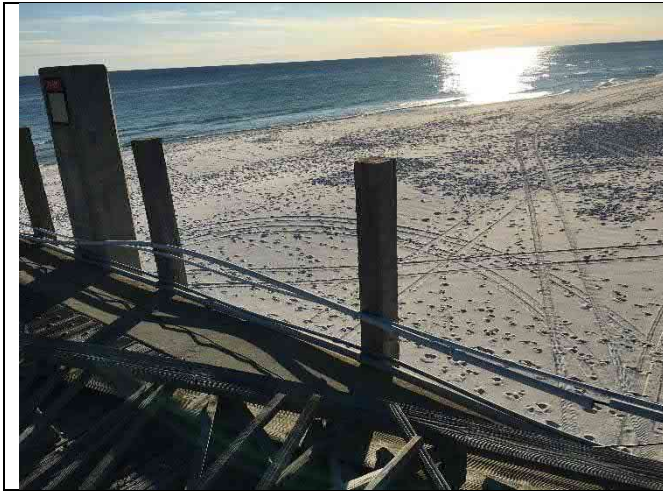
Bent 8W – Railing damage

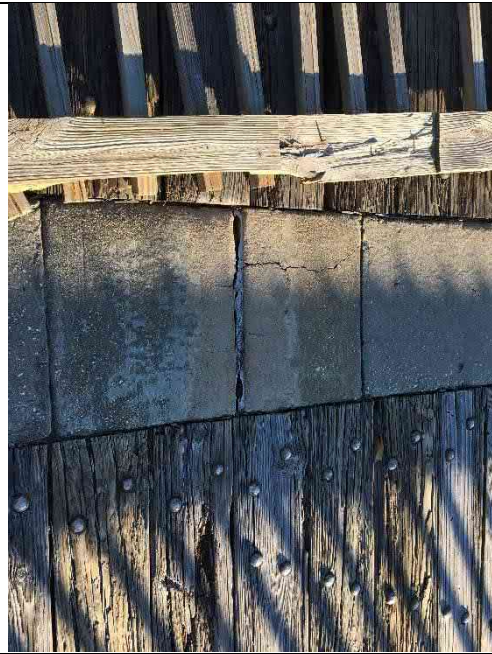
Span 8E Deck, damaged railing and utilities

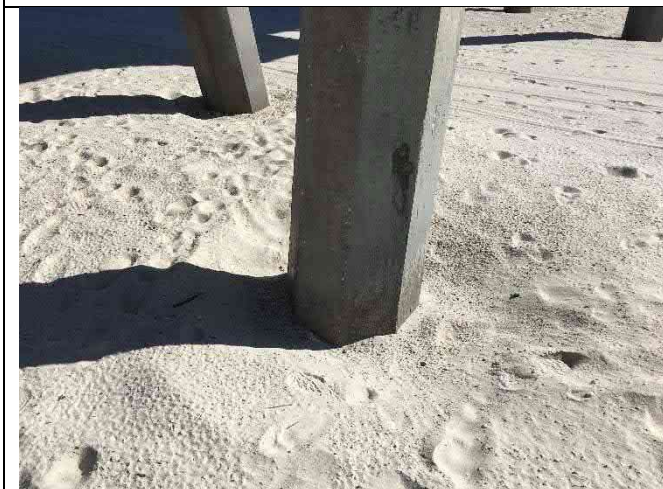
Beam 7-1 South – End cracking and spall 24"x4"x3", longitudinal cracking

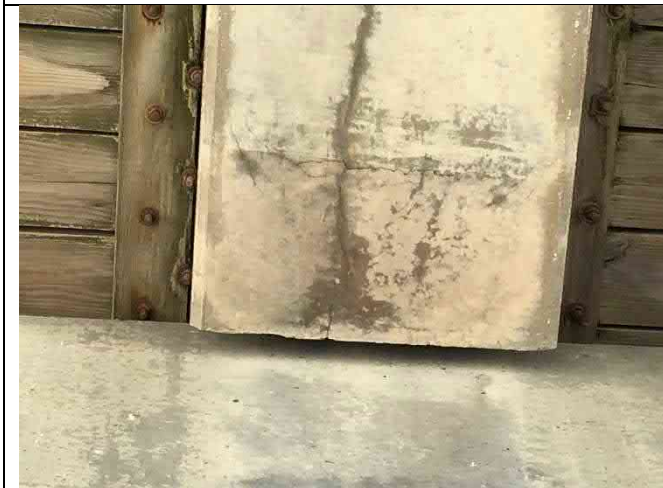
Beam 8-1 North – End cracking and delamination and spall 24"x12", longitudinal cracking

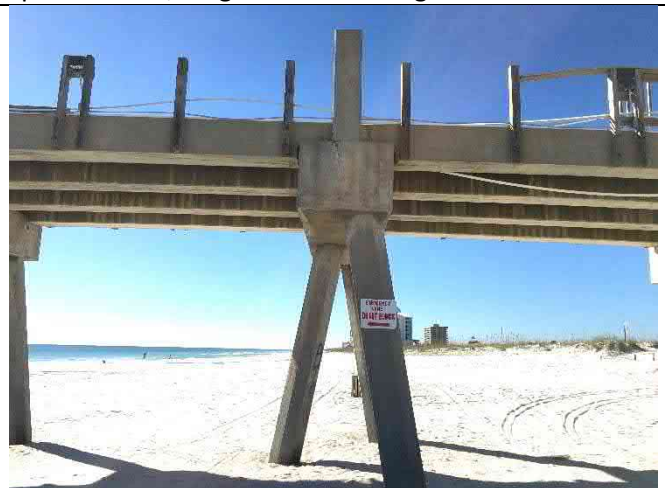
Beam 8-2 North – End cracking and delamination
