# **Preliminary Engineering Assessment (PEA)**

## **Pensacola Beach Gulf Pier**

Escambia County, FL

April 5, 2021

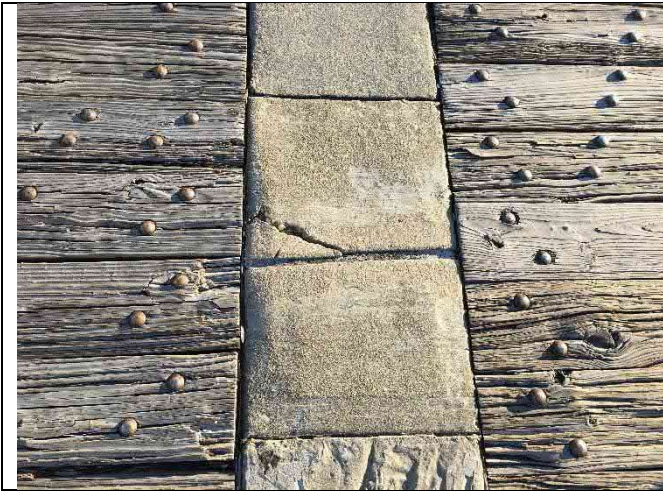
Bent 9W – Damaged railing and utilities

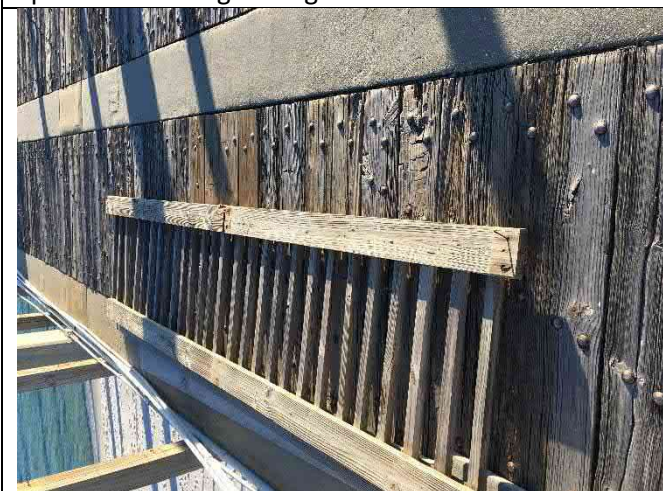
Span 9E – Railing damage

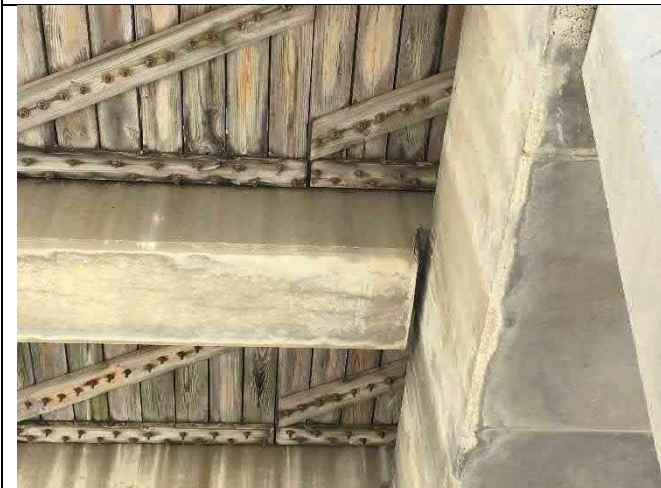
Beam 8-4 South – End spall 8"x4"x3", longitudinal cracking

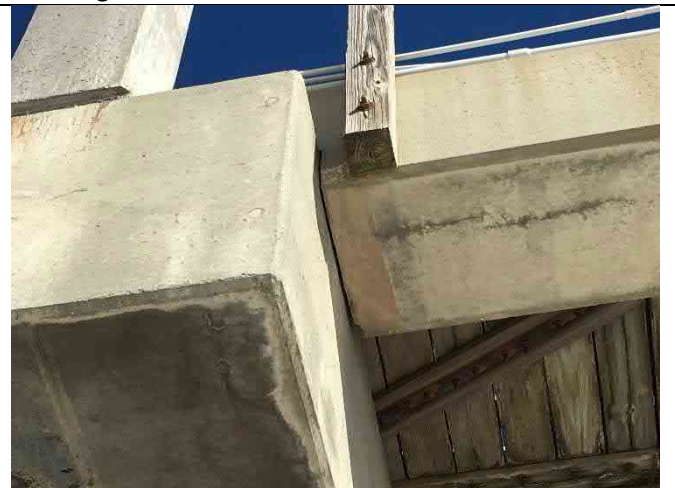
Beam 8-3 South – End spall 4"x4"x2", longitudinal cracking

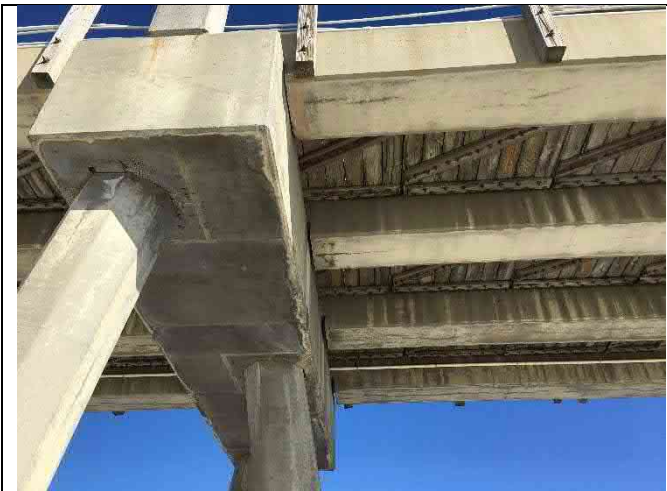
Beam 9-4 North – End spalls 8"x2"x2" combined, beam has moved north with gap closed

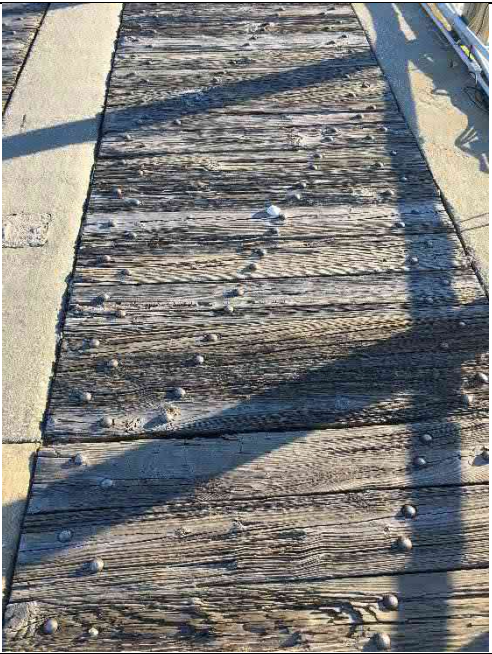
Span 10 Center Deck	Span 10W Deck – Gaps exceed 0.5"

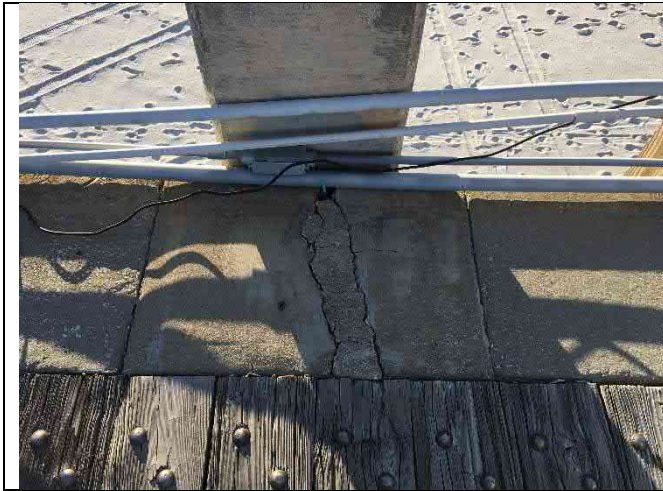
Bent 10W – Closure cracking

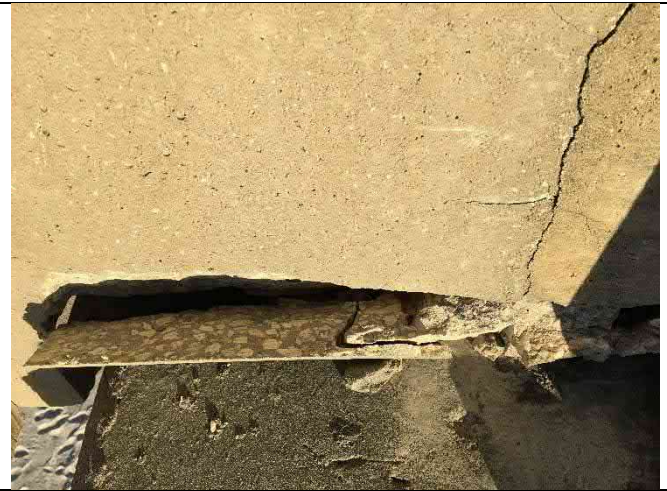
Beam 9-4 South – Spall 16"x4"x4", closure spall 14"x4"x4"

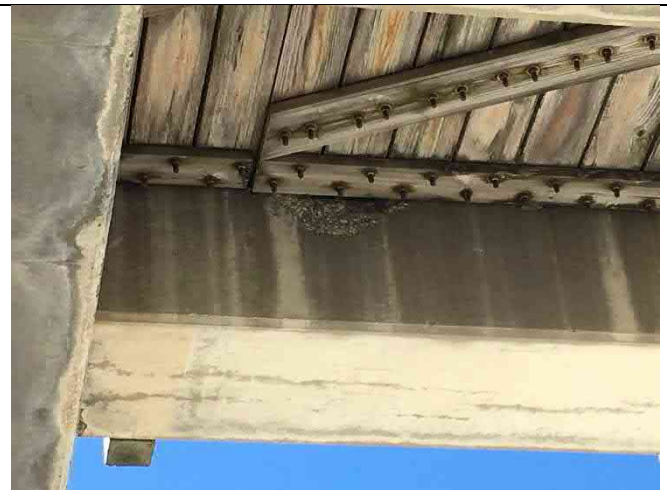
Beam 9-4 South – Spall 20"x12"x3" from deck impact

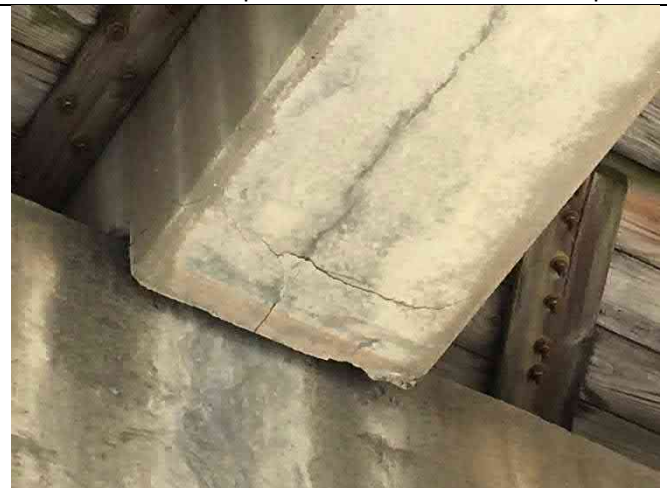
Beam 9-3 South – End cracking and delamination 24"x12"x4", longitudinal cracking

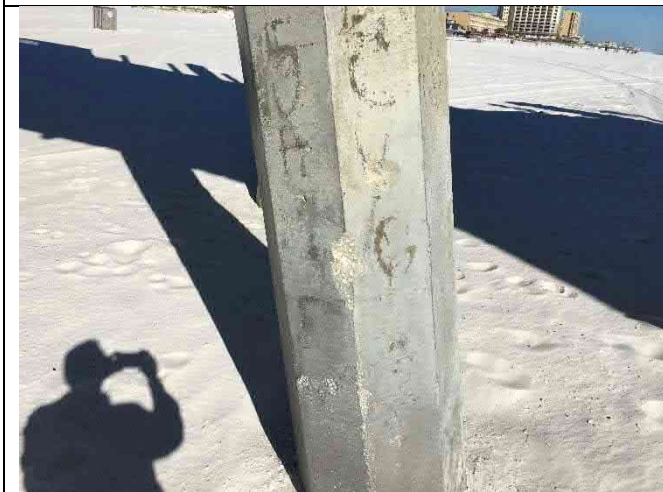
Pile 10-2 – Spalls 5"x5"x2", 12"x5"x2"

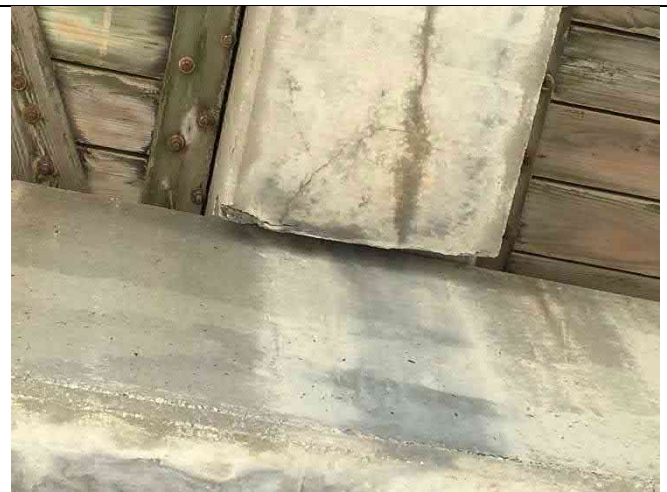
Beam 10-3 North – End cracking and spalls 24"x6"x4", longitudinal cracking

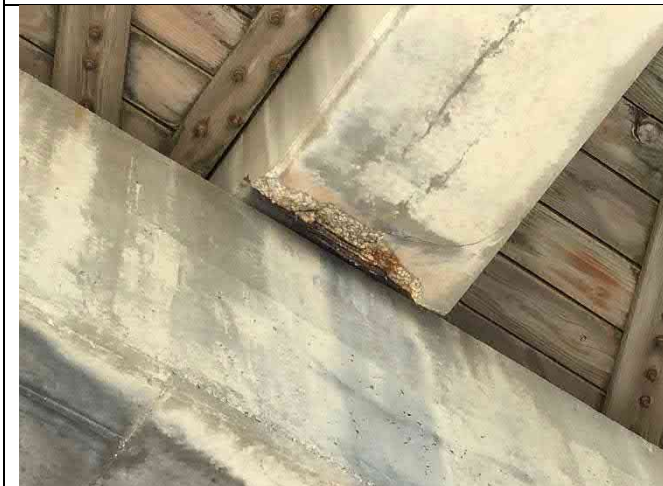
Beam 10-2 North - End cracking and spalls 24"x6"x4", longitudinal cracking

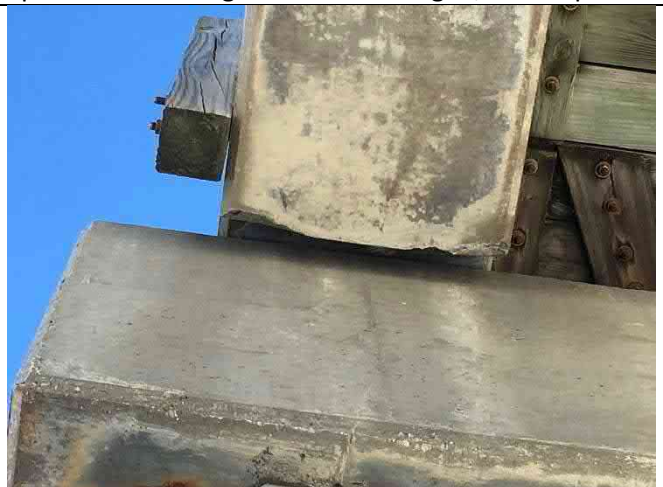
Beam 10-1 South – End spall 24"x3"x3", pile cap hairline crack

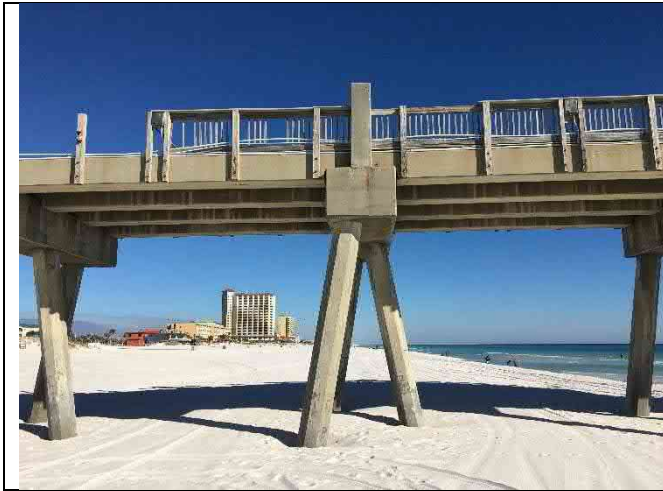
Bent 11W – Rust staining below light column

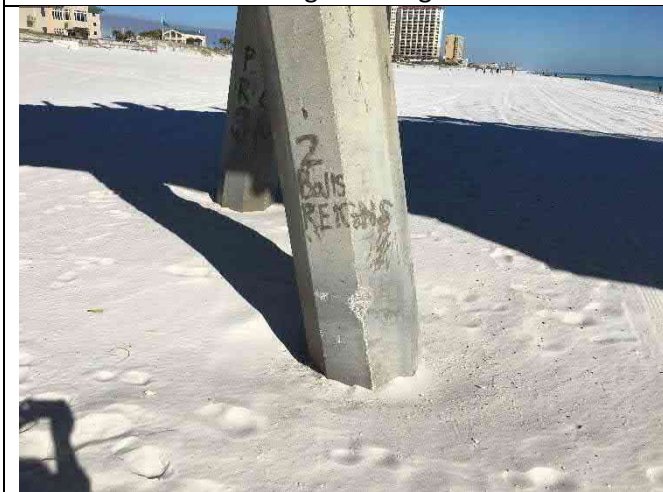
Pile 11-2 – Spall 5"x7"x2"

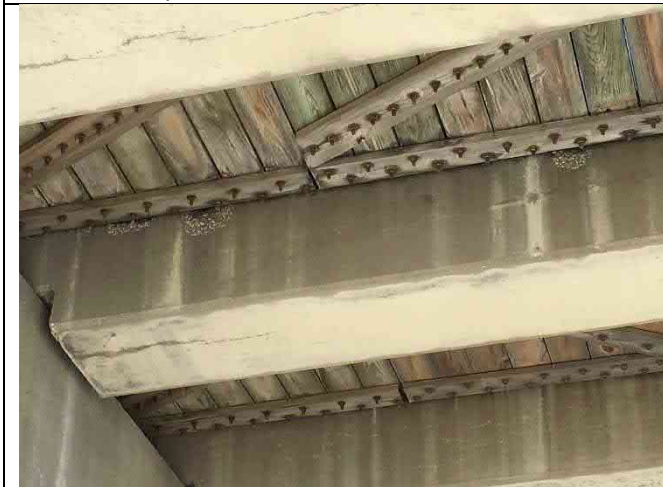
Beam 11-3 North – Top flange spalls 24"x8"x2" total, beam end cracking

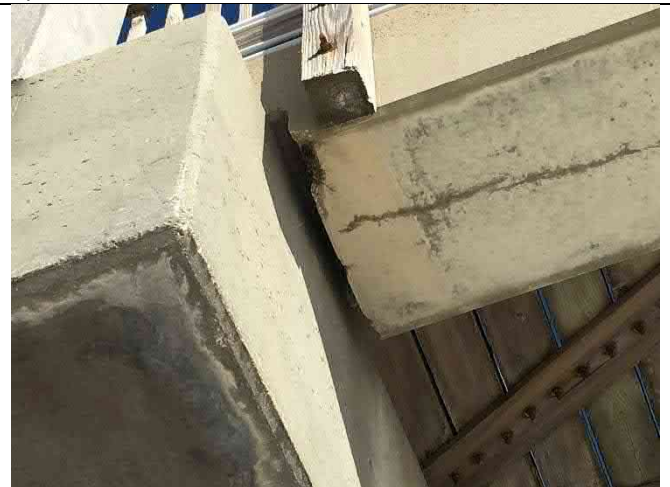
Beam 11-4 North – Spall 8"x4"x3", longitudinal cracking

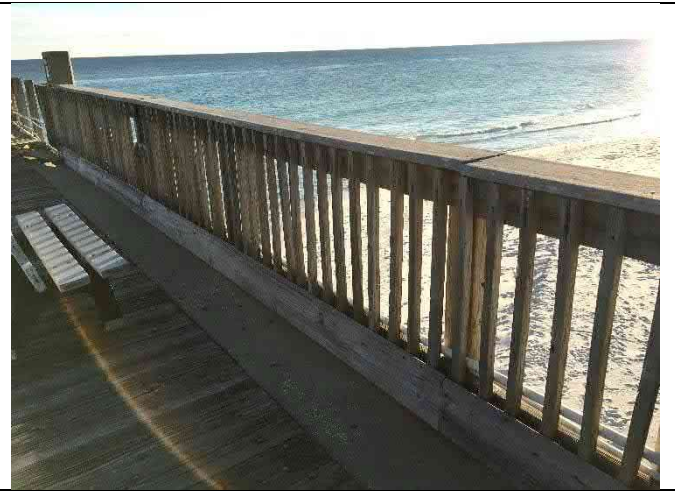
Span 12W – Railing loose with split wood

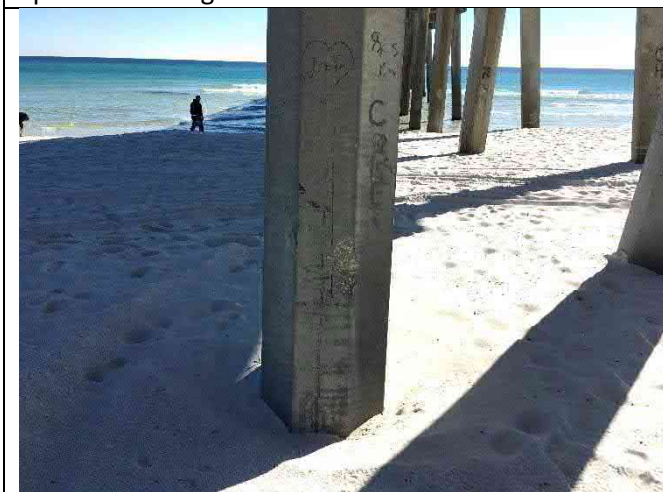
Pile 12-1 – Spall 12”x6”x2”

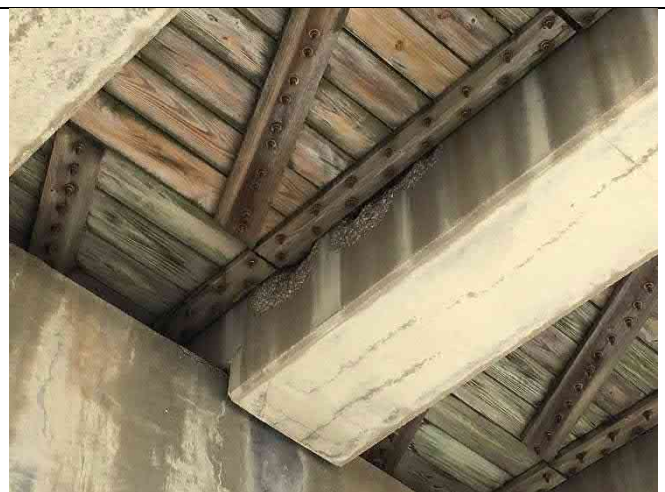
Beam 11-3 South – Top flange spalls 48”x12”x2”, beam end cracking, longitudinal cracking

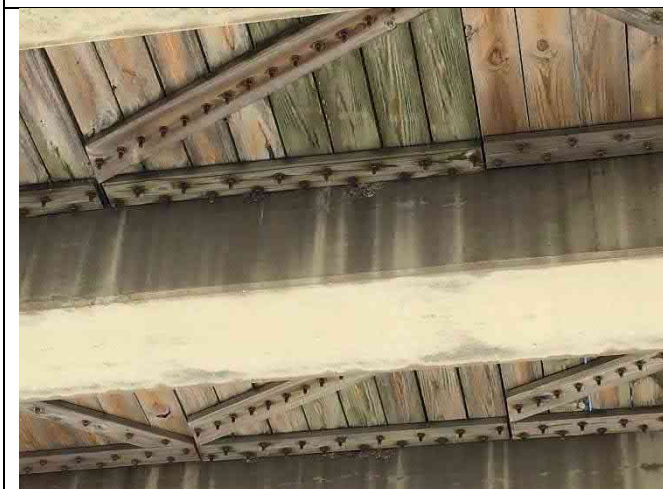
Beam 11-3 – Top flange spalls 12”x6”x2”

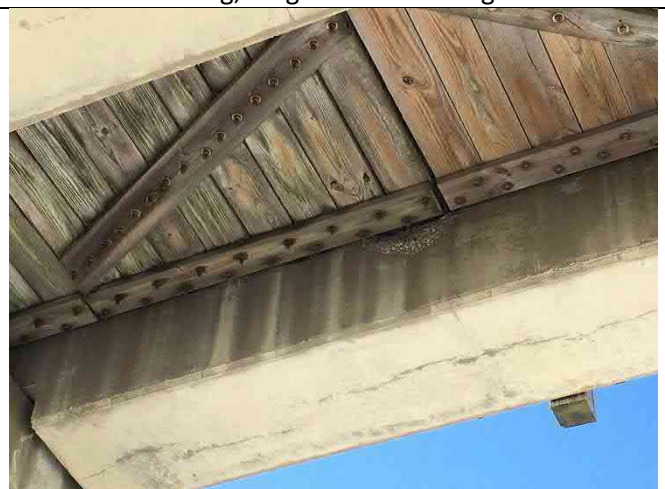
Beam 11-4 – Top flange spall 12”x8”x2”, longitudinal cracking

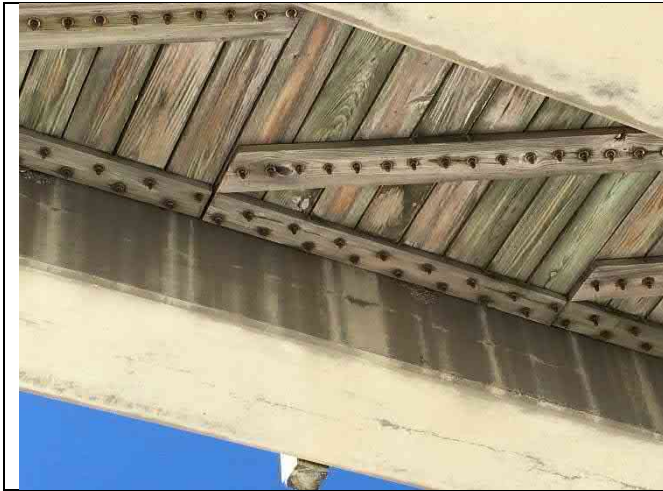
Beam 11-4 – Top flange spalls 36"x4"x1", longitudinal and horizontal cracking

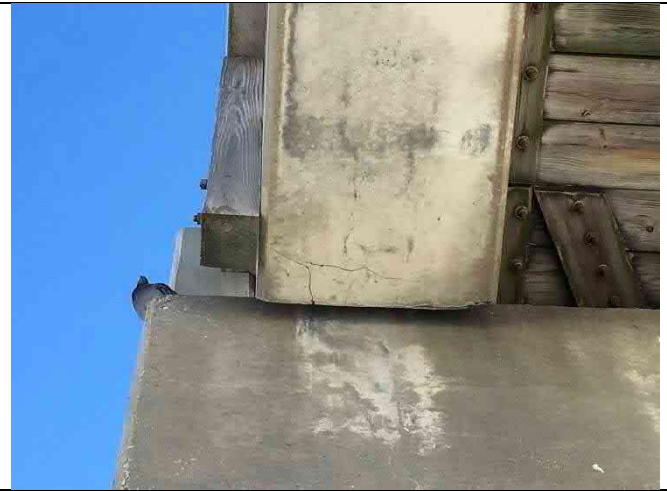
Beam 11-1 South – End cracking and delamination

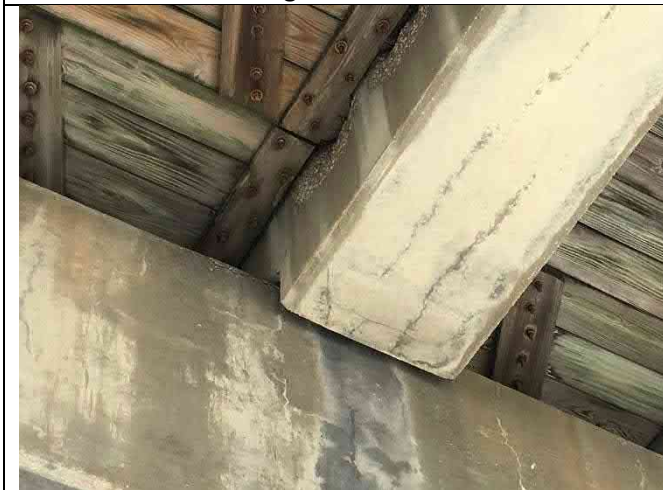
Beam 11-3 South – End cracking and delamination, pile cap cracks

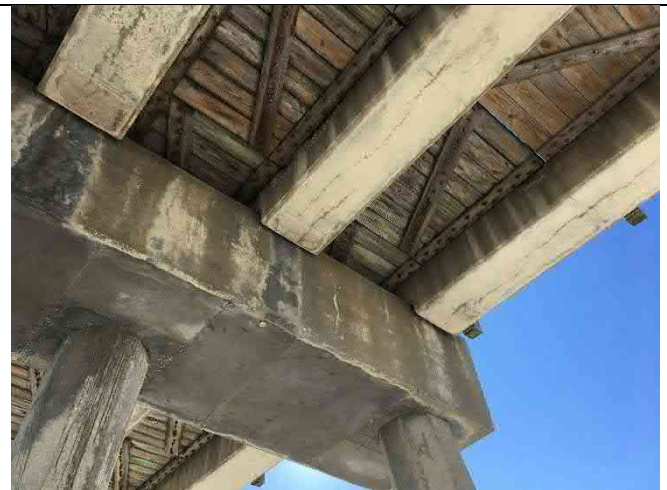
Bent 12 North Face – Pile cap cracks (30' +/-), spall 5"x5"x1"

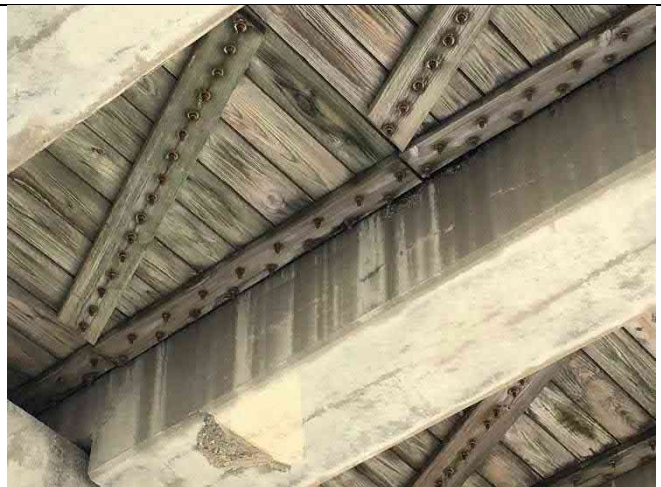
Beam 12-3 South – End cracking and spall 36"x24"x2", top flange spalls 36"x3"x2", longitudinal cracking

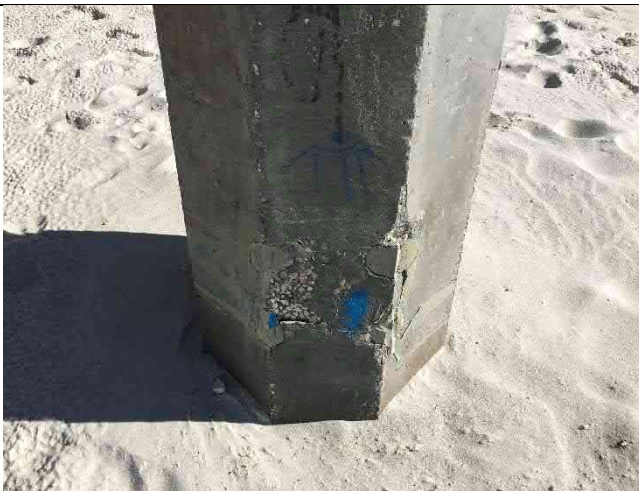
<p>Pile 13-3 – Spalls 20"x14"x2" (damage to previous repairs)</p>	<p>Bent 13W</p>

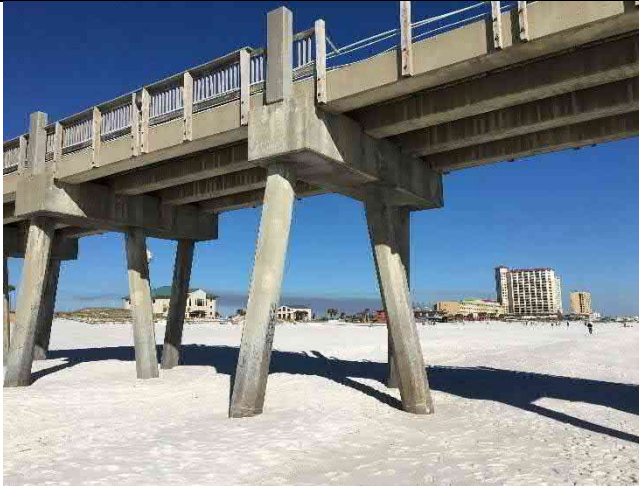
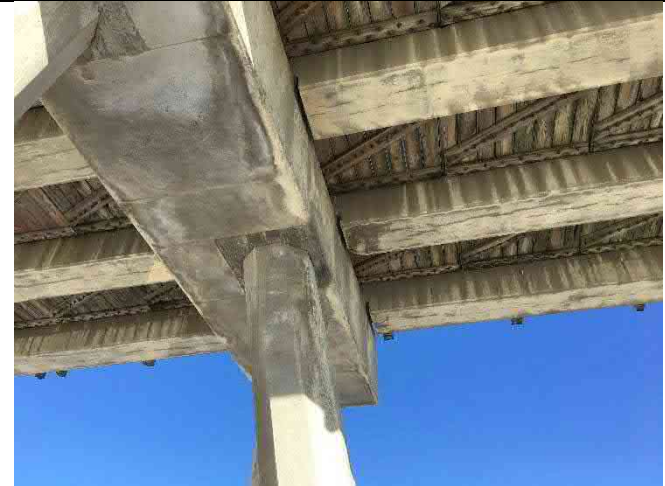
<p>Bent 13 South Face</p>	<p>Bent 13 – Top flange spall Beam 12-2 8"x6"x2", top flange spalls Beam 13-3 24"x4"x2", beam end cracking, longitudinal cracking</p>

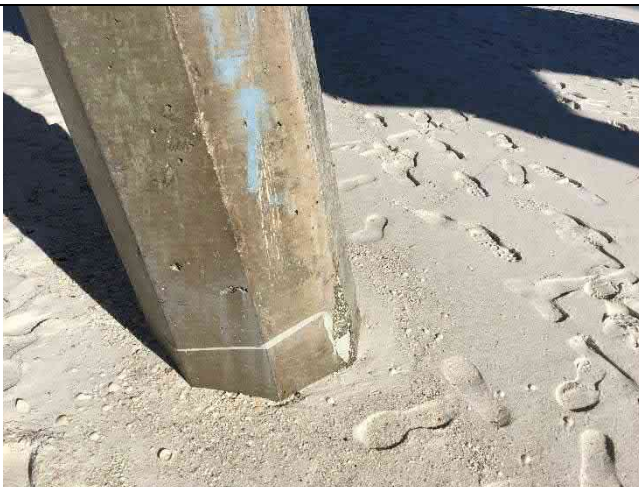
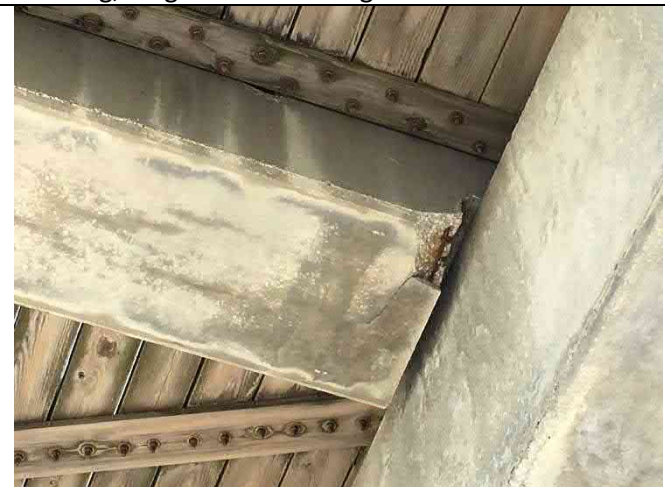
<p>Pile 13-2 - Spall 10"x5"x2"</p>	<p>Beam 13-2 North – End cracking, delamination and spall 24"x12"x3"</p>

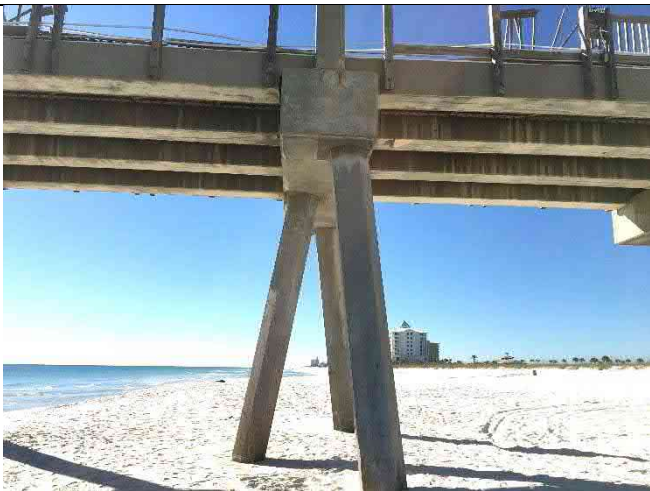
Bent 13E	Span 13 – Top flange spalls Beam 13-2 12"x4"x2", Beam 13-3 36"x4"x2" from deck impacts

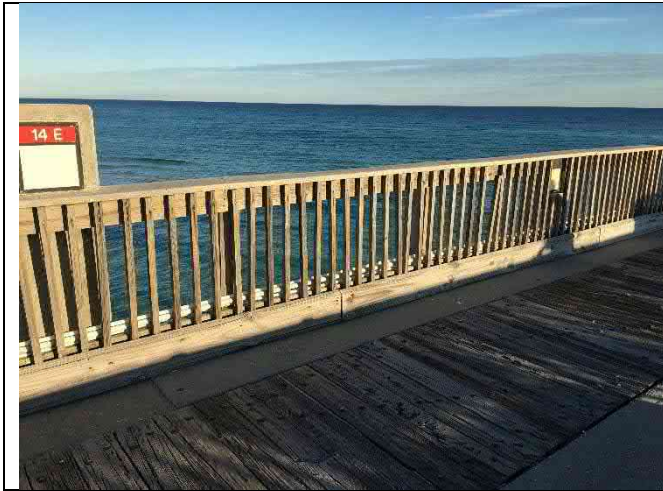
Span 14E – Railing loose with split wood members

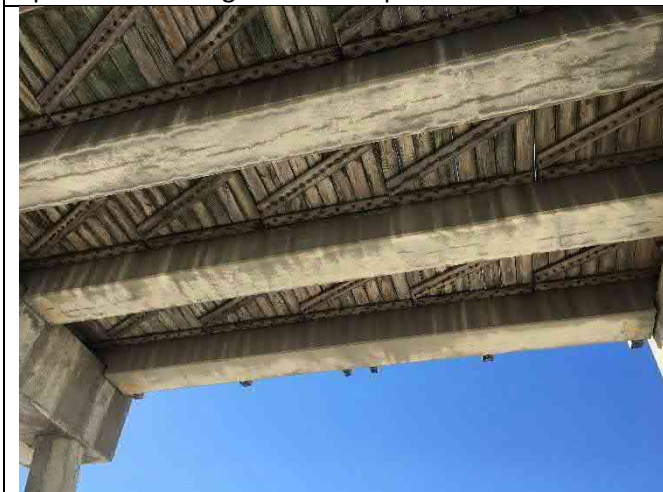
Beam 13-3 – Top flange spalls 36"x6"x1"

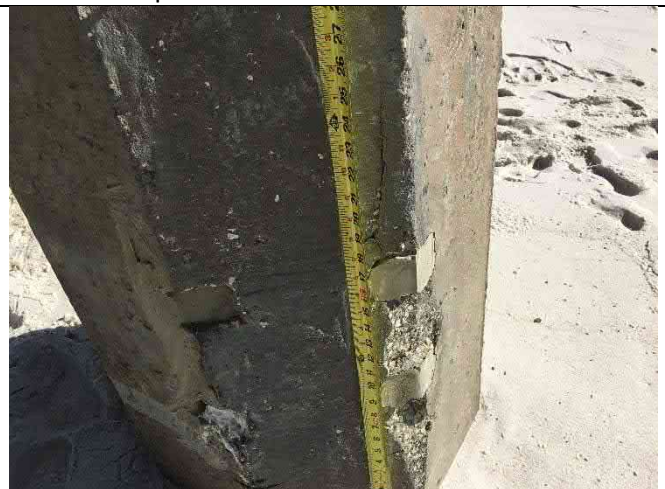
Pile 14-3 – Spall 26"x6"x2", 20"x6"x2"

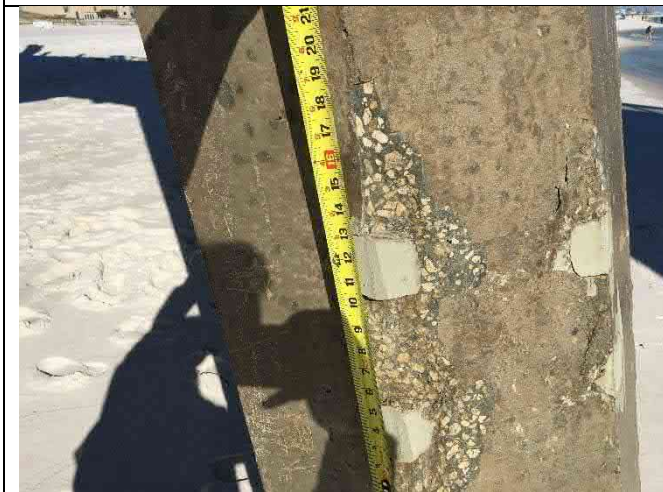
Pile 14-2 – Spalls 20"x10"x2", 16"x5"x2"

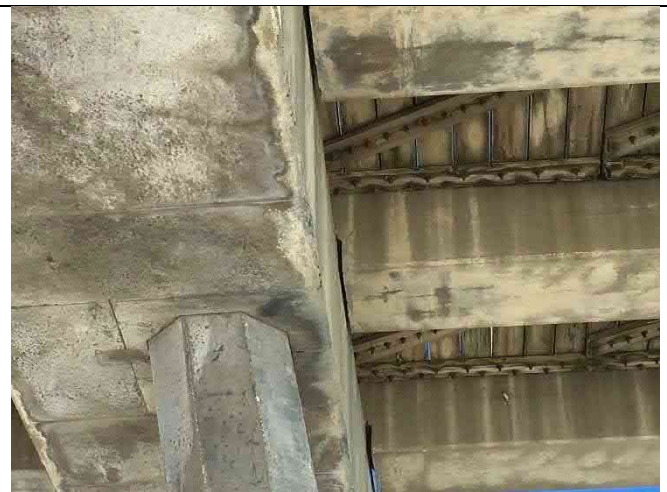
Span 14 North – Beams shifted north, end beam cracking

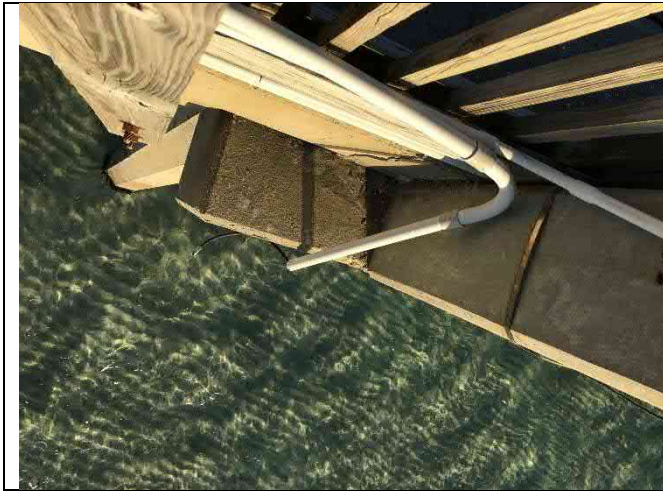
Bent 15W – Closure cracking, utility damage

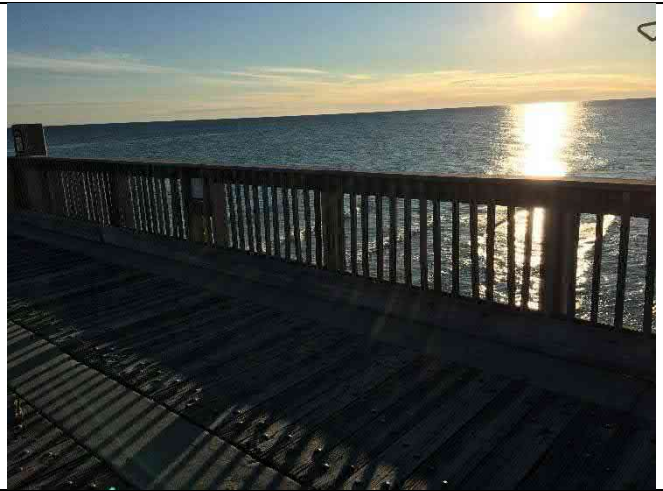
Span 15W – Railing loose with split wood members

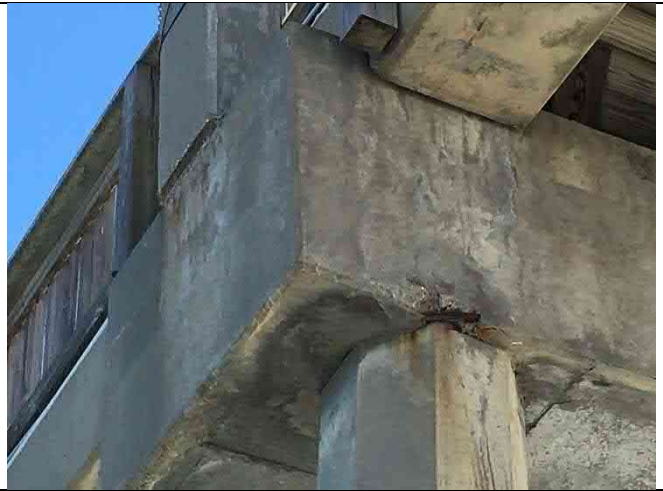
Bent 15 – Pile cap spall 14"x3"x2", hairline crack

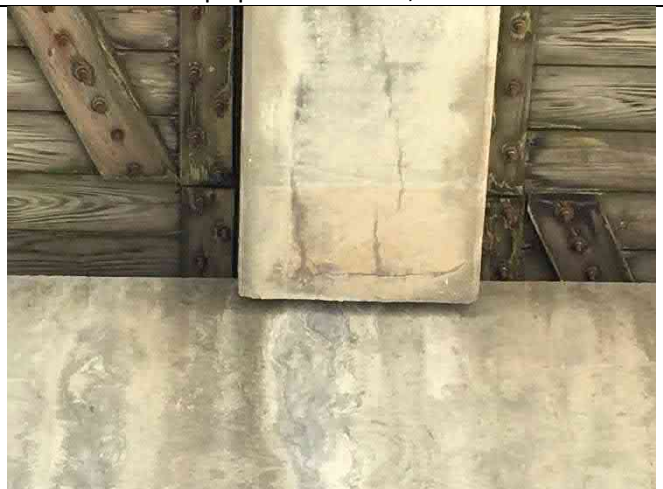
Beam 14-2 South – End beam cracking and delamination

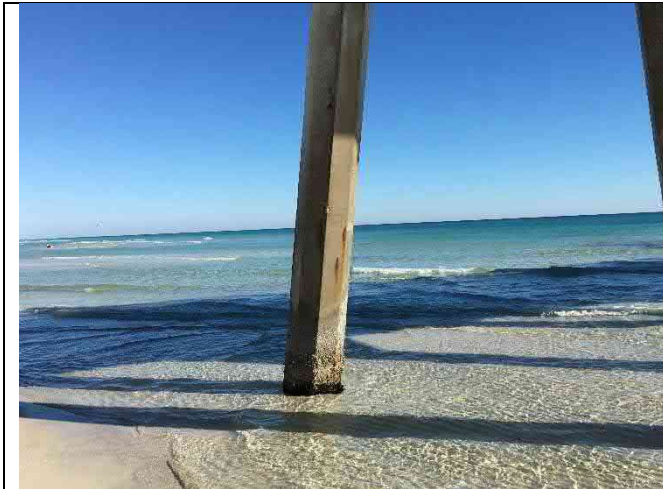
Pile 15-1 – Spall 5"x3"x2", rust stains

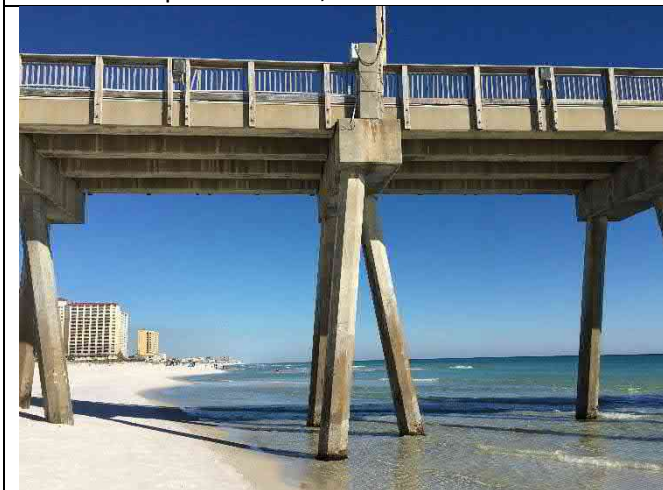
Bent 15W – Rust staining below light column, Pile 15-2 spall 4"x4"x2"

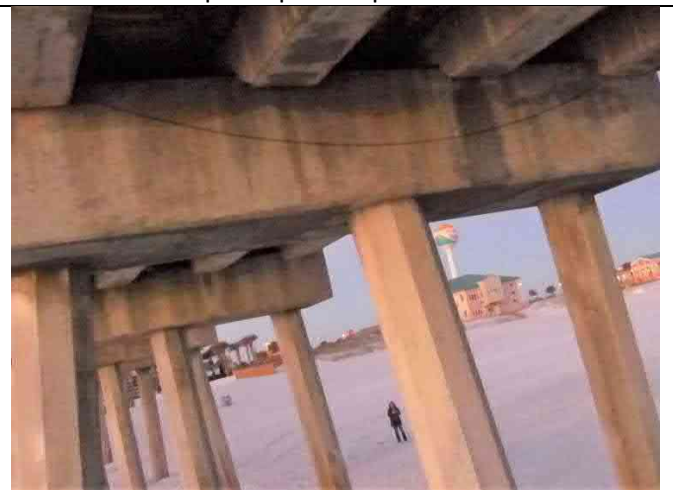
Bent 15 South Face – Beam 15-3 North end cracking and delamination

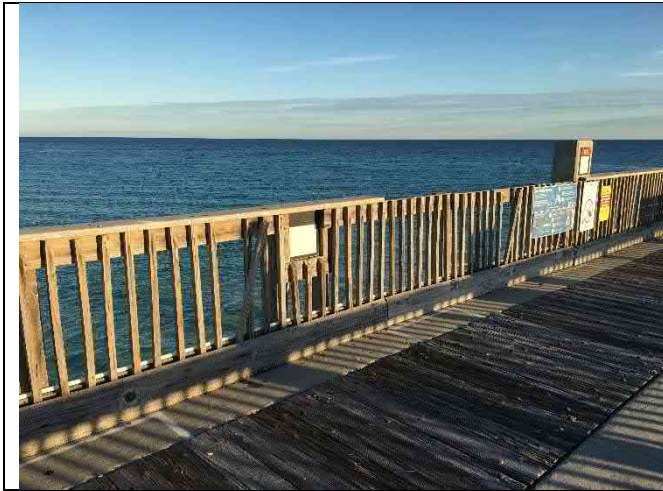
Span 16E – Railing damage

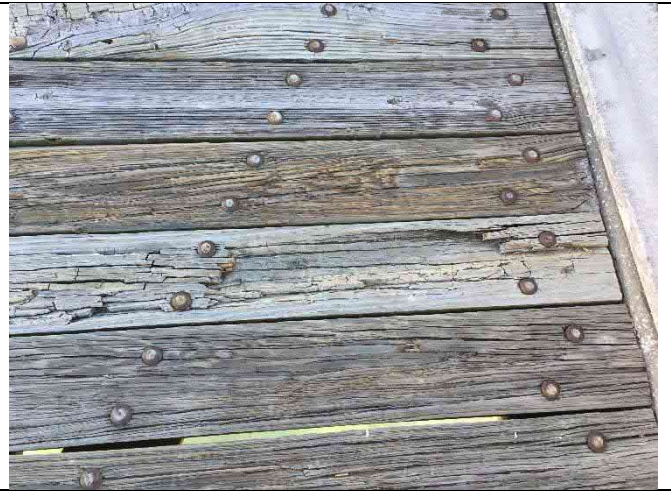
Span 16 – Deck damage with dips and gaps > 0.5"

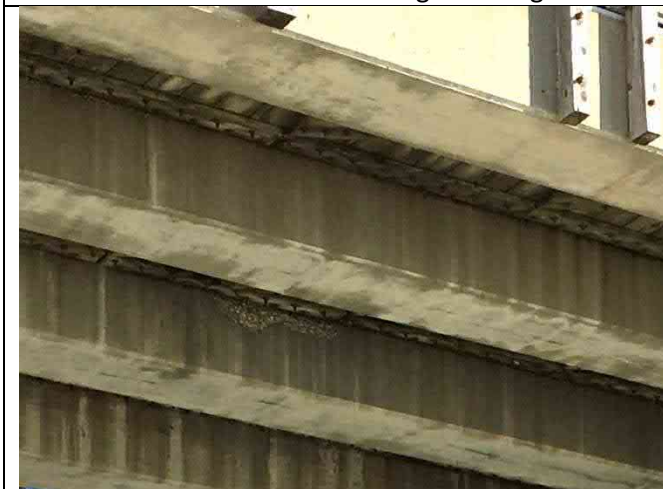
Beam 16-2 – Top flange spall 30"x8"x3"

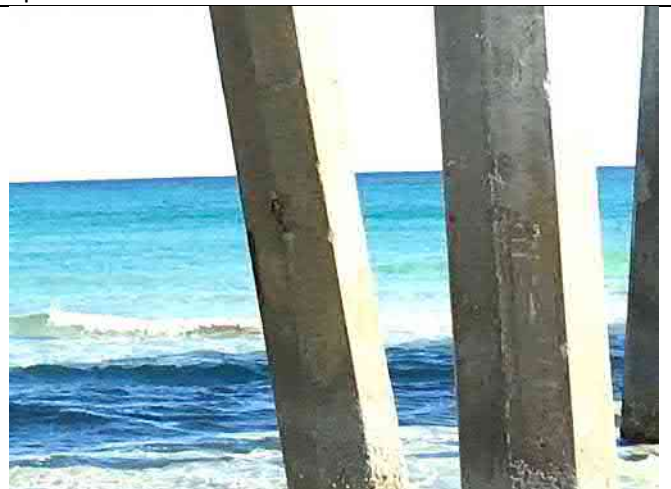
Pile 16-2 – Spall 12"x5"x2"

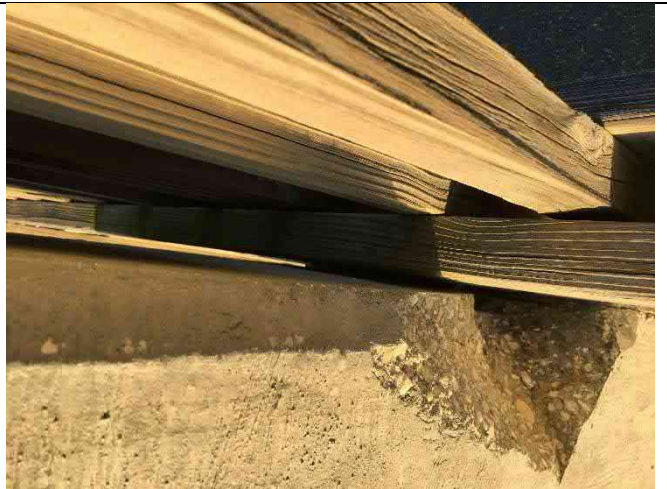
Bent 17W – Light column spall 12"x8"x4"

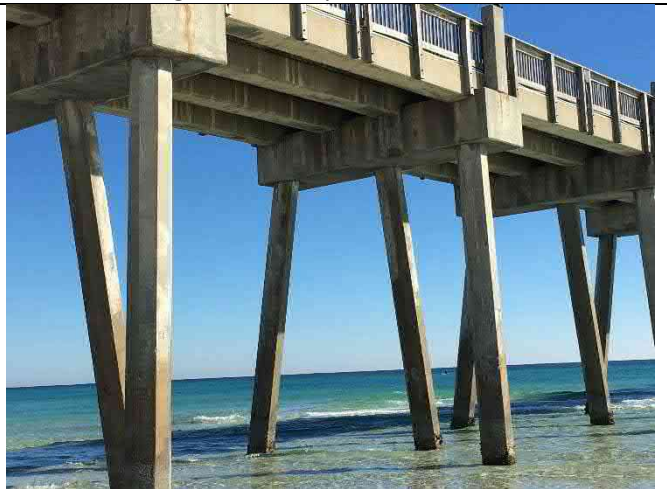
Bent 17 North Face – Pile repairs in place

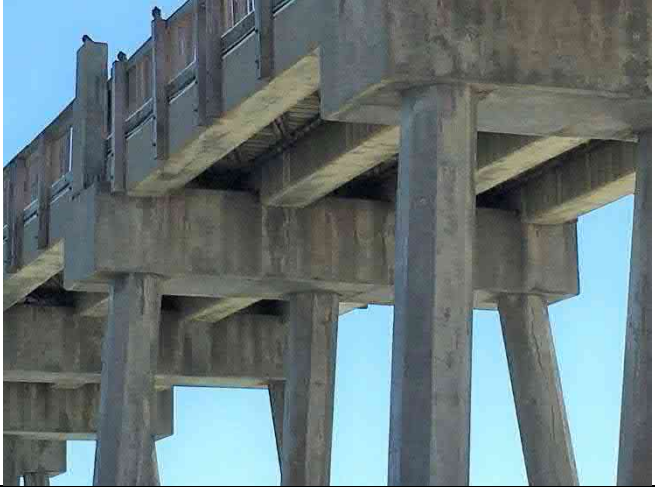
Bent 17 North Face	Bent 17 North Face – Beam end cracking (common)

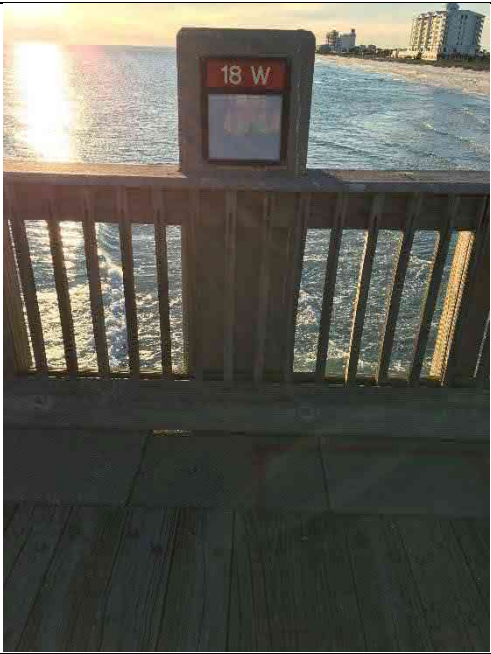
Bent 18W	Span 18W – Railing loose with split wood

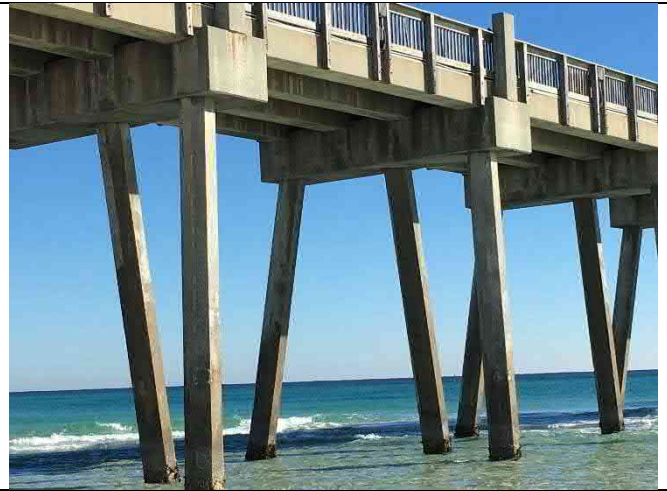
Span 18 – Bottom flange end cracking (common)

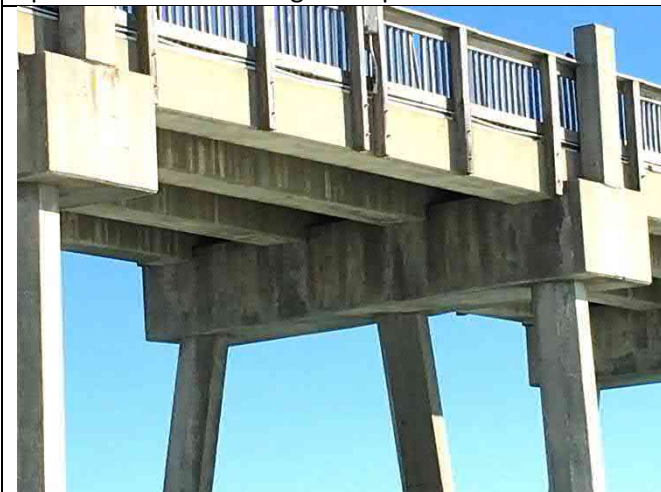
Beam 17-3 South – End cracking and delamination

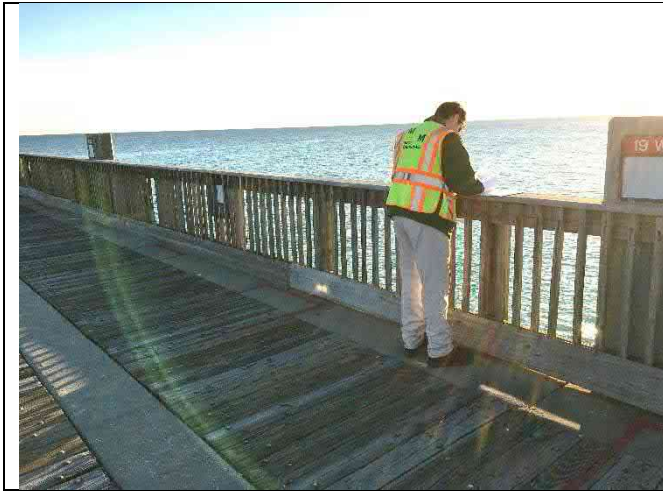
Span 19E – Loose rail with split wood members

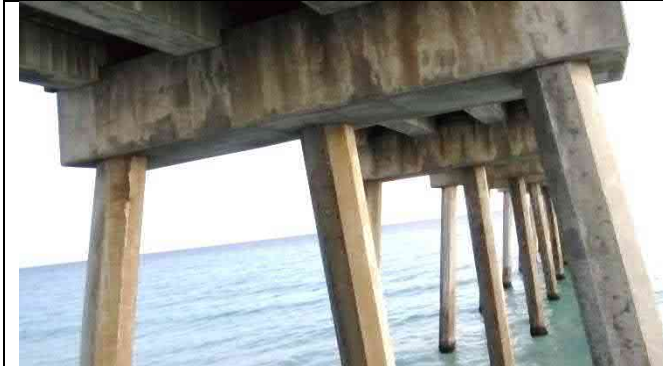
Piles 19-1 and 19-2 – Spalls 2~5"x5"x2" each

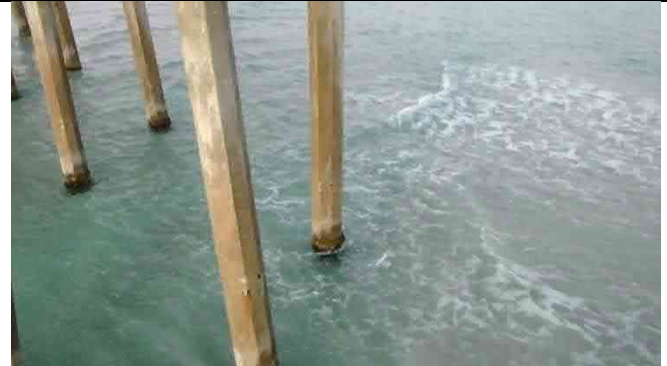
Bent 19 South Face – Beam end cracking (common)

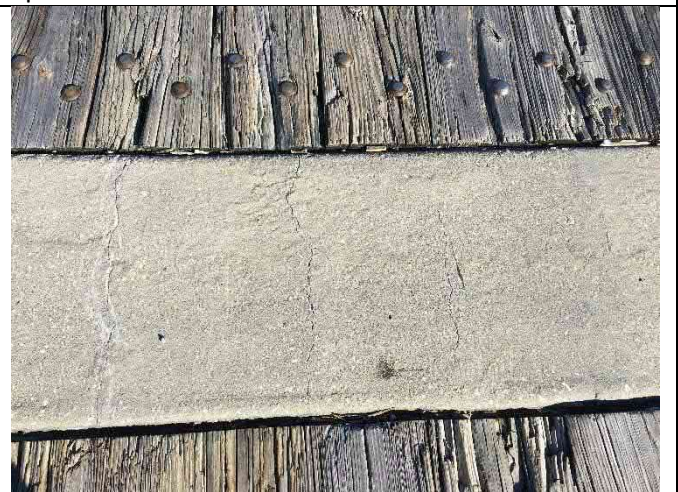
Beam 20-2 and 20-3 – Top flange cracking 12" +/- on center full length

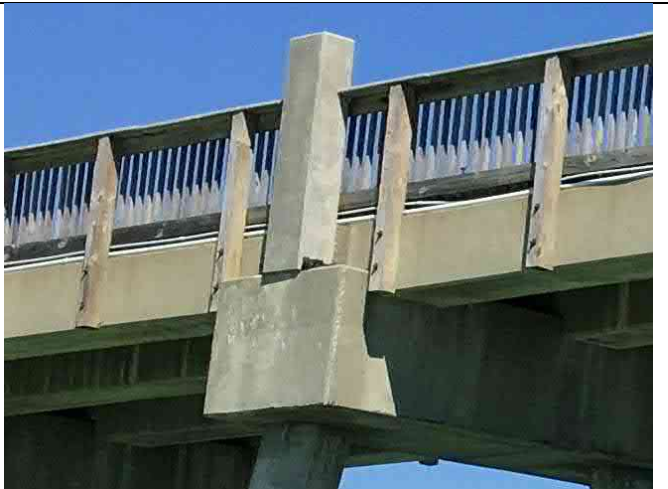
Bent 20W – Light column spall 12"x3"x3"

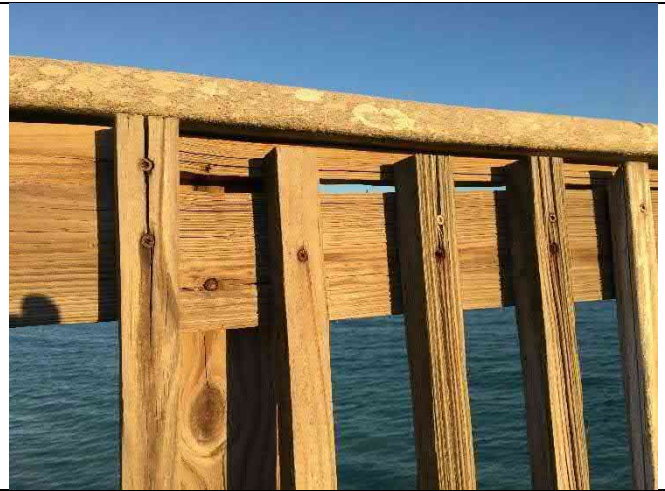
Span 21E – Typical railing split wood for section still connected

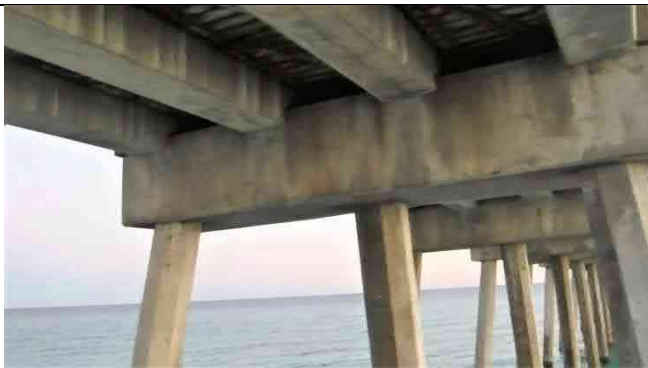
Bent 21 North Face – Beam end cracking

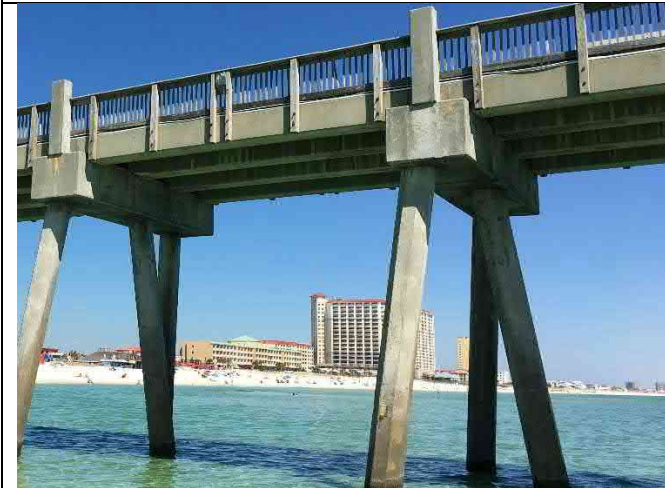
Pile 22-1 – 2~Spalls 5"x5"x2"

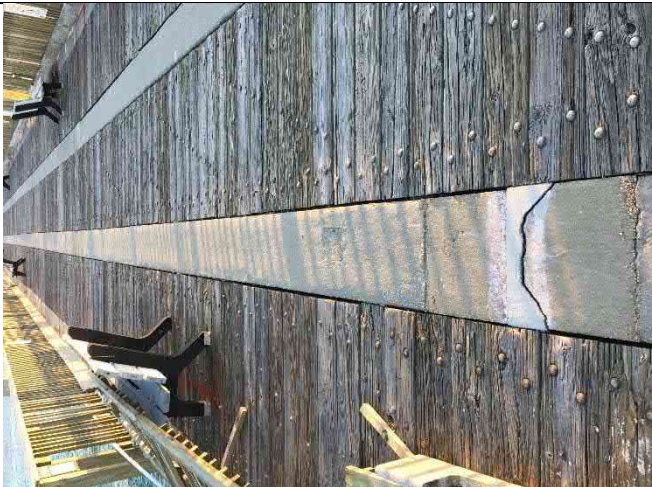
Bent 23W – Missing railing, closure cracking and spalls, utility damage, beam spalls	Span 23E – Railing damage, closure cracking

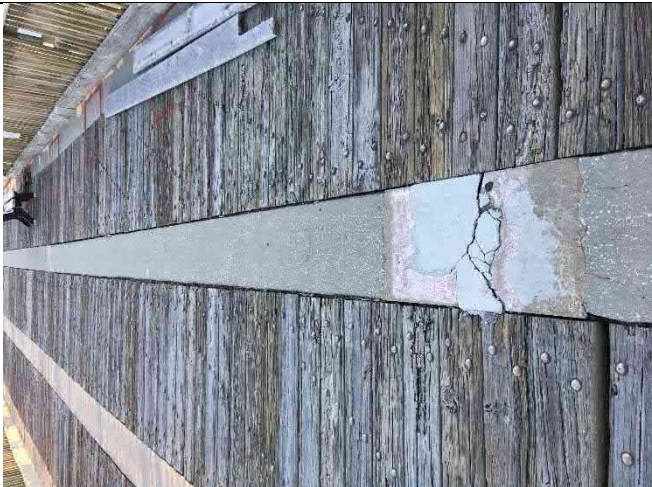
Span 23E – Closure cracking	Span 23 Center

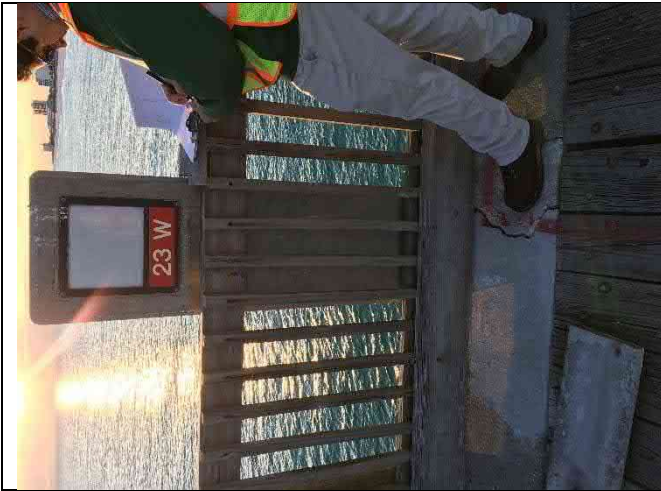
Span 23W – Closure cracking	Span 23W

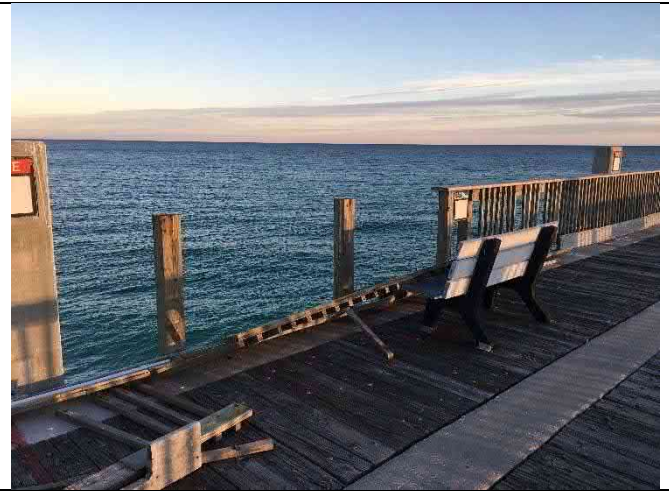
Bent 23W – Closure cracking

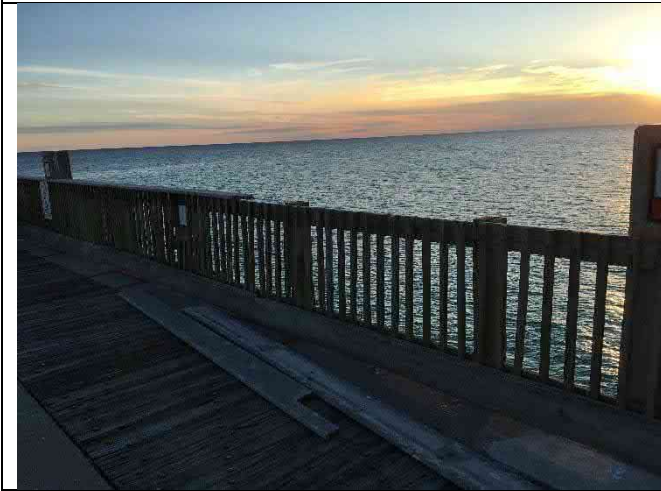
Span 23E – Railing damage
