# **Preliminary Engineering Assessment (PEA)**

## **Pensacola Beach Gulf Pier**

Escambia County, FL

April 5, 2021

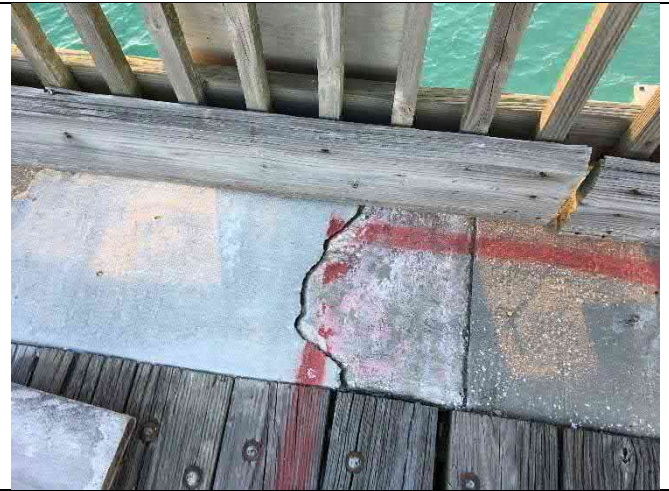
Span 23W – Railing damage

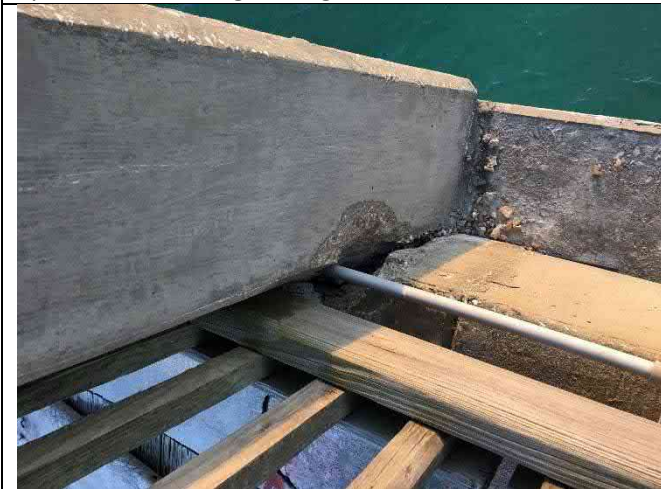
Bent 23W – Closure cracking

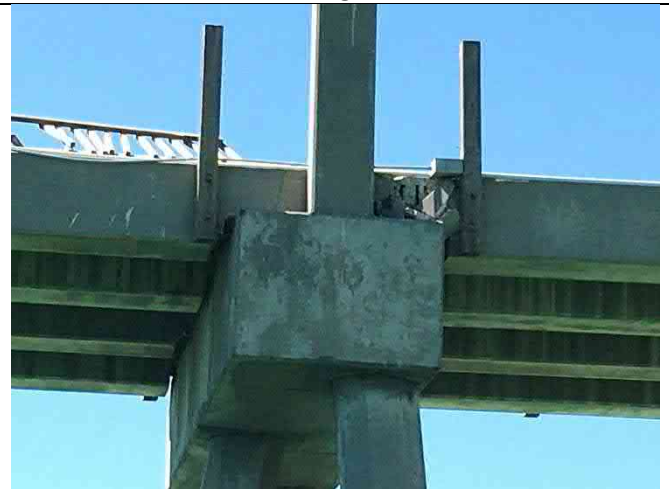
Bent 23W – Light column spall 14"x6"x4"

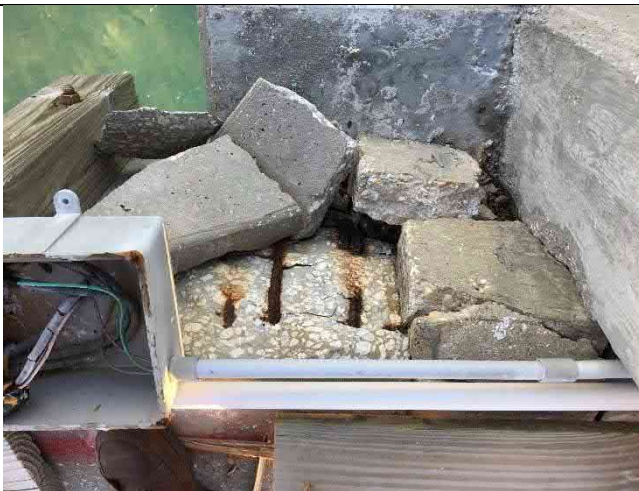
Beam 22-1 South – Spall 16"x16"x6", closure spall 16"x12"x6"

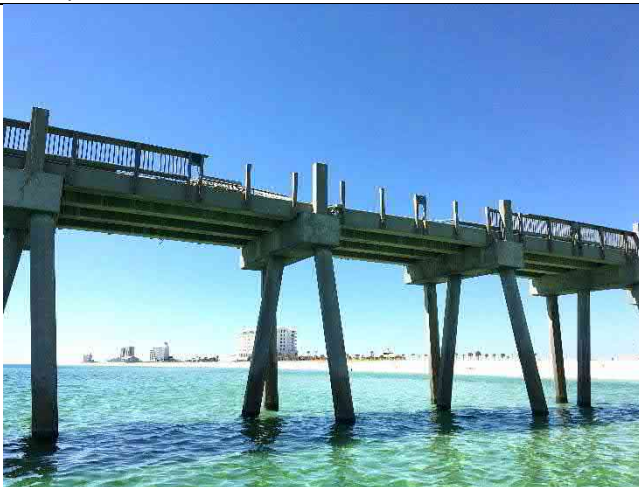
<p>Bent 23E – Beam 22-1 end spall, closure pour cracking and spall</p>	<p>Bent 23E – Closure cracking</p>

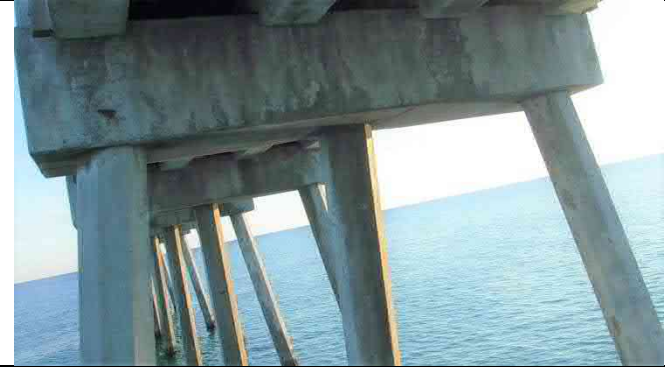
<p>Bent 23E, Spans 22 and 23</p>	<p>Bent 23W – Pile 23-3 partial spall at repair 4~6"x6"x1"</p>

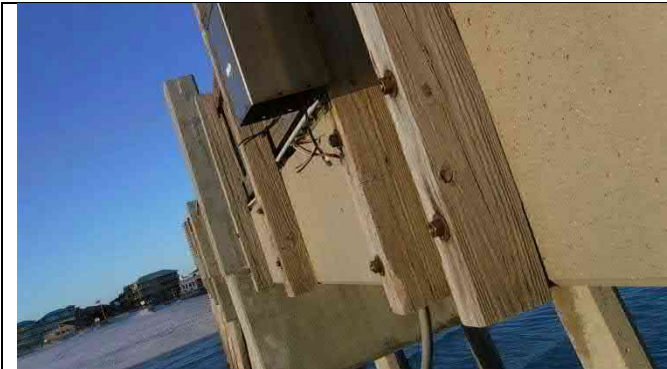
<p>Bent 23 – Piles 23-2 and 23-3 spalls 2x4~5"x5"x1"</p>	<p>Bent 23 North Face – Pile cap spall 6"x3"x2", beam end cracking</p>

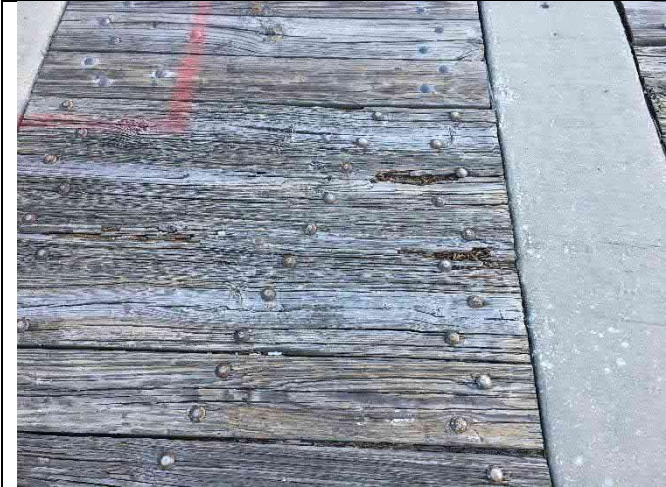
Span 24W – Loose railing with split wood members

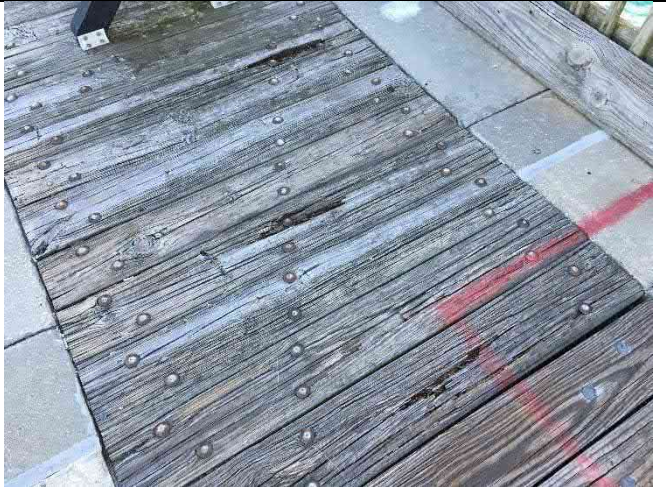
Span 24 – Deck damage

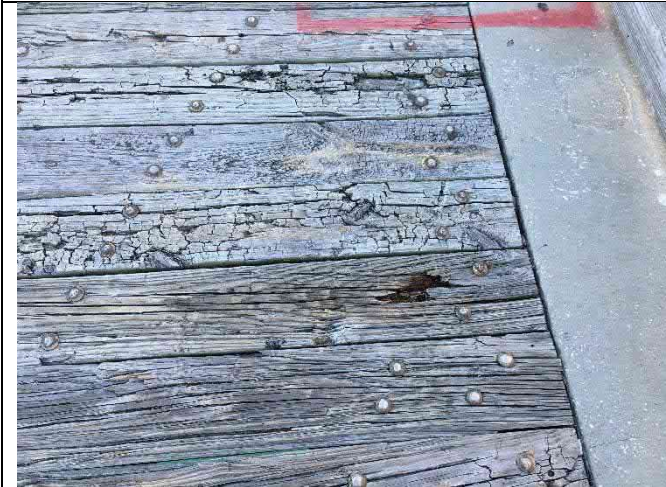
Span 24 – Deck damage

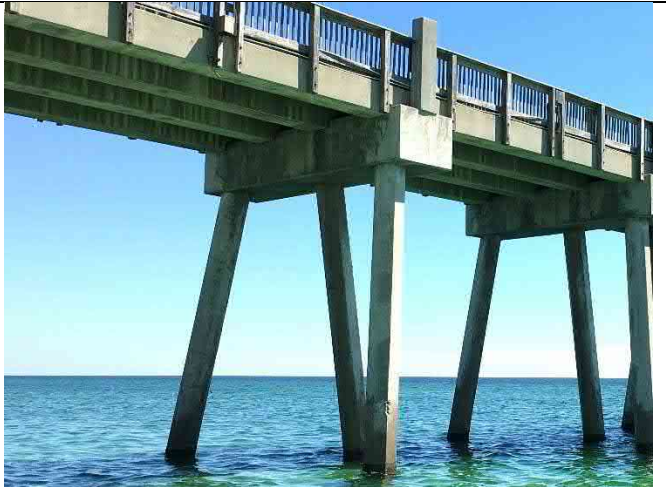
Span 24 – Deck decay

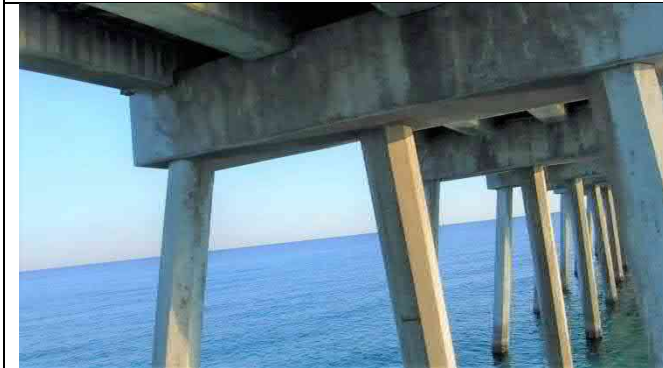
Pile 24-3 – Pile repair partially damaged 4~5"x5"x1"

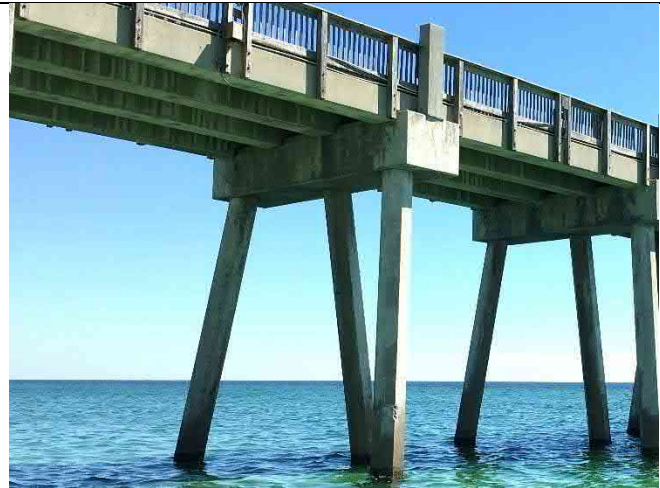
Bent 24W – Pile 24-3 repair partial damage  
4~5"x5"x1"

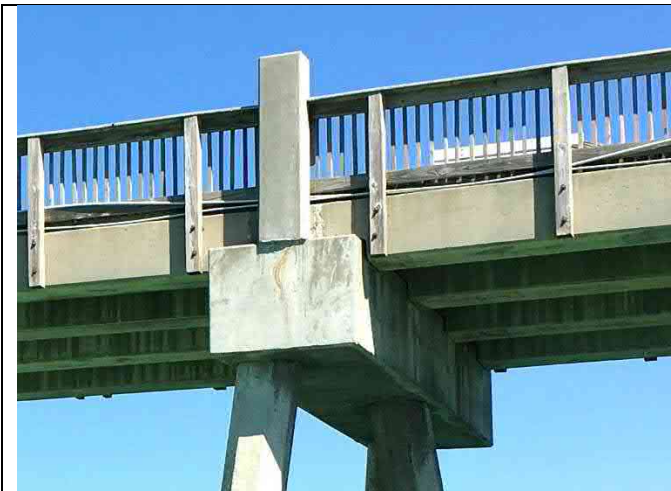
Bent 24W – Span 24 beams shifted north, rust staining under light column, closure pour cracking

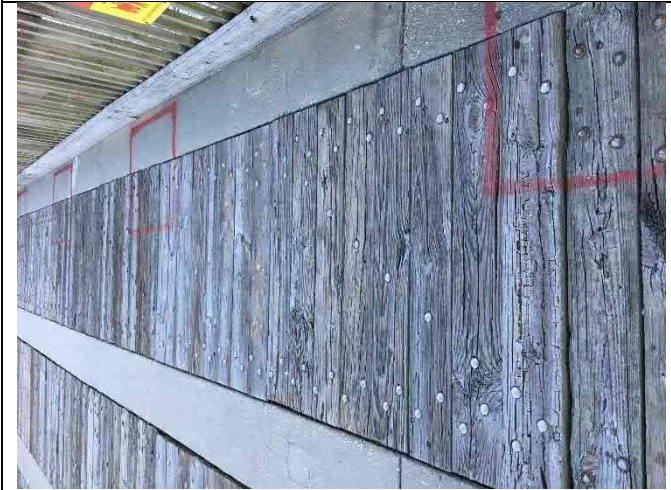
Span 25 Center – Deck damage > 0.5"

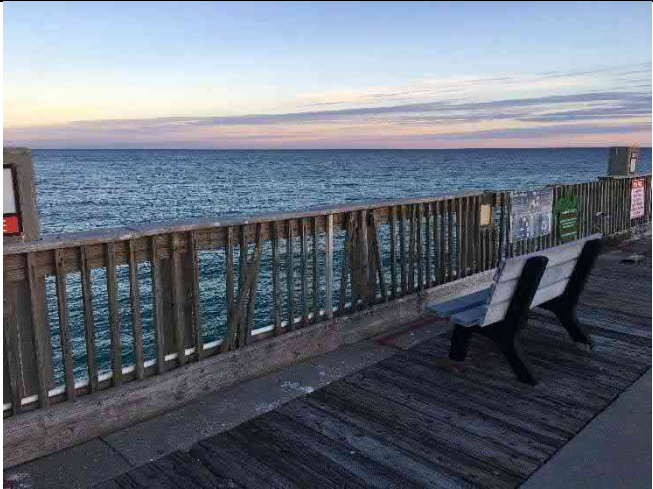
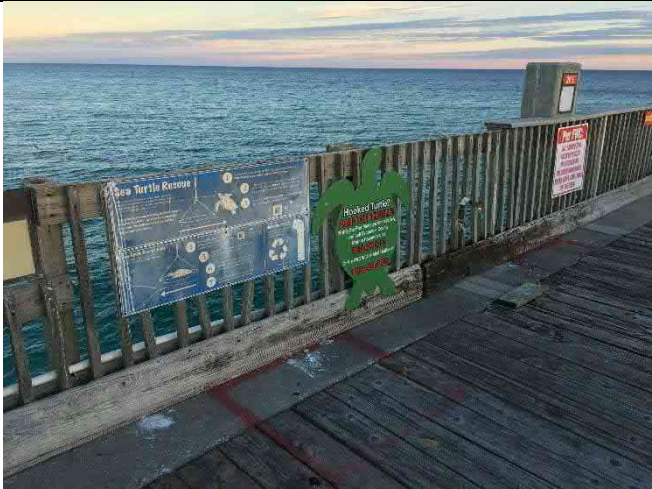
Span 25E – Railing damage	Span 25E – Signs and water, railing damage

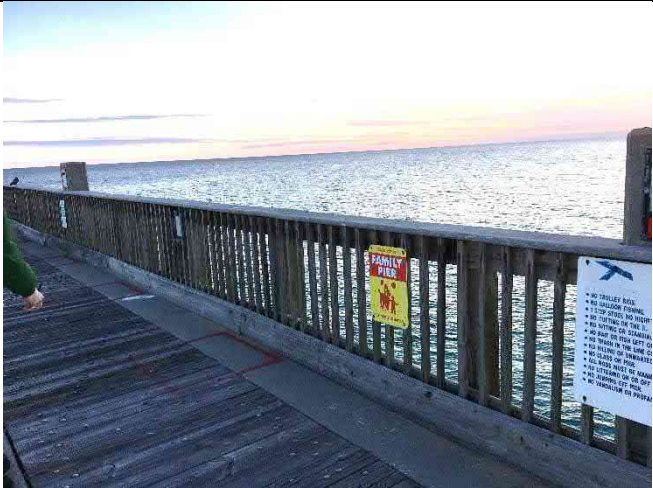
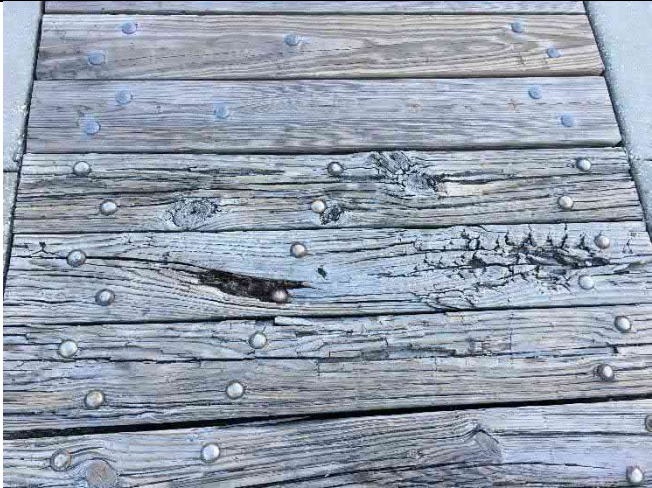
Span 25W – Loose railing with split wood members	Span 25 – Damaged deck

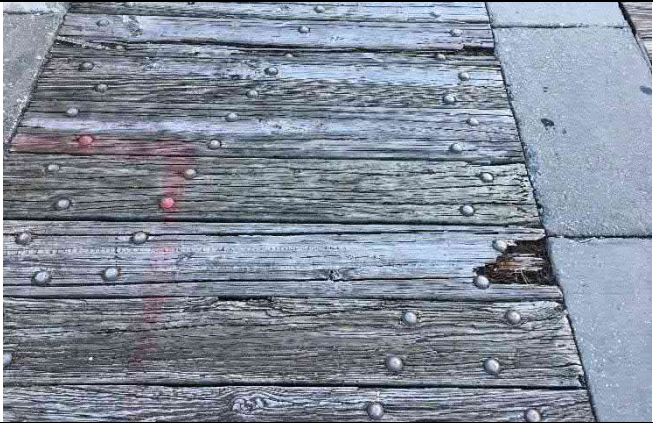
Span 25 – Damaged deck	Bent 25 North Face

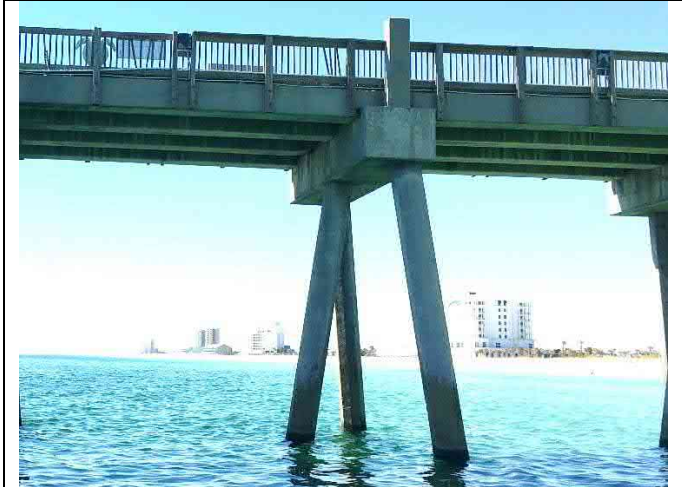
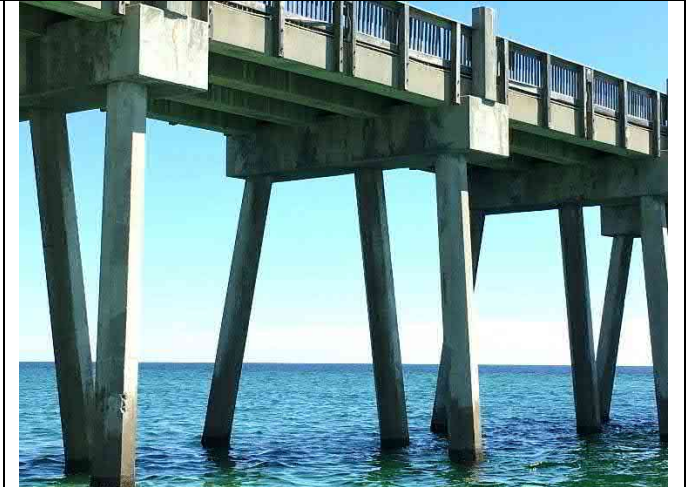
<p>Bent 25E – Previous pile spall repairs partially damaged 12~3"x3"x1"</p>	<p>Bent 25 North Face</p>

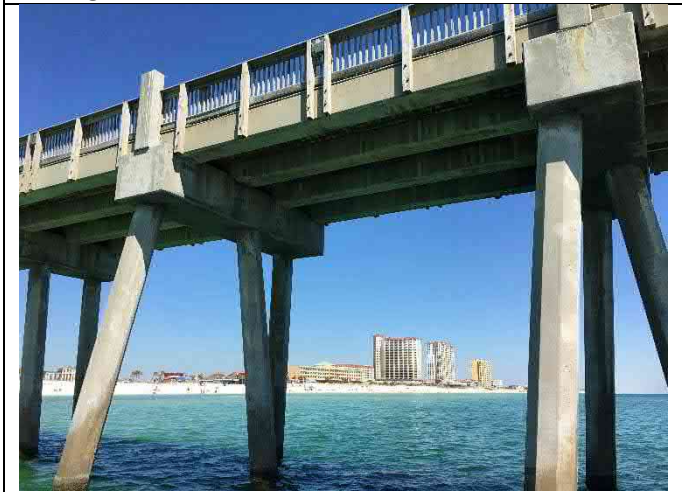
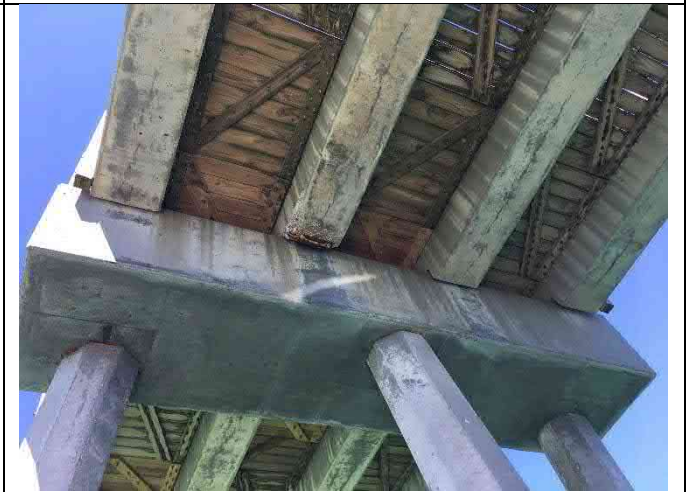
<p>Bent 25 South Face – Span 25 beams shifted north, Beam 25-3 top flange spalls 36"x2"x1"</p>	<p>Beam 25-3 North – End cracking, delamination and spall 24"x24"x4"</p>

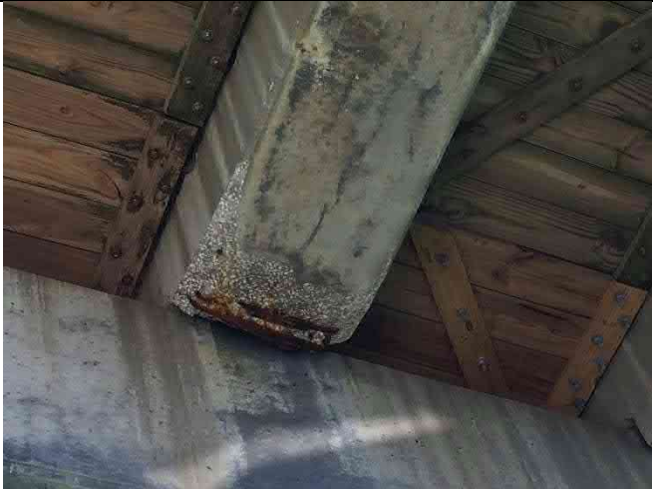
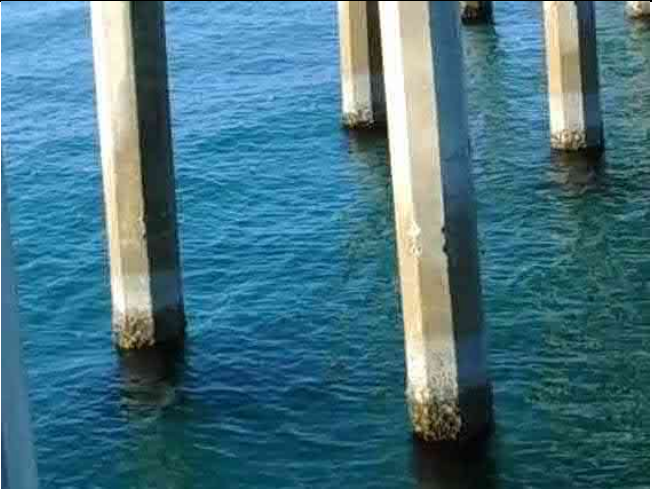
Beam 25-3 North – Cracking, delamination and spall 24”x24”x4”, longitudinal cracking	Bent 25 – Pile spall repair damage

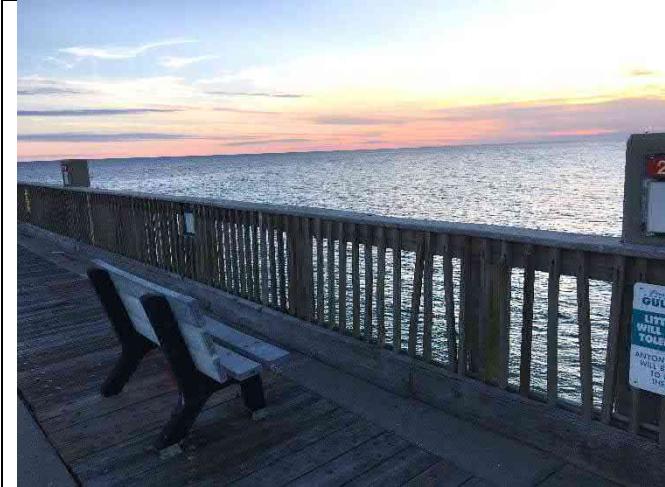
Span 26W – Railing loose with split wood members

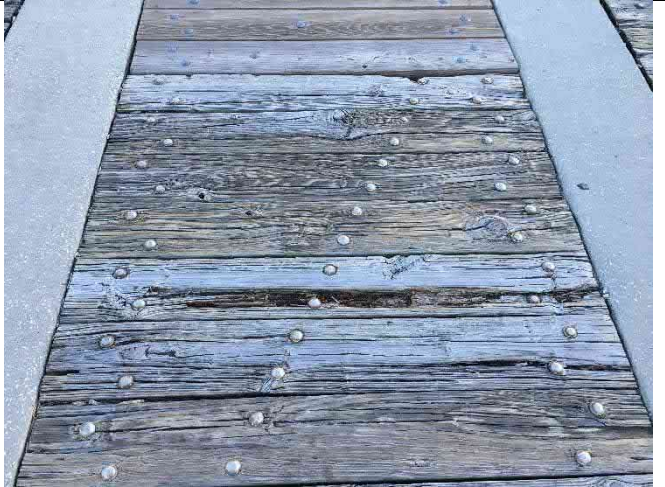
Span 26 – Damaged deck with gaps and dips > 0.5"

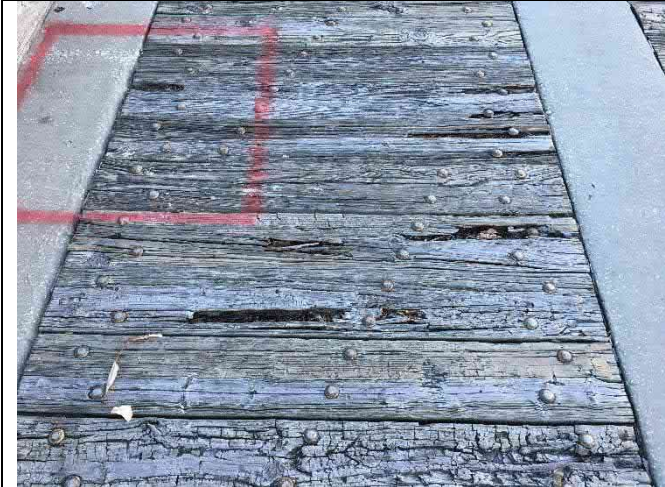
Span 26 – Damaged deck with gaps and dips > 0.5"

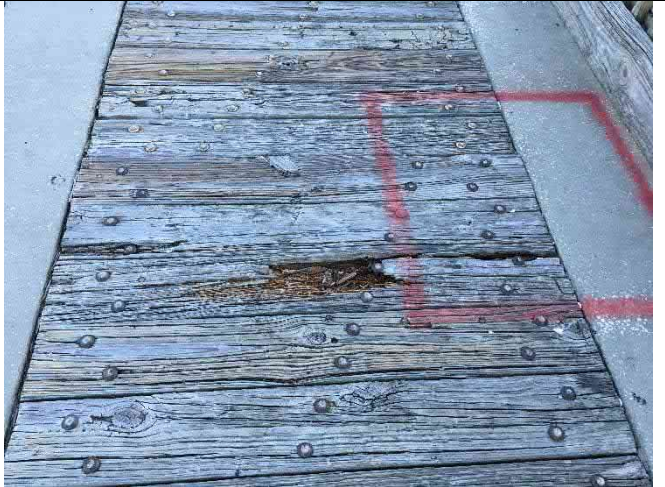
Span 26 – Damaged deck with gaps and dips > 0.5"

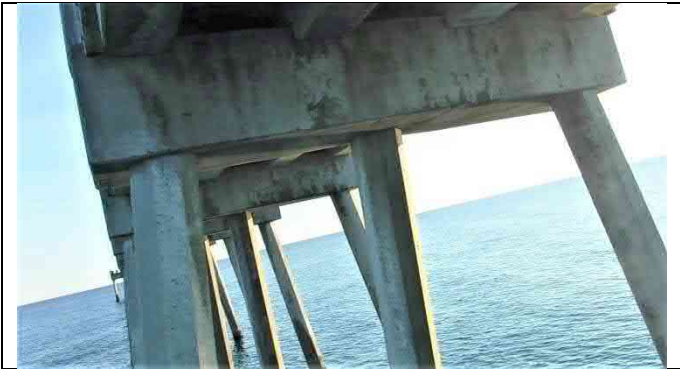
Bent 26 North Face	Pile 26-1 – Spalls 4~4"x4"x1"

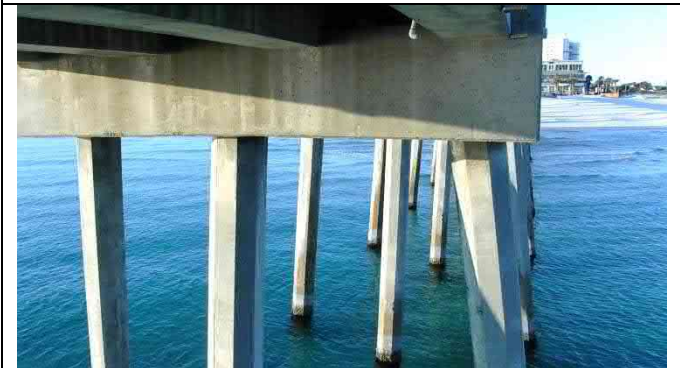
Bent 26 South Face – Pile 26-1 spalls, waterline damage	Bent 26 South Face

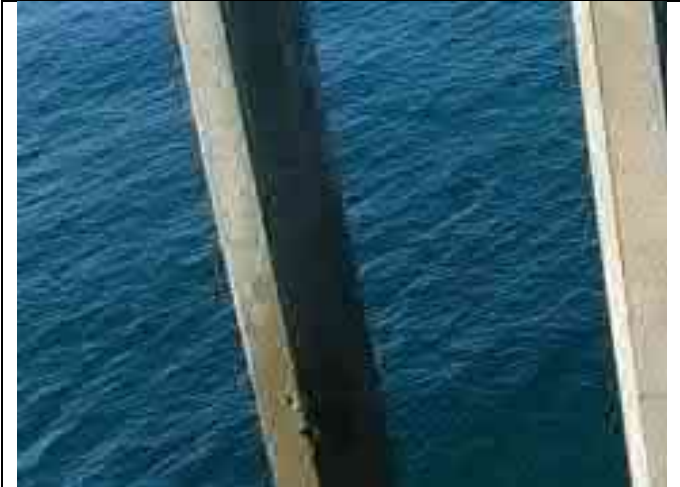
Pile 26-2 and 26-3 – Spalls 2x4~4"x4"x1"	Bent 26E

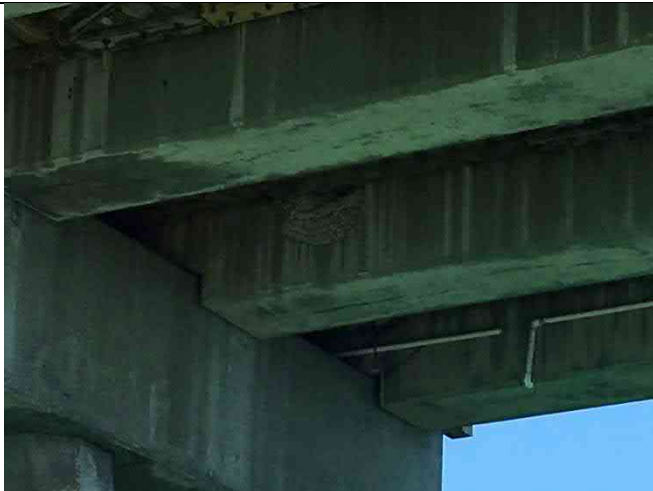
Beam 26-2 North – Spall 24”x20”x3”

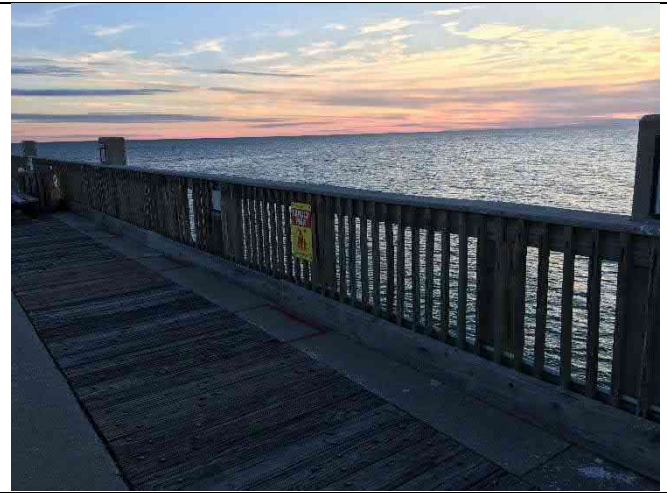
Span 27W – Railing loose with split wood members

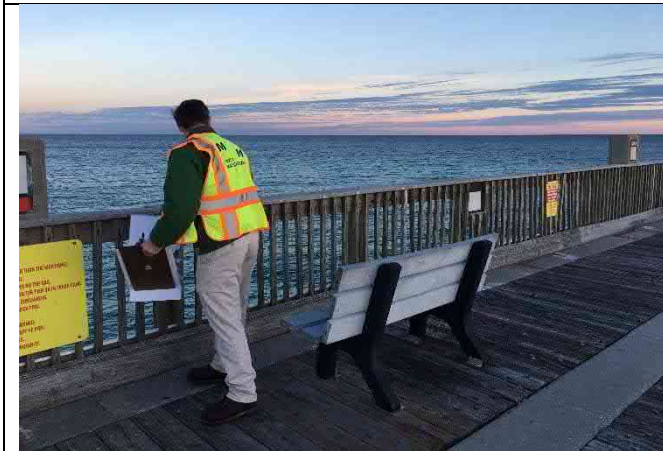
Span 27E – Railing loose with split wood members

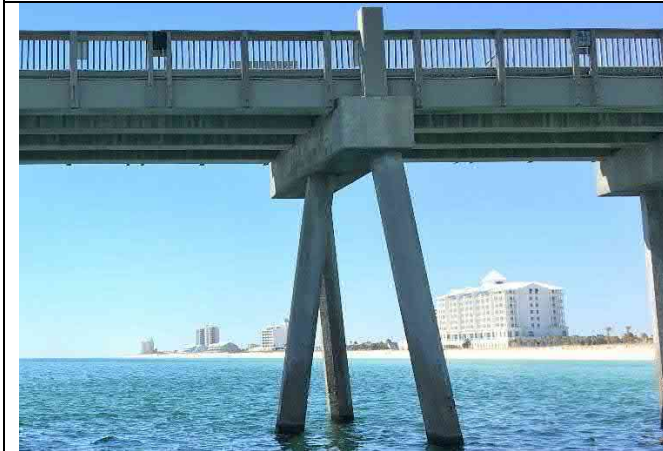
Bent 27E – Spall repairs damaged all piles  
3x4~4"x4"x1"

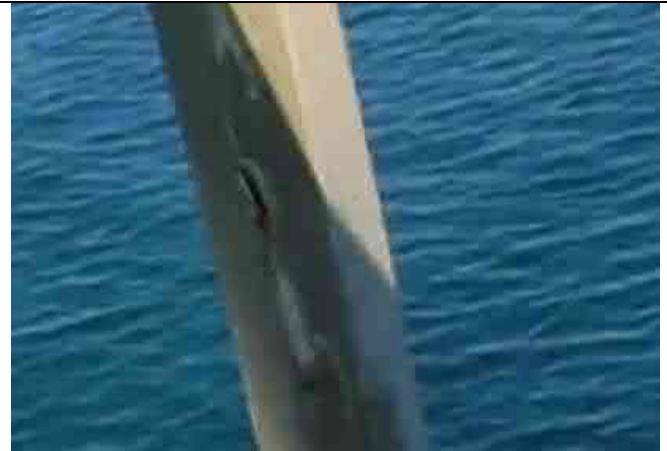
Pile 27-1 – Spall 12"x5"x2"

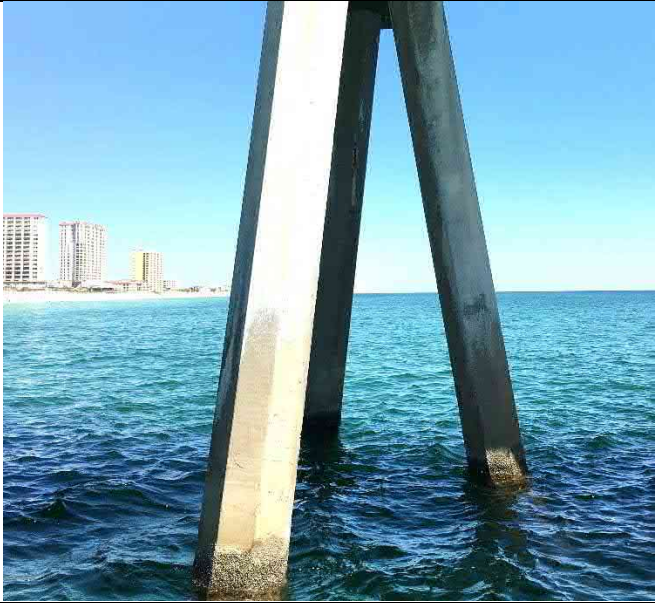
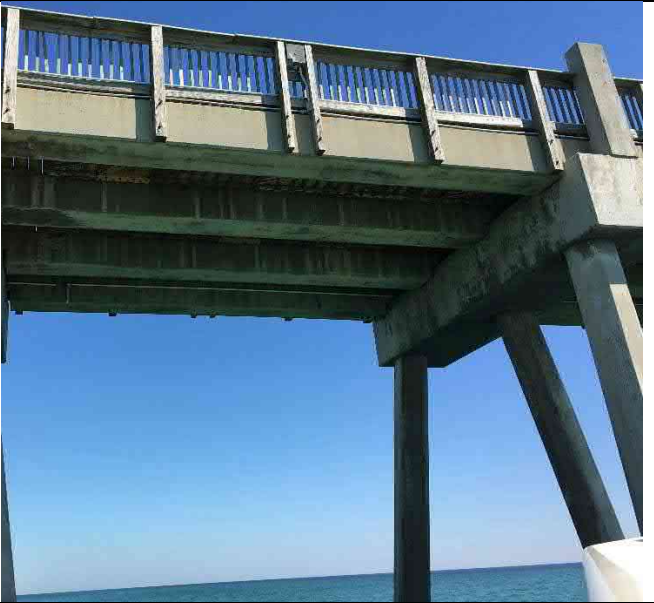
Bent 27W - Spall repairs damaged 3x4~4"x4"x1", Pile 27-1 spall 12"x5"x2"	Bent 27 North Face, Span 26

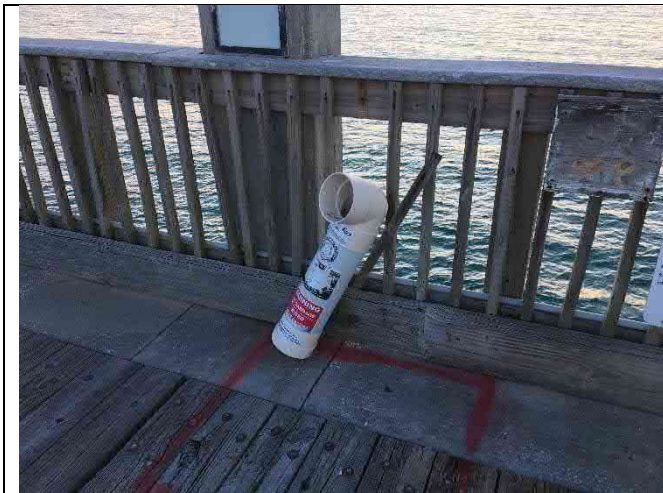
Span 28W at Bent 29W – Fishing line receptacle damage

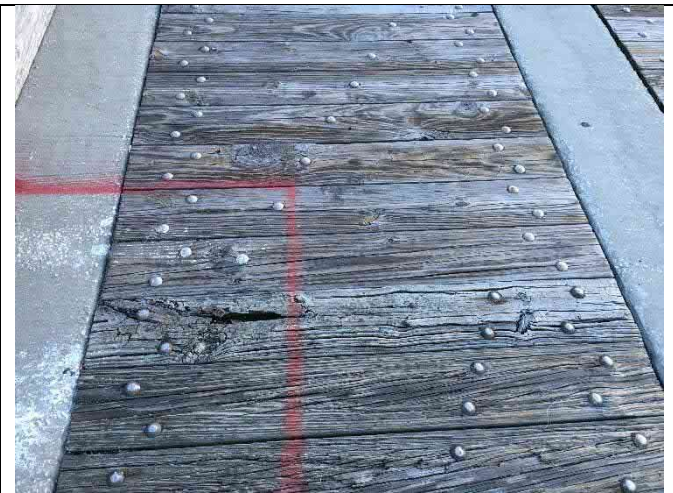
Span 28 – Timber deck deterioration

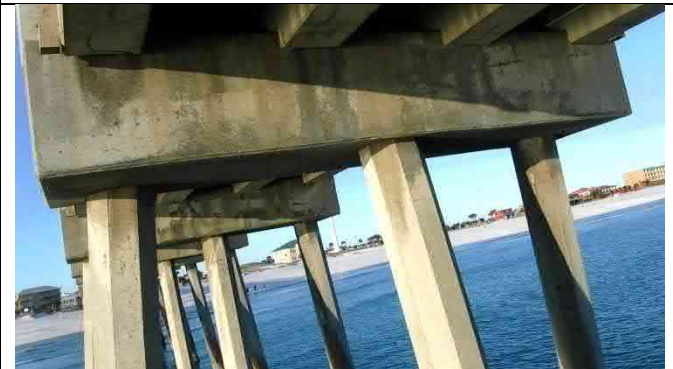
Bent 28 South Face – Beam 28-4 North end cracking, delamination and spall 24"x6"x4", Pile 28-1 top spall 10"x4"x1"

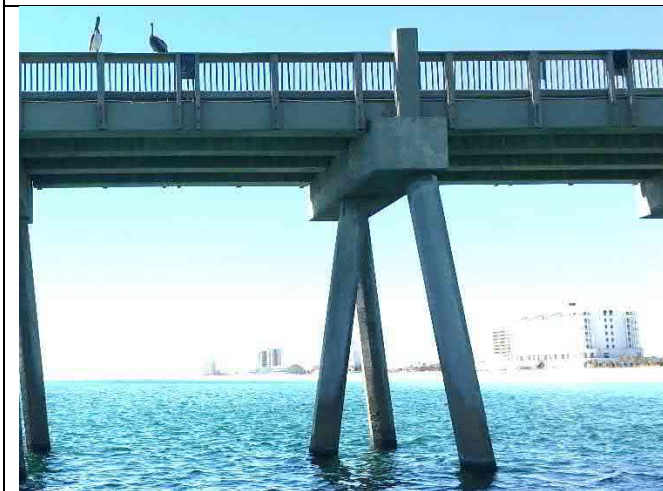
Bent 28E – Piles 28-1, 28-2, 28-3 previous spall repair damage 3x4~5"x5"x2"

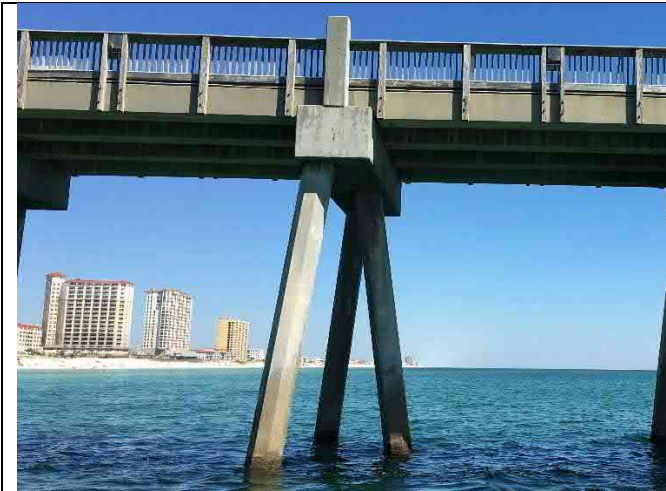
Bent 28W -Beams shifted north

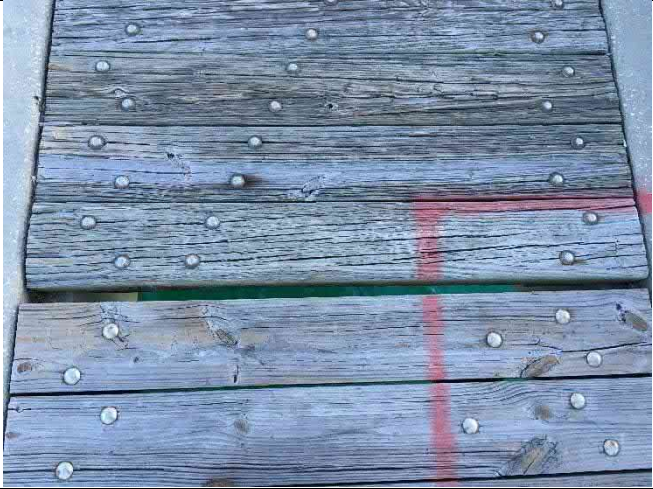
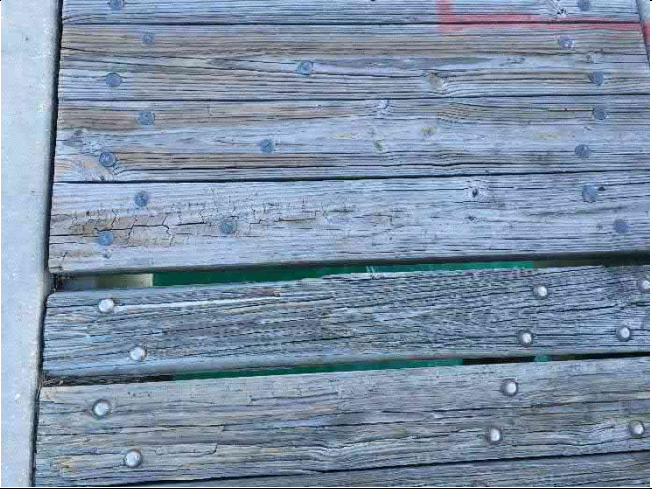
Span 29 – Damaged deck with gaps and dips > 0.5"	Span 29 – Damaged deck with gaps and dips > 0.5"

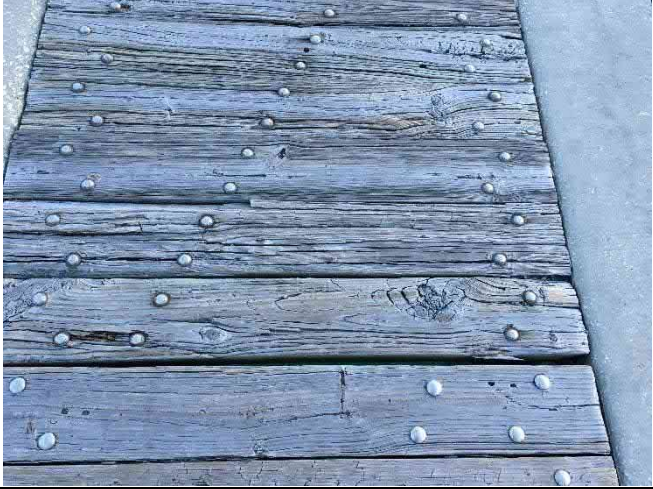
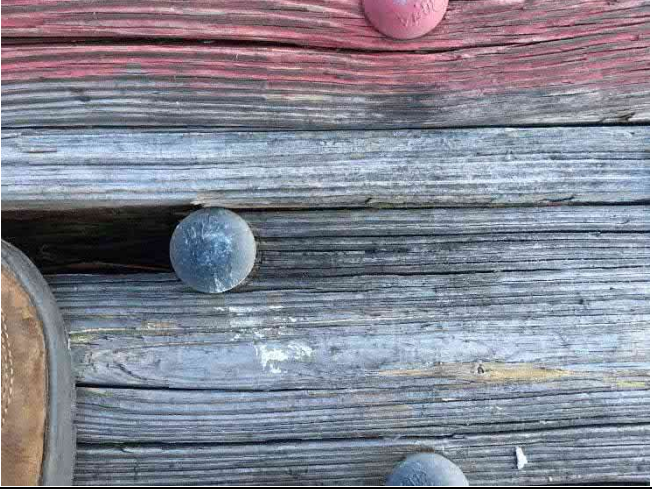
Span 29 – Damaged deck with gaps and dips > 0.5"	Span 29 – Damaged deck with gaps and dips > 0.5"

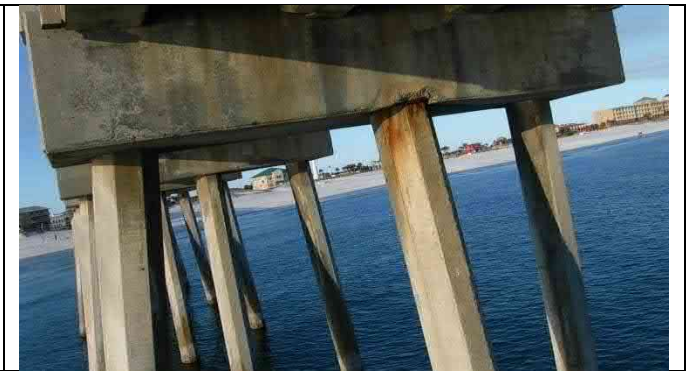
<p>Bent 30 North Face</p>	<p>Bent 30 South Face – Beam 30-1 and 30-3 end cracking, delamination and spalls 24"x12"x4", Pile cap spall over Pile 30-2 24"x8"x3" with rust stains, Pile 30-1 top spall 8"x6"x1"</p>

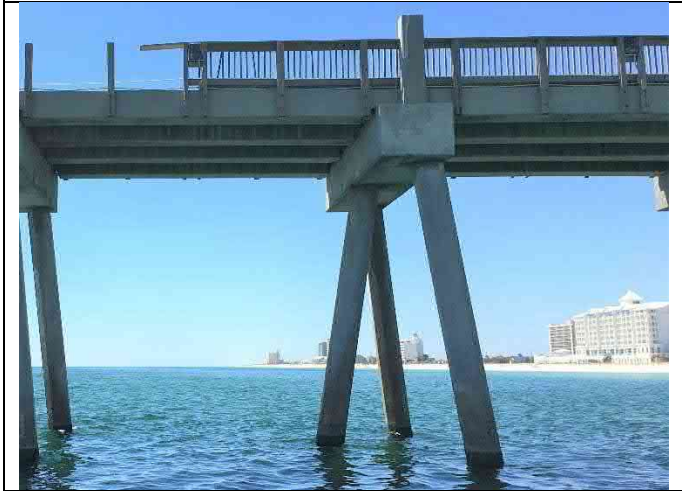
<p>Bent 30E – Pile spall repairs damaged 3x4~5"x5"x2"</p>	<p>Bent 30W</p>

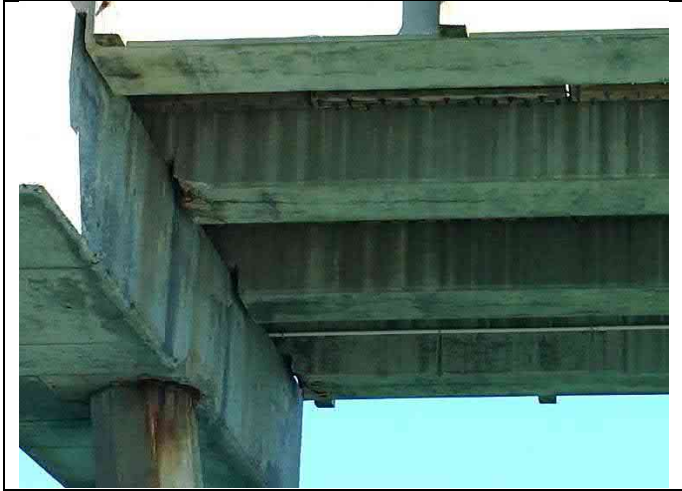
<p>Bent 30 – Beams 30-1, 30-3 north end cracking, delamination and spalls 24"x12"x4", pile cap spall over Pile 30-2</p>	<p>Bent 31E</p>

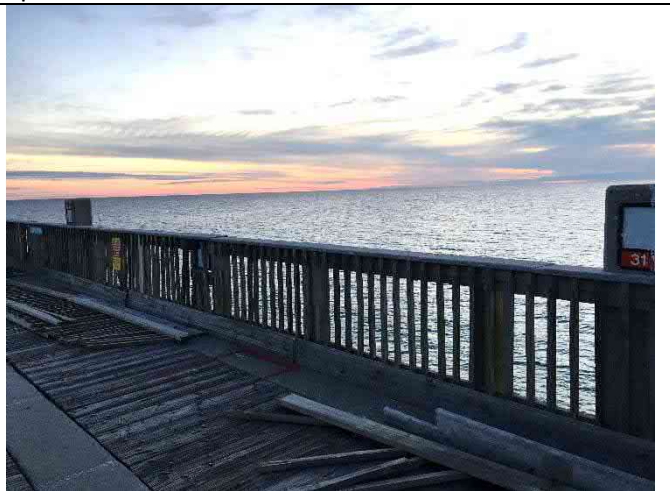
Span 31W – Railing loose with split wood members

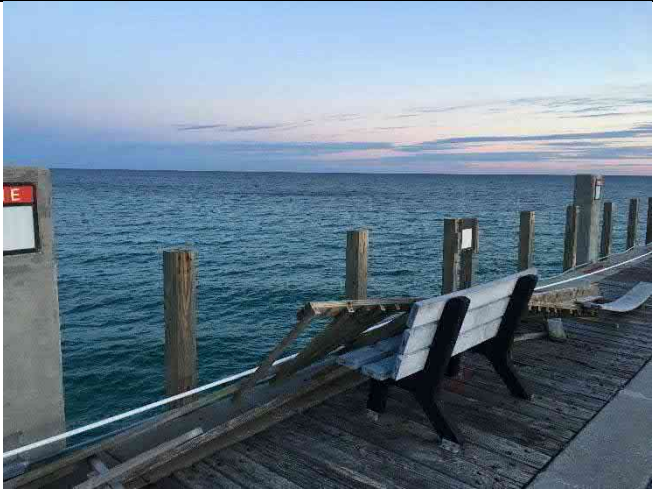
Span 31E – Railing destroyed	Span 31 – Deck damage with gaps and dips > 0.5"

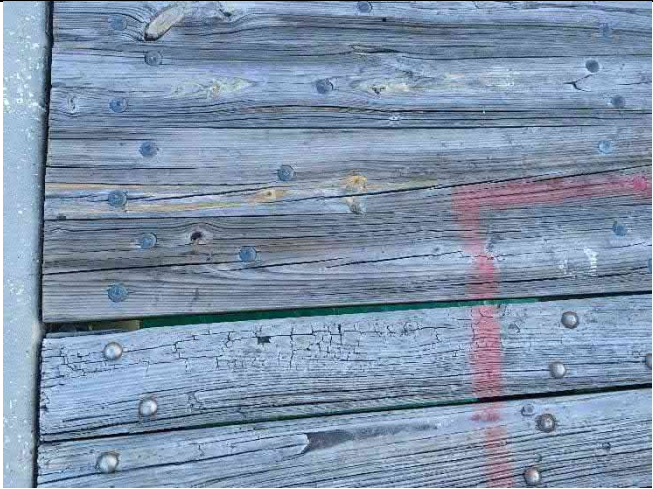
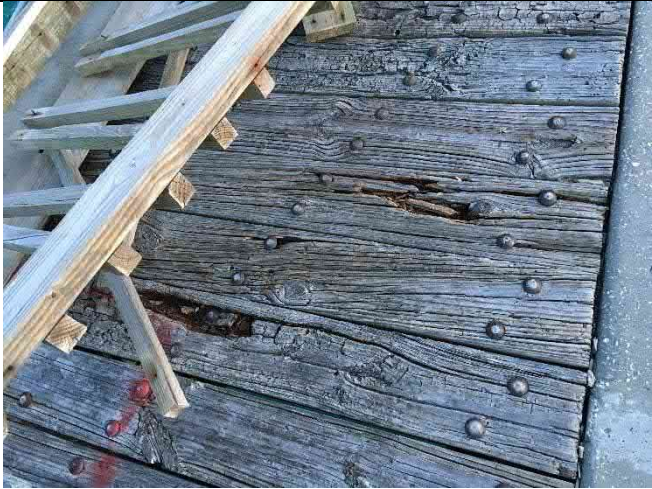
Span 31 – Deck damage with gaps and dips > 0.5"	Span 31 – Deck damage with gaps and dips > 0.5"

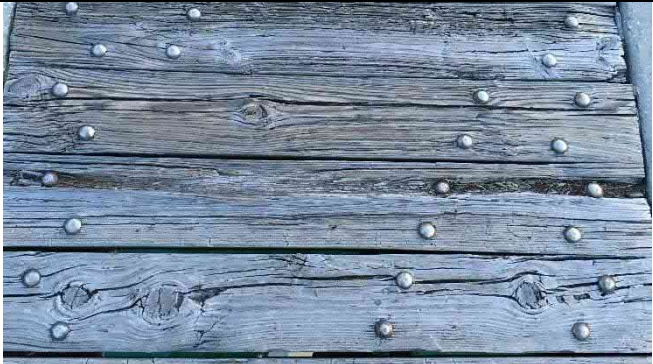
Span 31 – Deck damage with gaps and dips > 0.5"	Bent 31 North Face

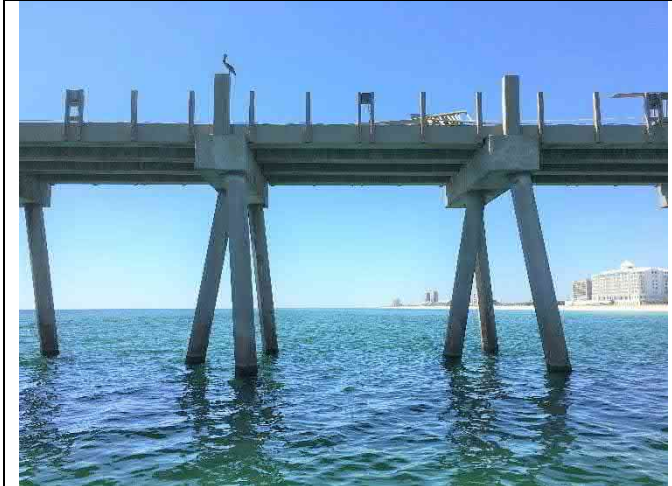
Bent 31E – Pile spall repairs damaged 3x4~4"x4"x1"

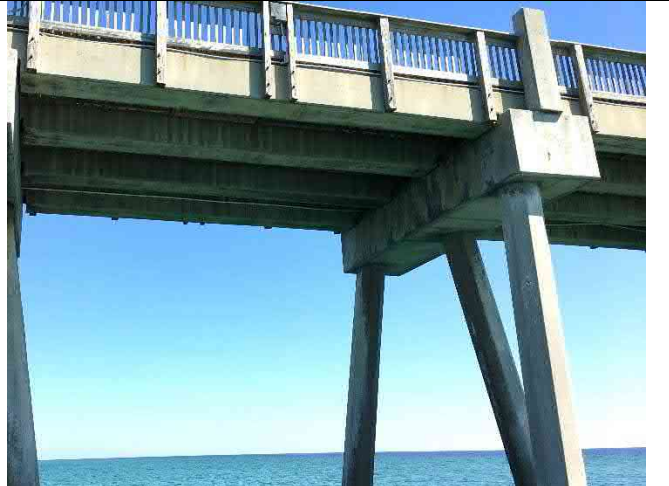
Bent 31W North Face – Pile cap spalls 2~4"x4"x2", minor rust stain under light column

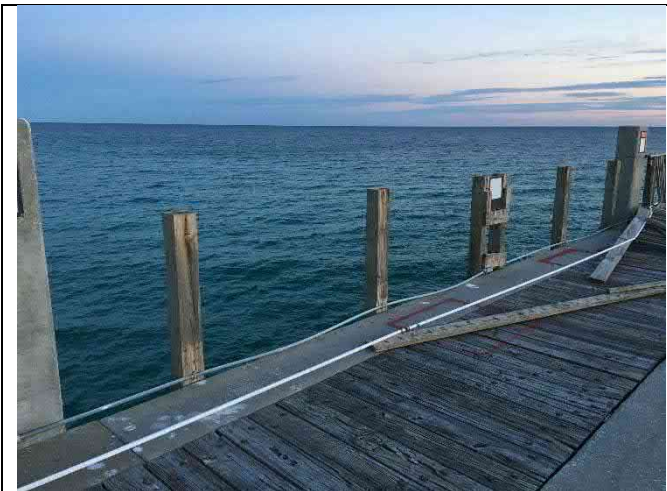
Span 32E – Railing destroyed	Span 32 – Decking damaged with gaps and dips >0.5"

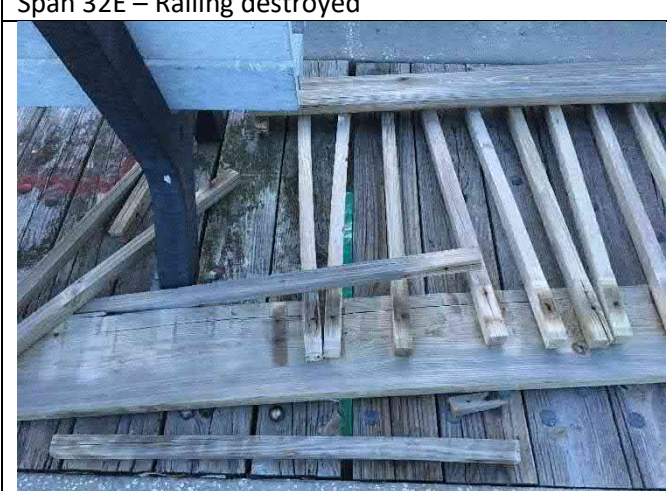
Span 32 – Decking damaged with gaps and dips >0.5"	Span 32 – Decking damaged with gaps and dips >0.5"

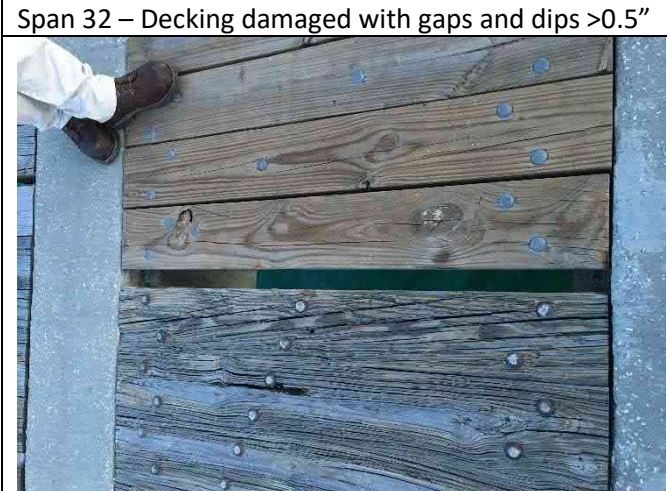
Span 32 – Decking damaged with gaps and dips >0.5"	Span 32 – Decking damaged with gaps and dips >0.5"

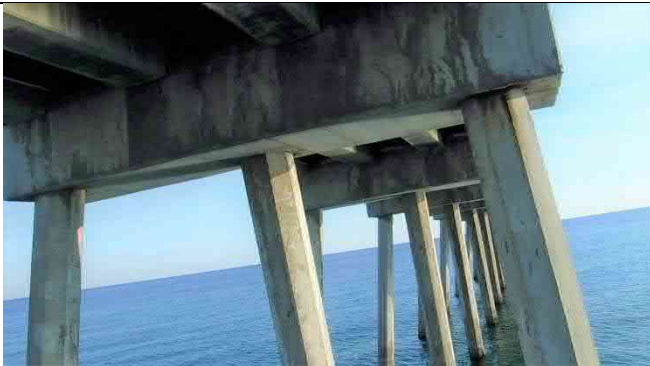
<p>Bent 32 North Face – Rust staining top of Pile 32-3</p>	<p>Bent 32 North Face</p>

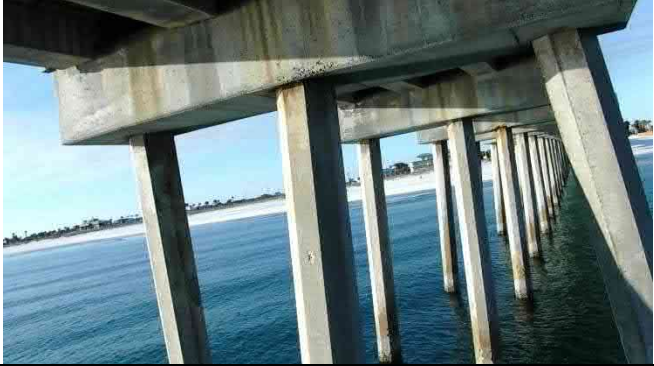
<p>Bent 32 South Face</p>	<p>Bent 32 South Face – Pile 32-2 upper spall 5"x5"x2", Beams 32-3 and 32-4 north end ,rust staining top of Piles 32-2 and 32-3</p>

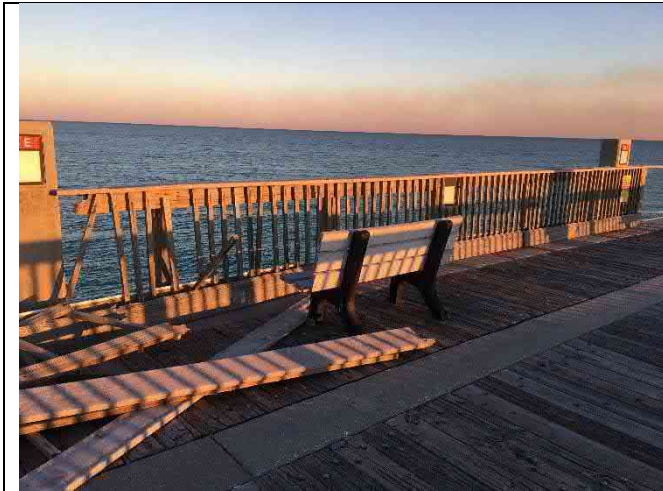
Span 33E – Railing damaged

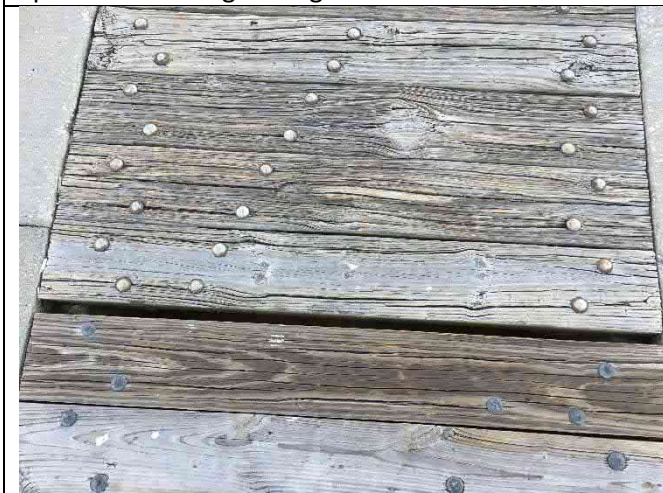
Span 33 – Deck damage with gaps and dips > 0.5"

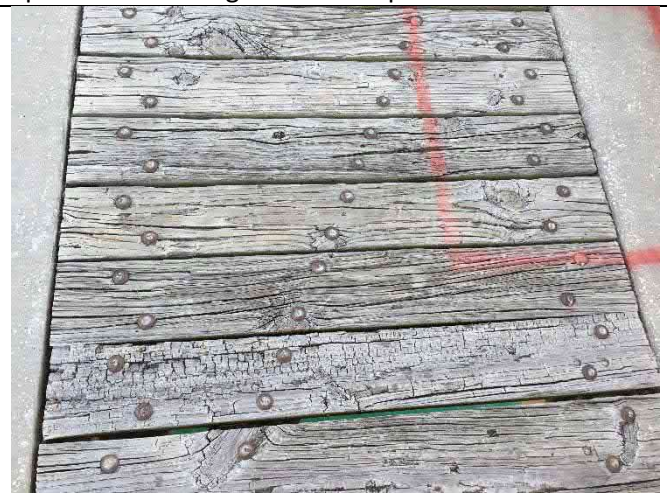
Span 33 – Deck damage with gaps and dips > 0.5"

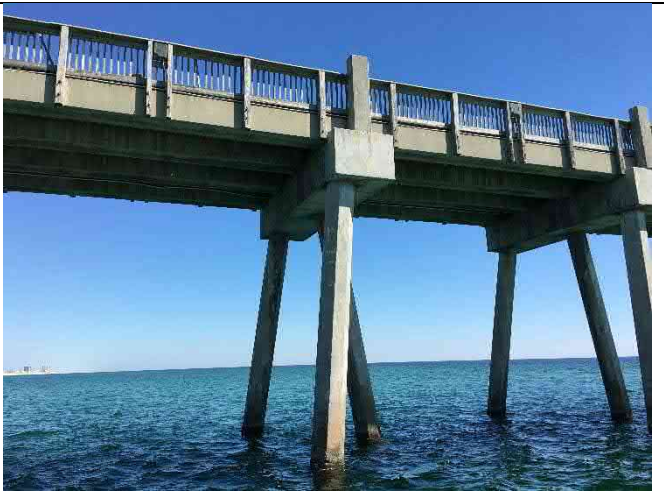
Bent 33W – Pile spall repair damage 3x4~5"x5"x2"

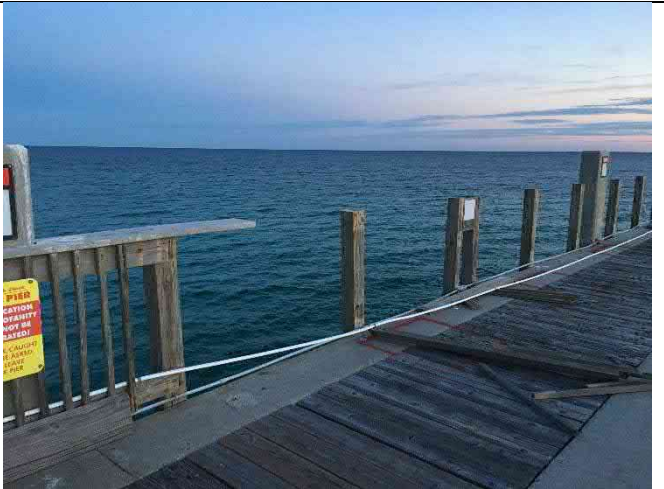
Span 34E – Railing damage

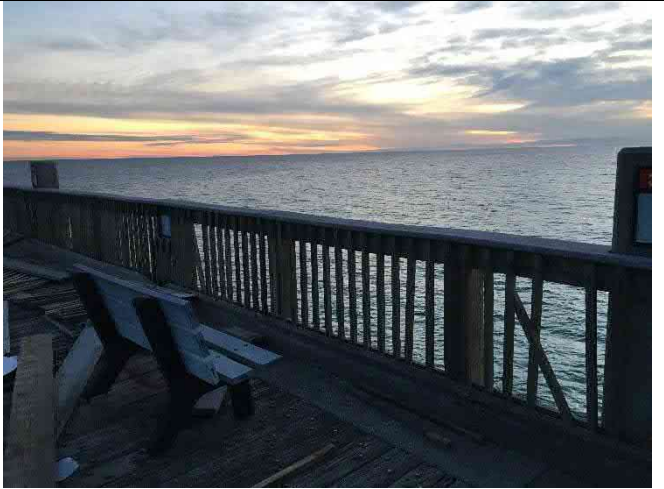
Span 34W – Railing damage
