# **Preliminary Engineering Assessment (PEA)**

## **Pensacola Beach Gulf Pier**

Escambia County, FL

April 5, 2021

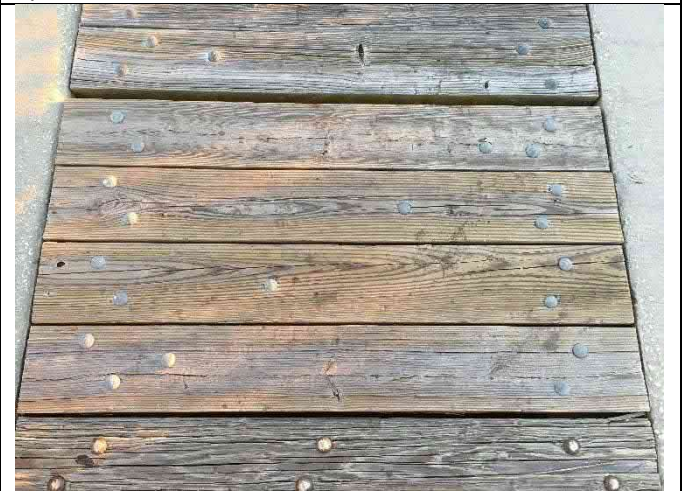
Span 34 – Deck gaps > 0.5"

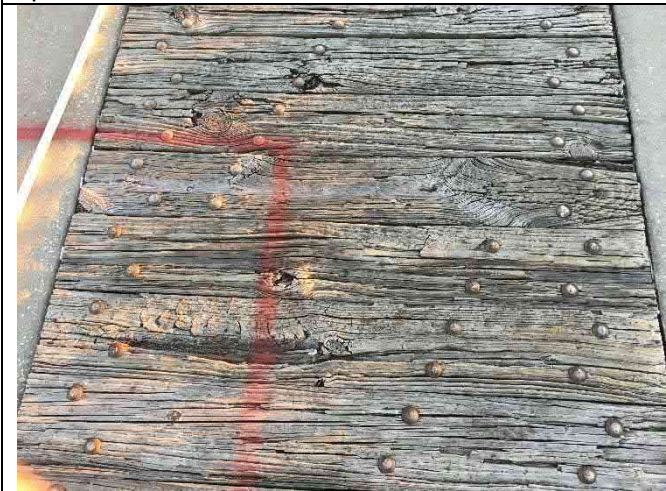
Span 34 – Deck damage with gaps and dips > 0.5"

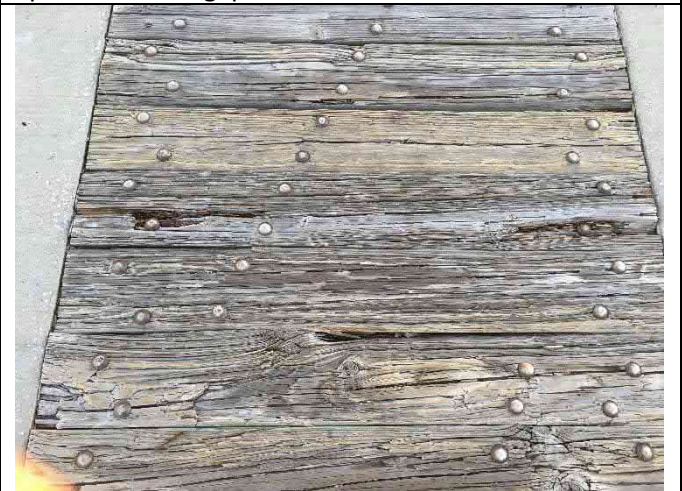
Span 34 – Deck damage with gaps and dips > 0.5"

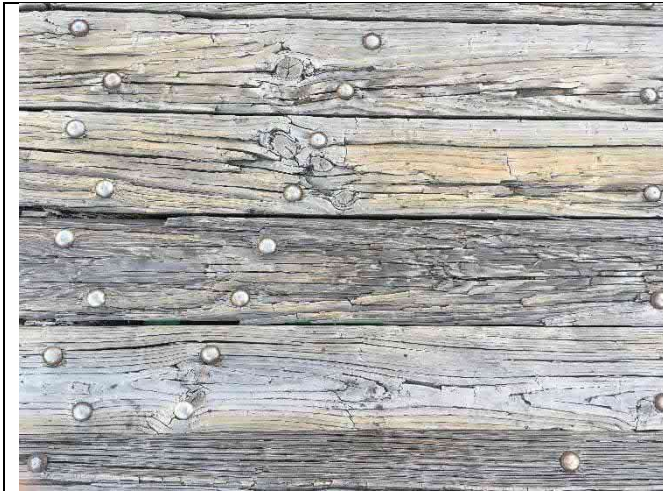
Span 34 – Deck damage with gaps and dips > 0.5"

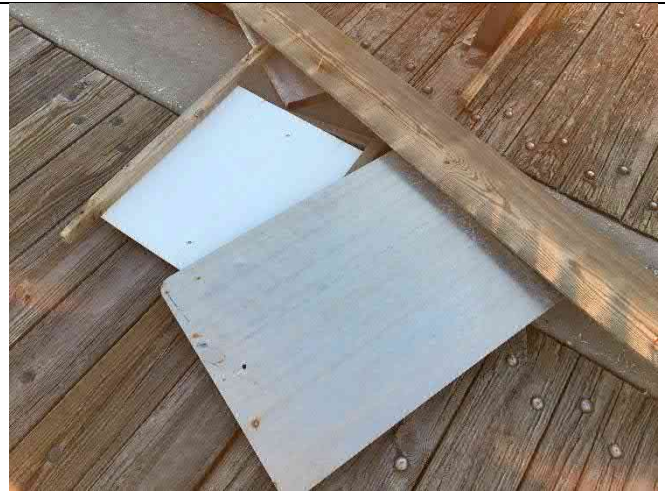
Span 34 – Signage damage

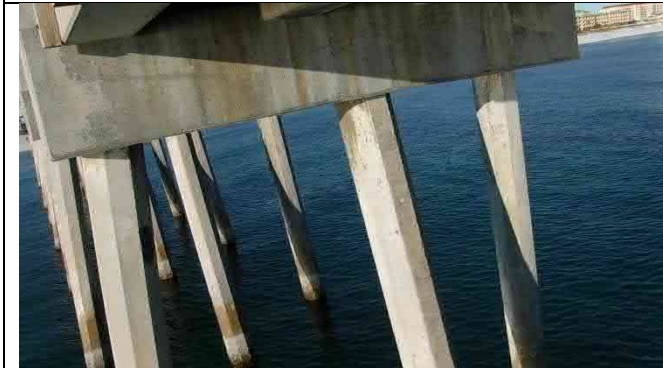
Bent 34 South Face – Beam 34-4 North end cracking and delamination 24"x6"x3"

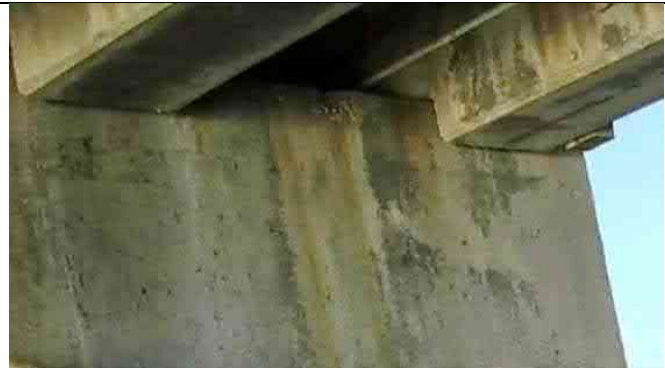
Bent 34 South Face – Pile cap top spall 8"x6"x1"

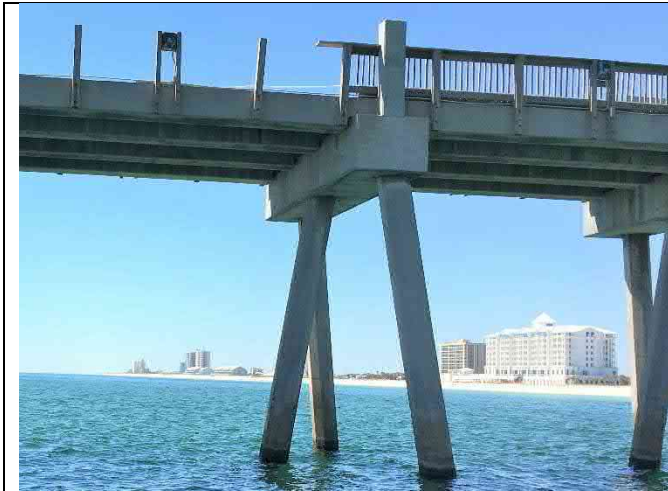
Bent 34E – Pile spalls 3x4~5"x5"x2"

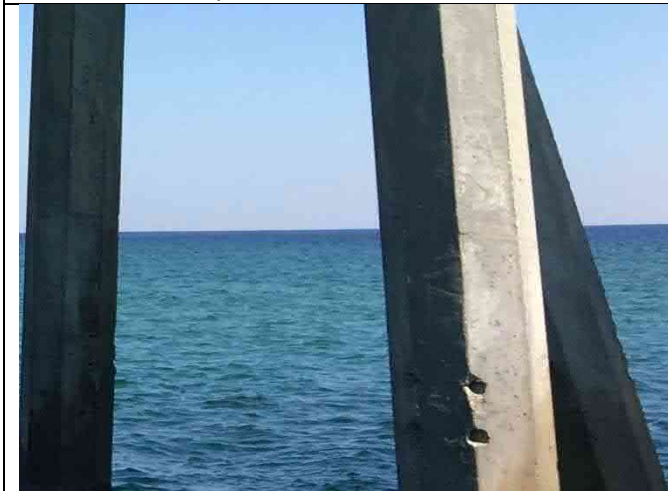
Pile 34-3 – 4~5"x5"x2" spalls (previous repair damaged)

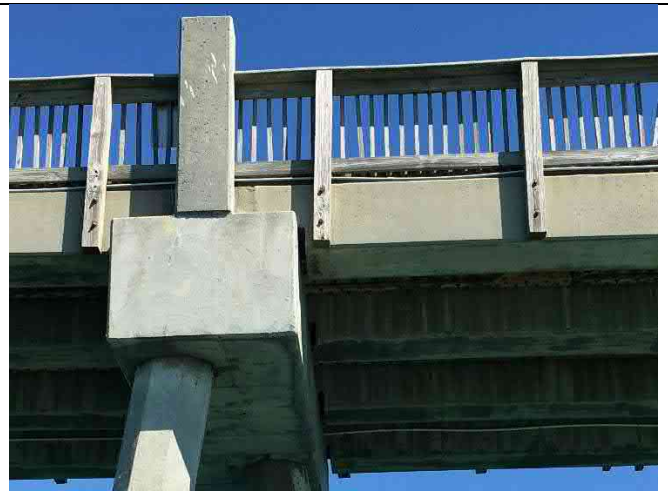
Bent 34W – Beam 34-3 end cracking and delamination

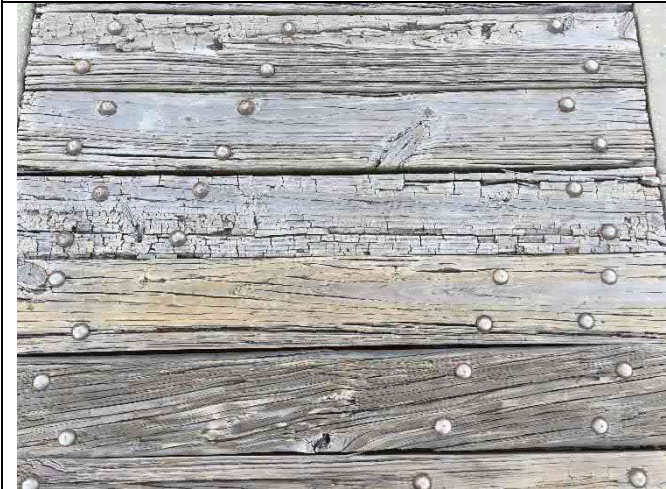
Span 35 – Deck damage with gaps and dips > 0.5"

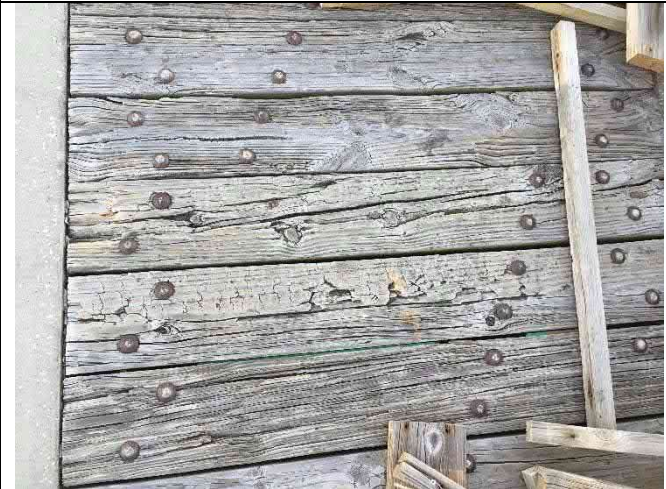
Span 35 – Deck damage with gaps and dips > 0.5"

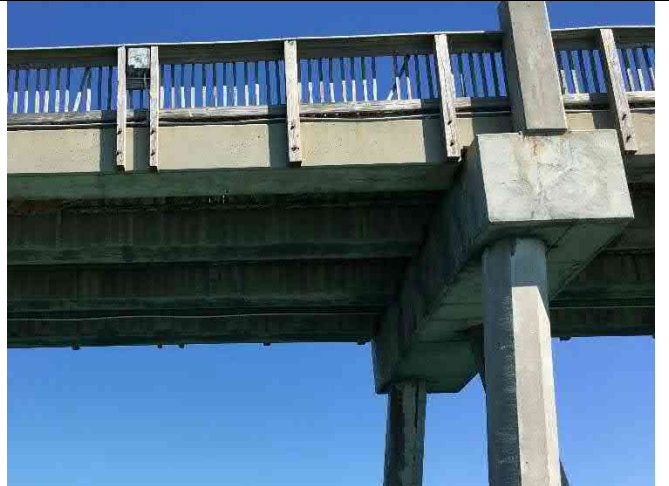
Bent 35W – Beam 34-4 South end cracking, delamination and spall 24”x4”x3”

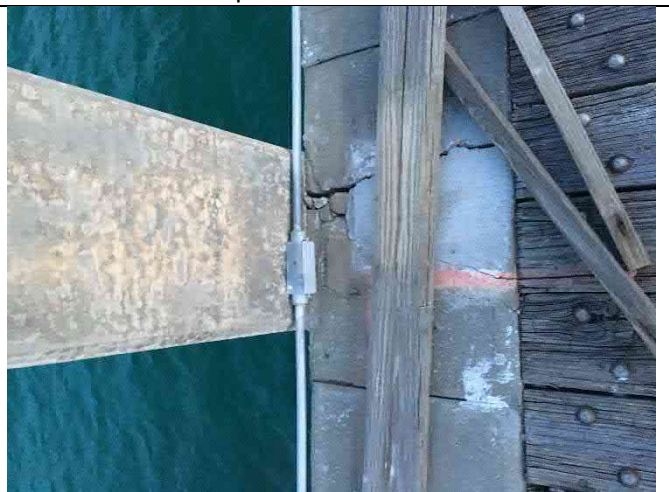
Bent 36E – Closure pour cracking and spalls

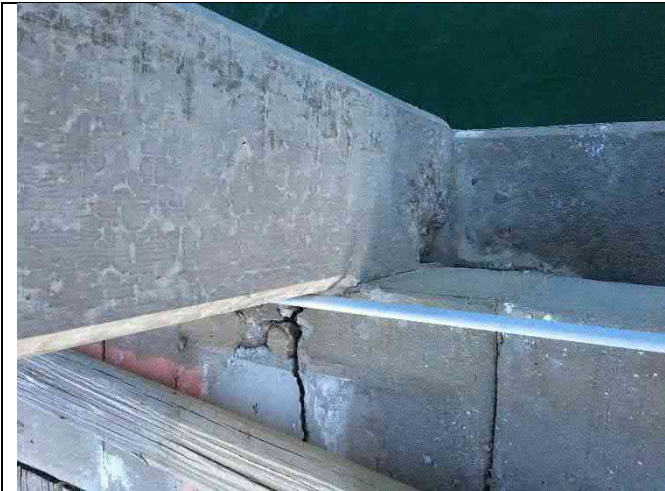
Bent 36E – Closure pour cracking and spalls

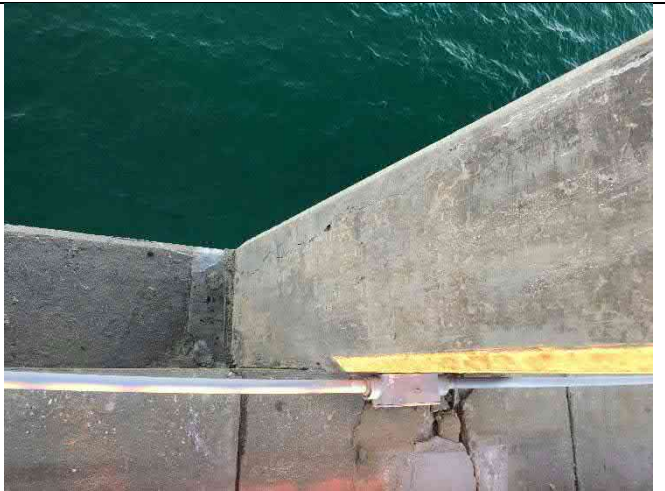
Bent 36E – Previous light column repair good

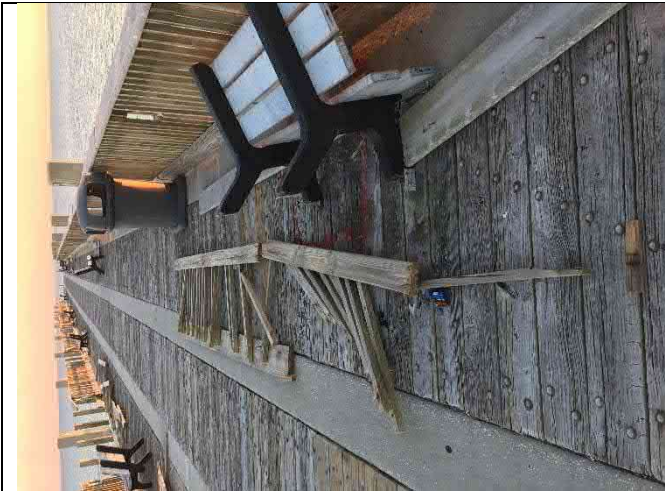
Span 36W – Bench to deck connection damage

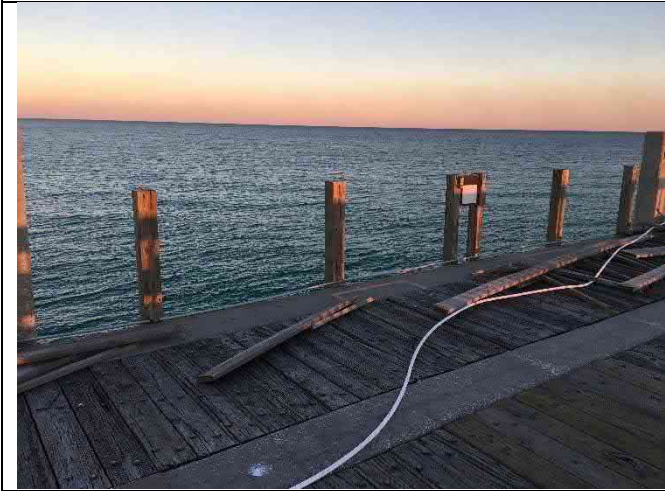
Span 36E – Railing destroyed, utility damage

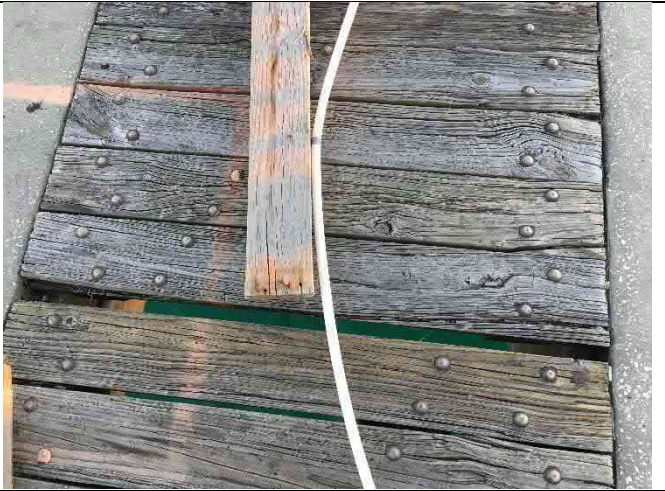
Span 36 – Deck damage with gaps and dips > 0.5"

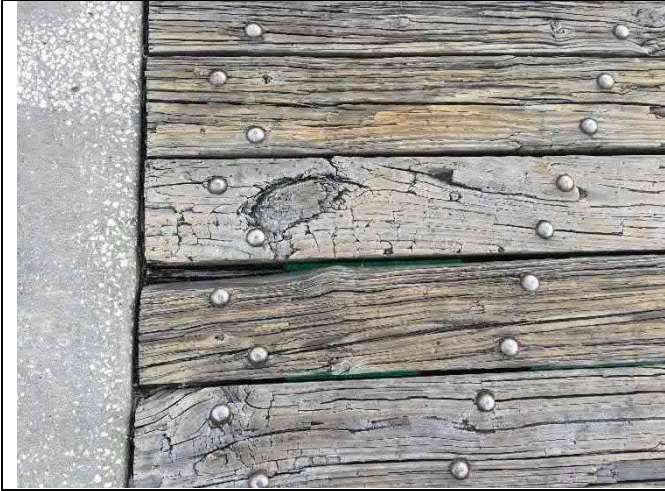
Span 36 – Deck damage with gaps and dips > 0.5"

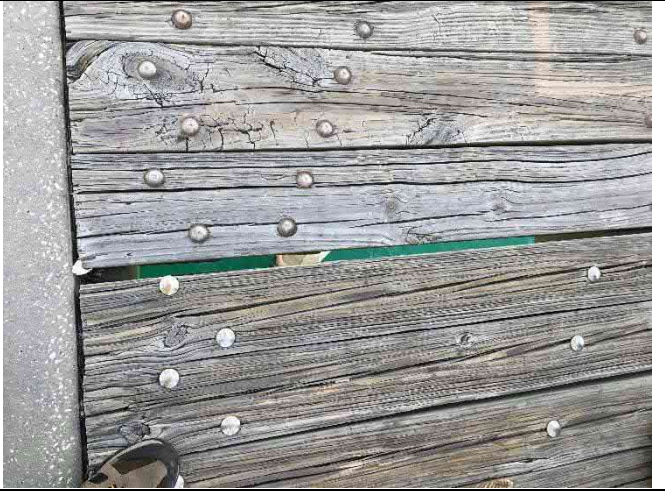
Span 36 – Deck damage with gaps and dips > 0.5"

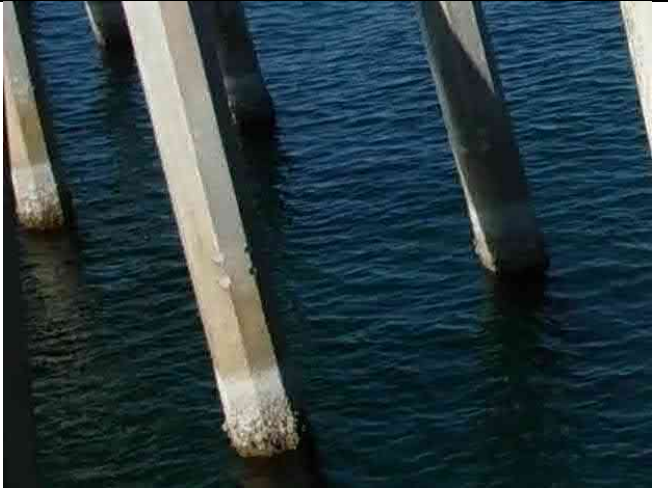
<p>Bent 36 Piles previous spall repairs damaged 3x4~4"x4"x2"</p>

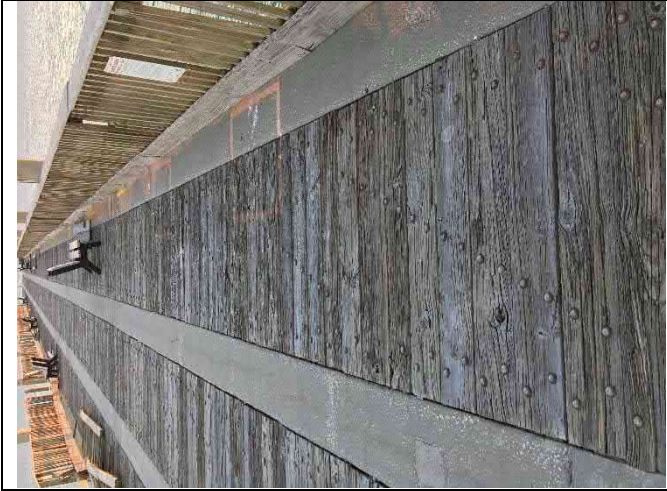
Span 37W	Bent 37E – Light column cracking (8' +/-)

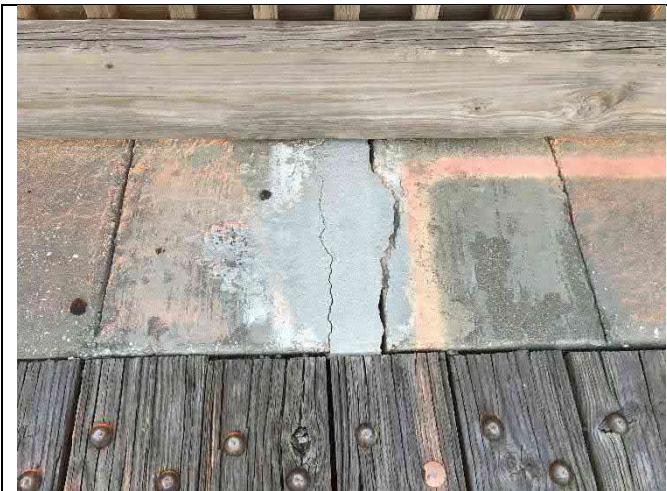
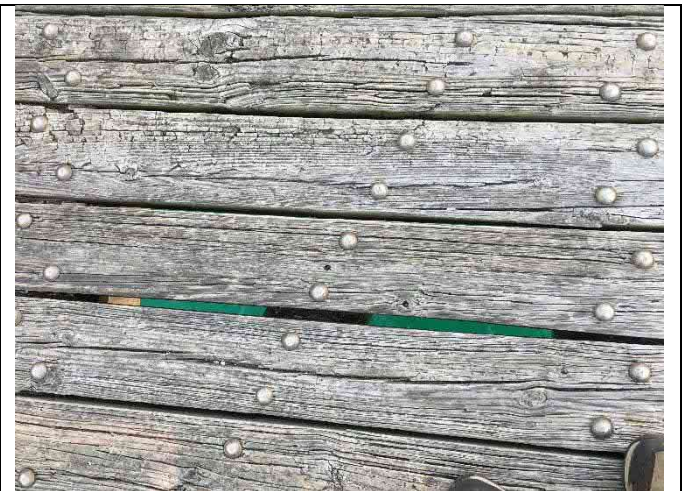
Bent 37W – Closure cracking	Span 37 – Deck damage with gaps and dips > 0.5"

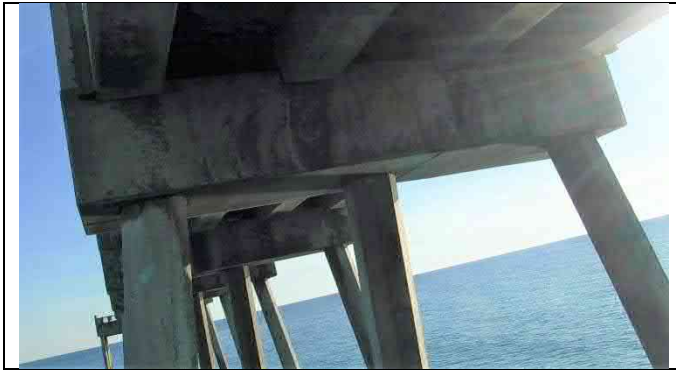
Bent 37 North Face – Pile 37-1 top spall 4"x4"x1"

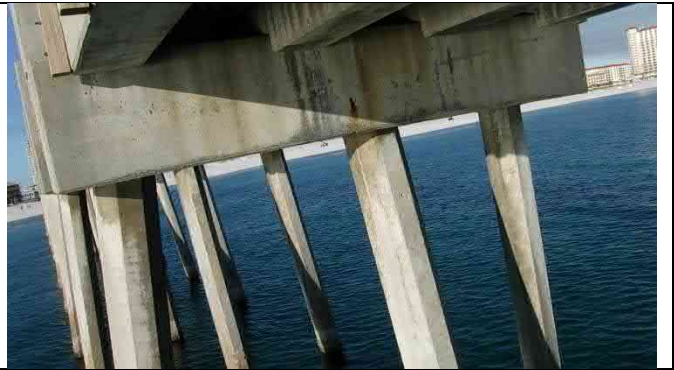
Bent 37 South Face – Pile cap spall with rust staining 3"x3"x2"

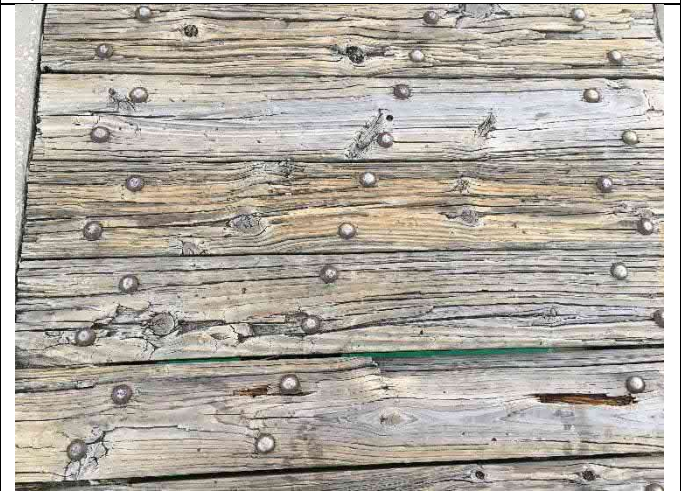
Span 38 – Deck damage with gaps and dips > 0.5"

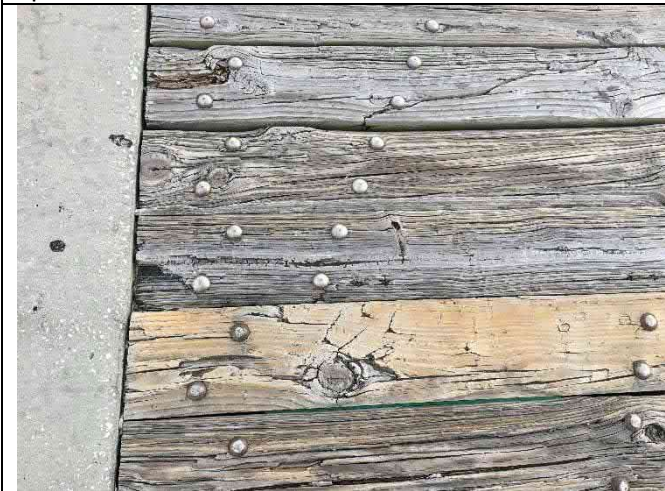
Span 38 – Deck damage with gaps and dips > 0.5"

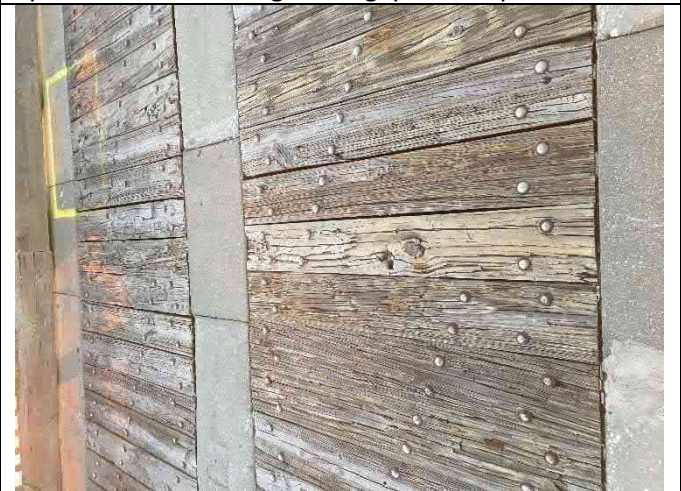
Span 38 – Deck damage with gaps and dips > 0.5"

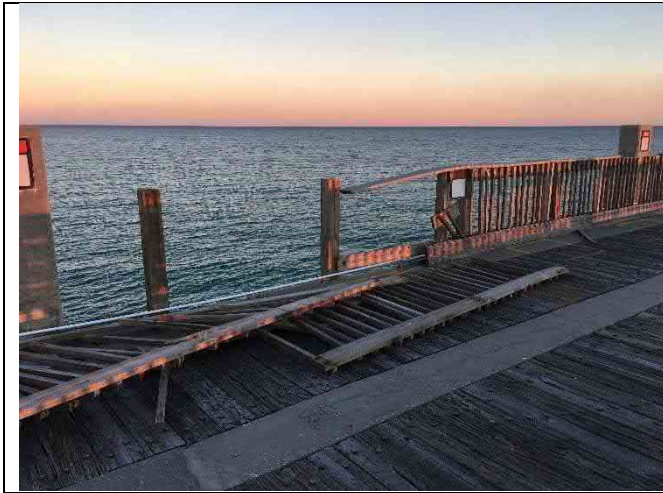
Span 38E – Railing damage

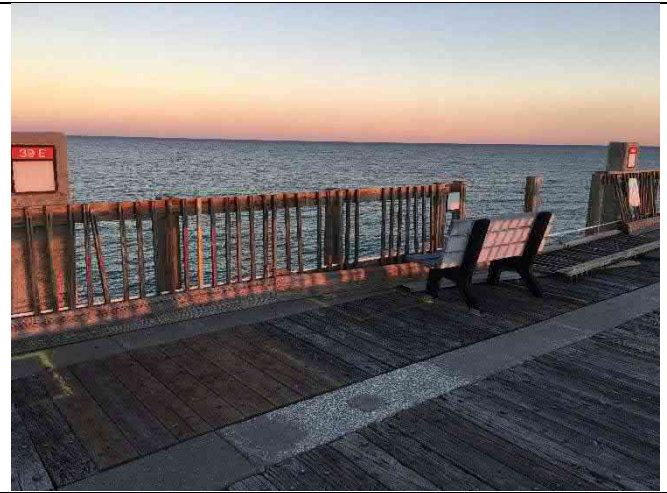
Span 39E – Railing damage

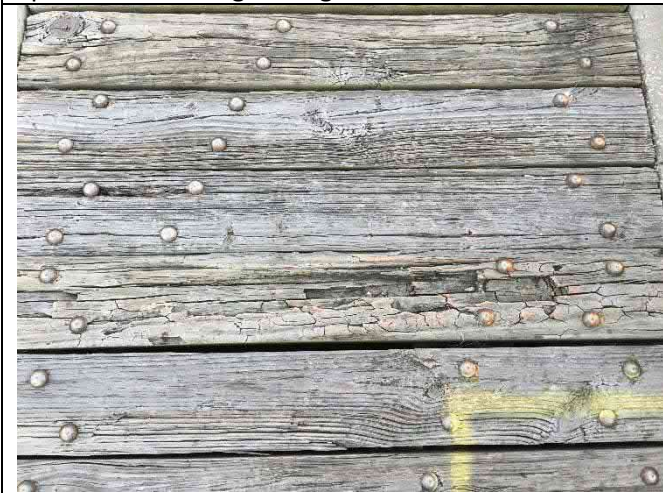
Span 39 – Deck damage with gaps and dips > 0.5"

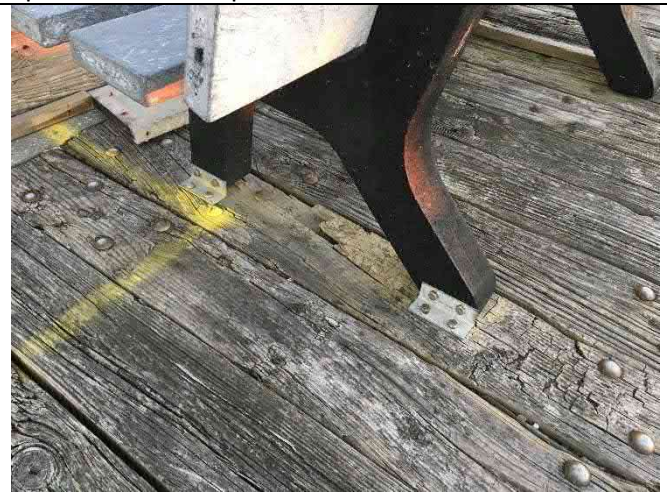
Span 39 – Broken deck below bench

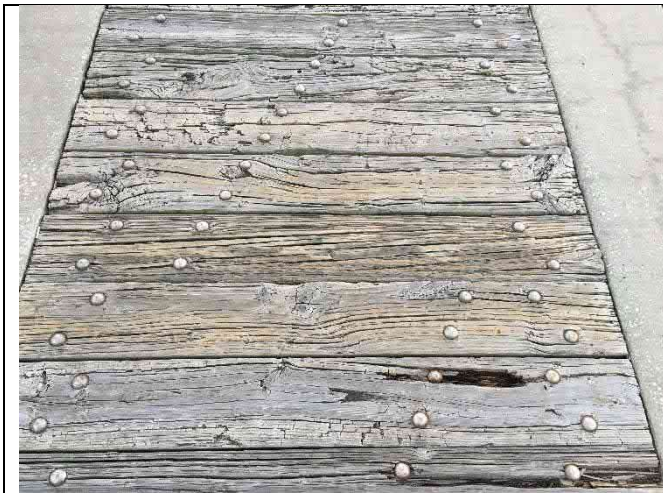
Span 39 – Deck damage with gaps and dips > 0.5"

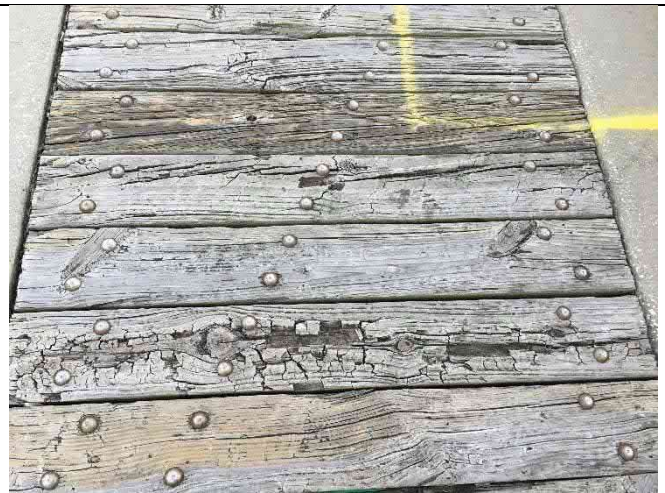
Span 39 – Deck damage with gaps and dips > 0.5"

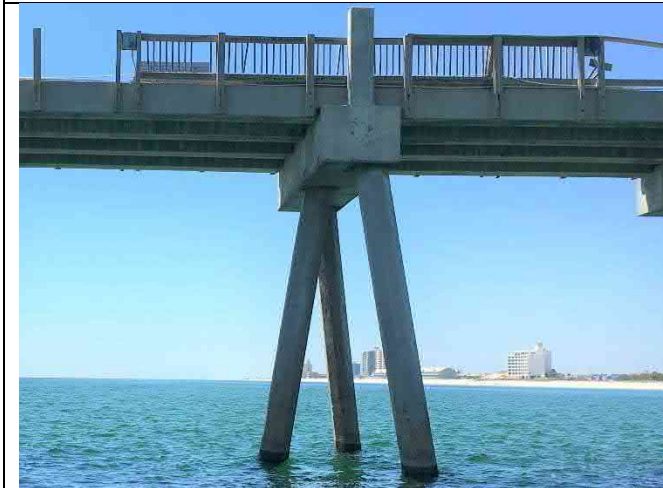
Bent 39E – Pile spall repairs in place but not filling holes 3x4~4"x4"x1"

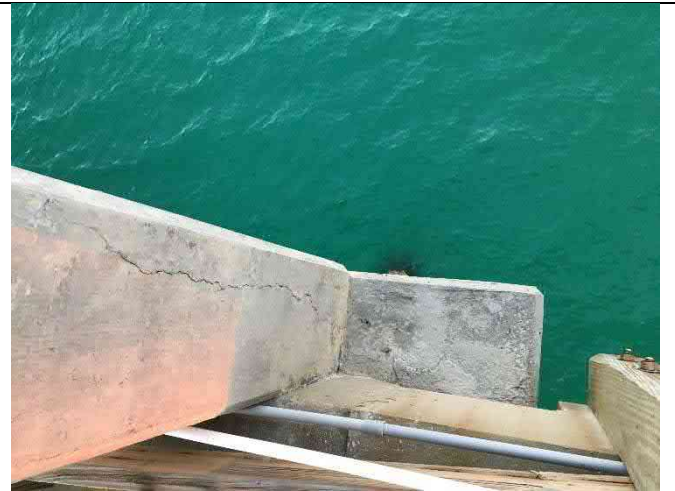
Bent 40E – Light column cracking (8' +/-)

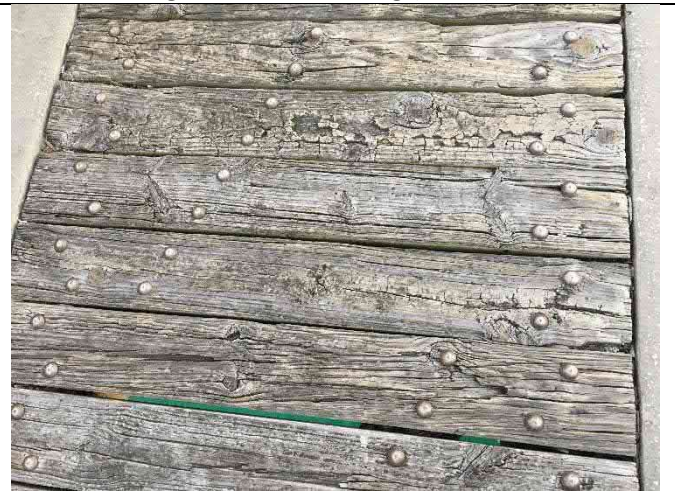
Span 40 – Deck damage with gaps and dips > 0.5"

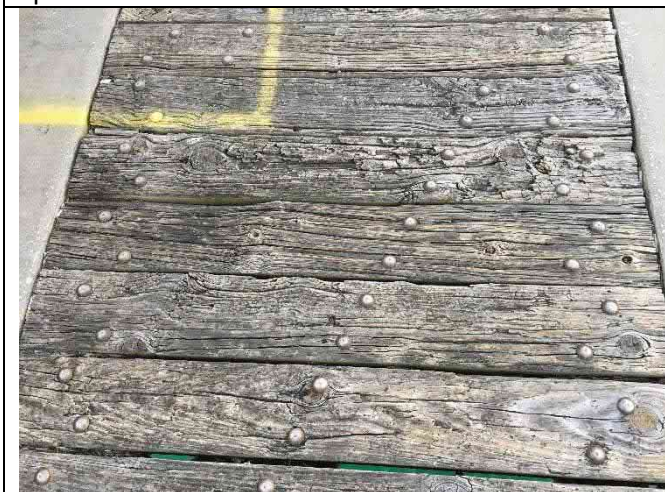
Span 40 – Deck damage with gaps and dips > 0.5"

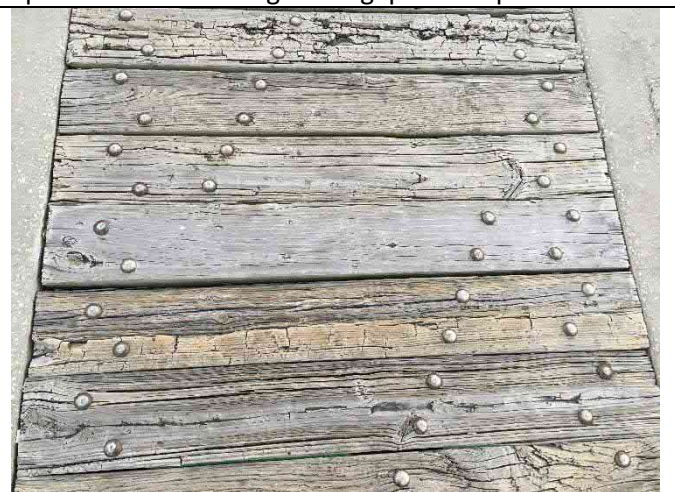
Span 40 – Deck damage with gaps and dips > 0.5"

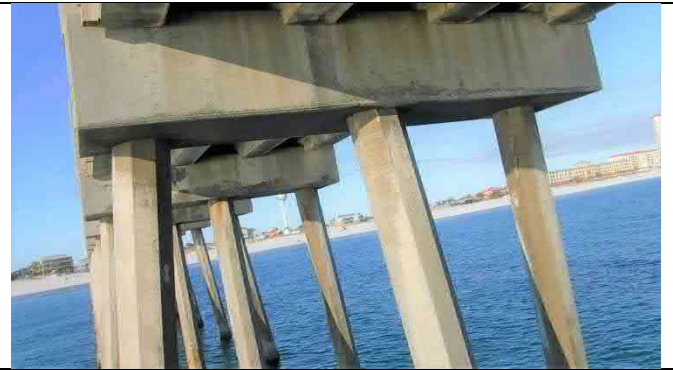
Bent 40 South Face – Pile 40-1 top spalls 15"x3"x1", 8"x8"x2"

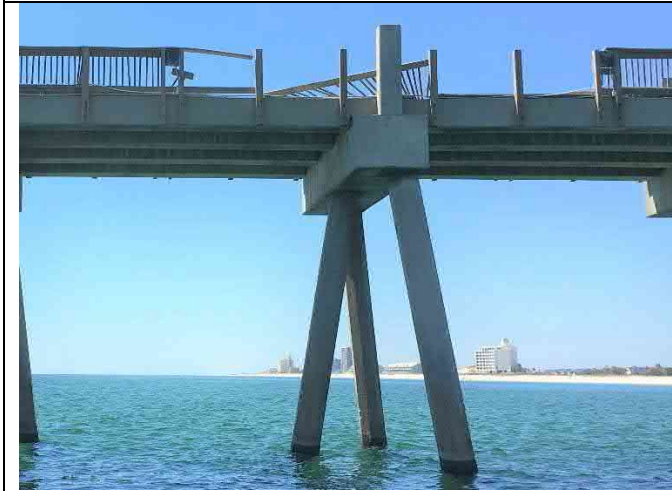
Bent 40E – Piles 40-1, 40-2 spall repairs not completely filled 2x4~4"x4"x1"

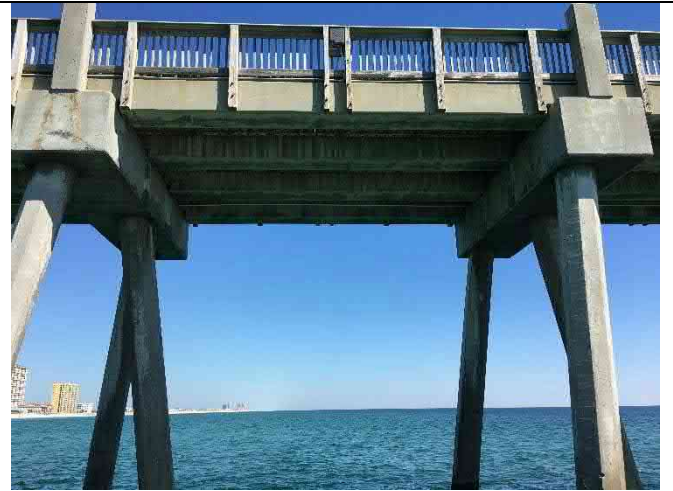
Bent 39W, 40W – Pile 40-1 top spalls, Pile 40-3 spall repairs damaged 4~4"x4"x2"

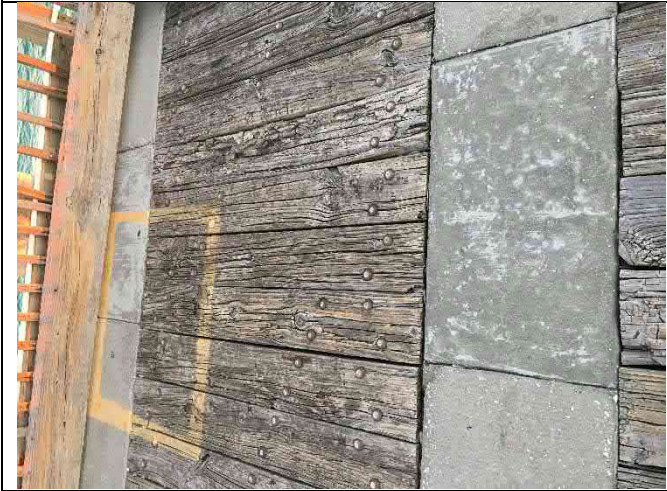
Bent 41 - Deteriorated deck	Span 41 – Deck damage with gaps and dips > 0.5"

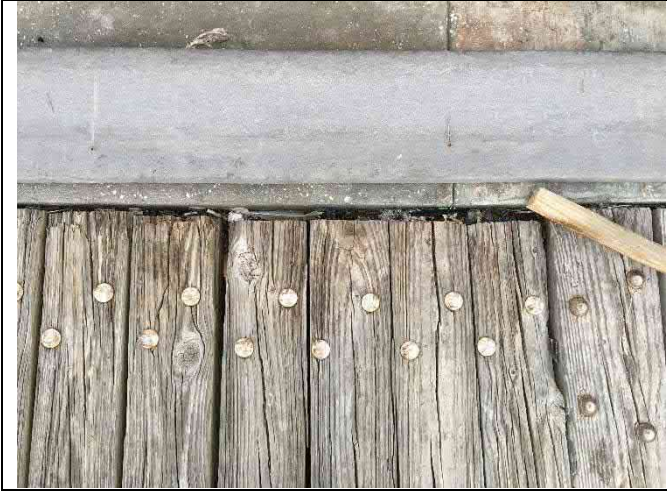
Span 41 – Deck damage with gaps and dips > 0.5"	Span 41 – Deck damage with gaps and dips > 0.5"

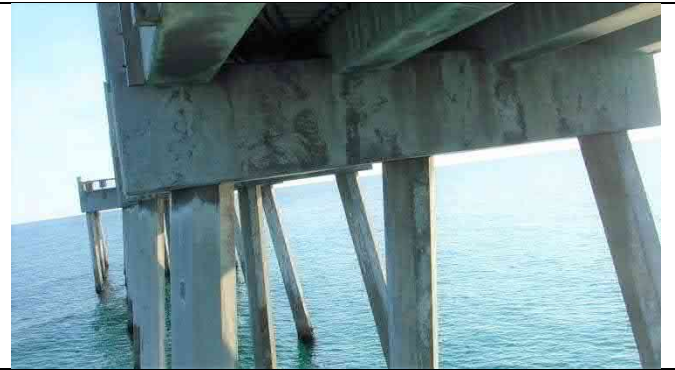
Bent 41 North Face – Pile 41-1 top spall 8"x3"x1",  
Beam 40-1 South end cracking and delamination  
24"x6"x3"

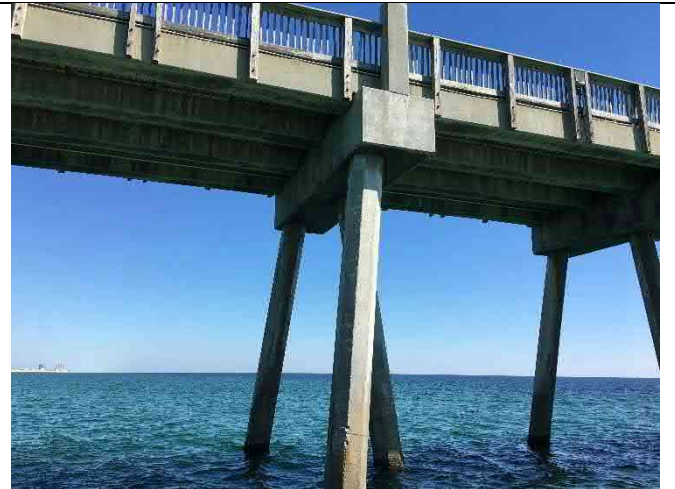
Bent 41W – Pile spall repair damage 3x4~4"x4"x2"

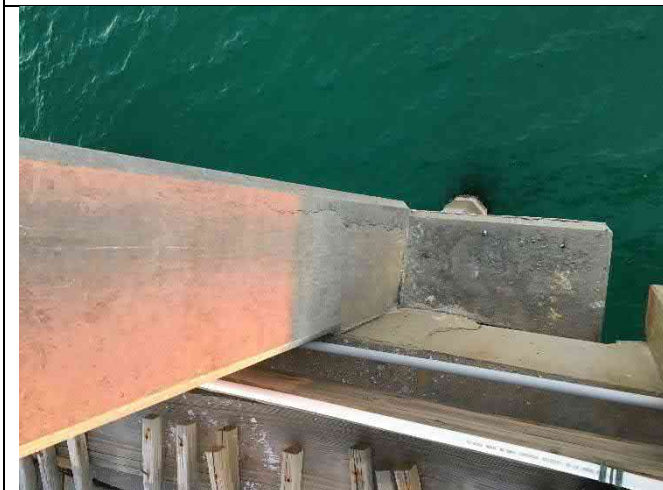
Bent 42E – Beam 42-1 closure cracking (16" +/-), light  
column cracking (5' +/-)

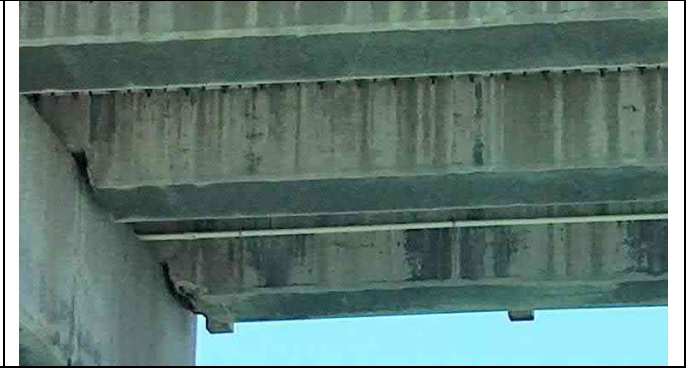
<p>Bent 42 South Face – Pile cap top spall 4"x4"x1", Beam 42-1 and 42-2 end cracking, delamination and spalls</p>	<p>Beam 42-1 north end cracking, delamination and spall 24"x12"x4", Beam 42-2 north end spall 24"x3"x3"</p>

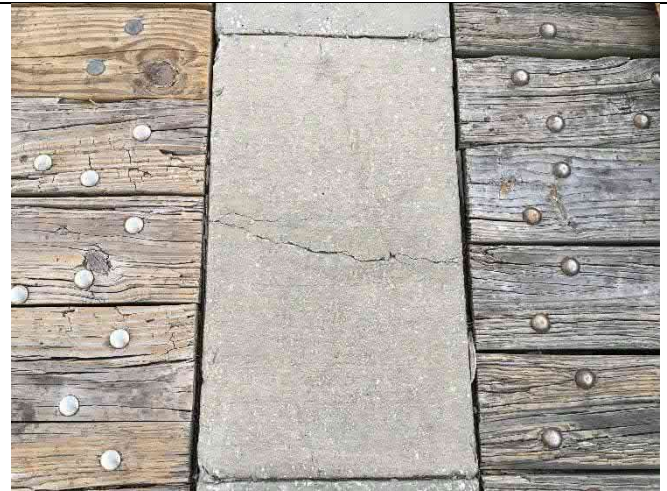
Bent 43 – Closure cracking

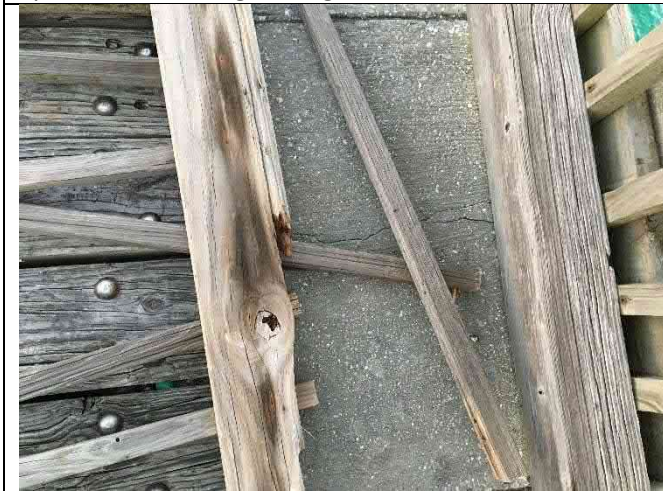
Bent 43 – Closure cracking

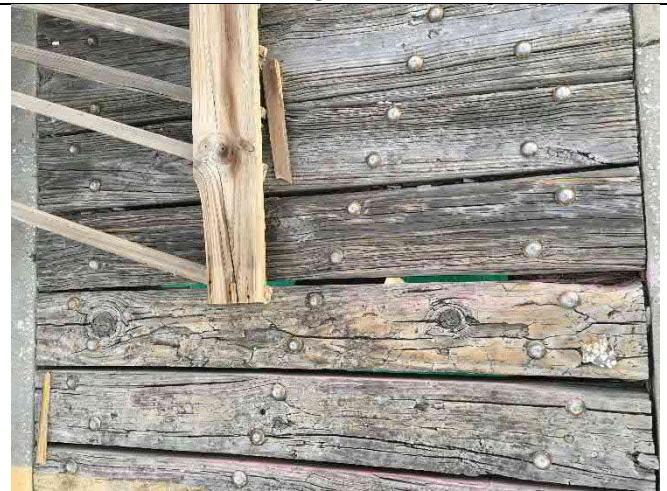
Span 43 – Deck damage with gaps and dips > 0.5"

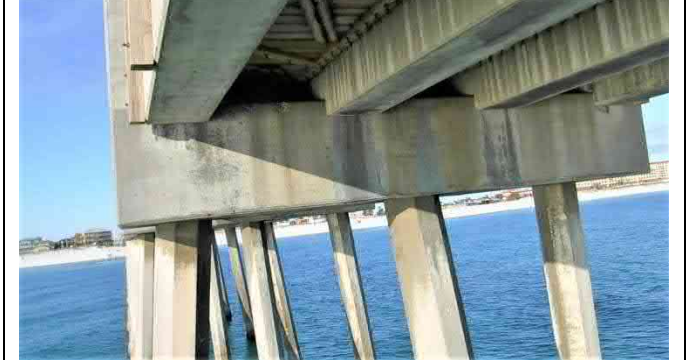
<p>Bent 43 North Face</p>	<p>Bent 43 South Face – Pile cap spalls 2~4"x4"x1", Pile 43-1 top spall 4"x4"x1"</p>

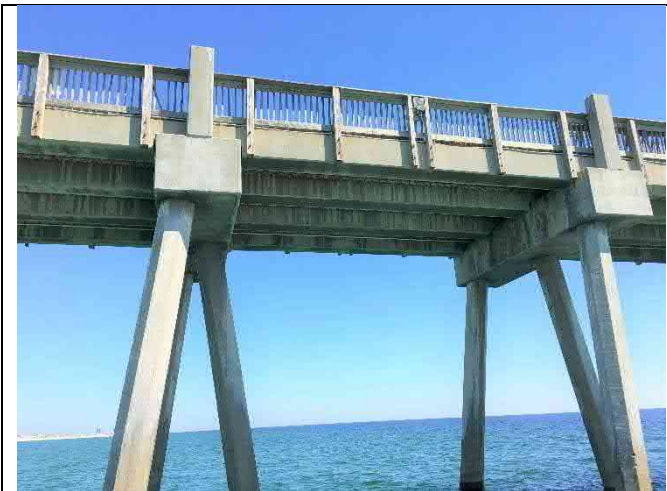
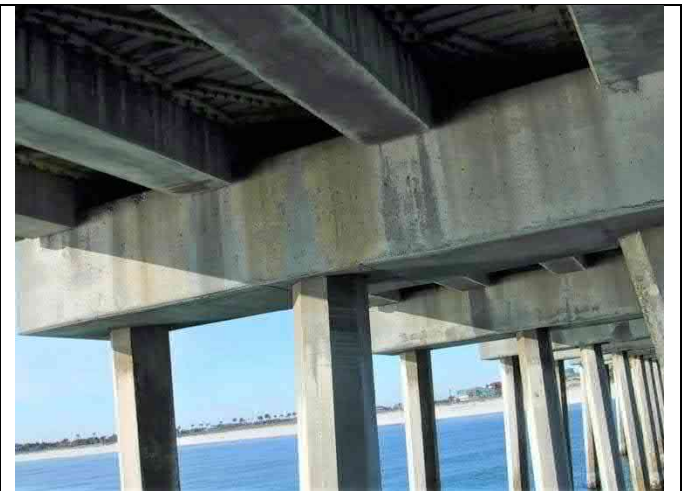
Bent 43W - Pile spall repair damage 3x4~4"x4"x2"	Bent 43 South Face

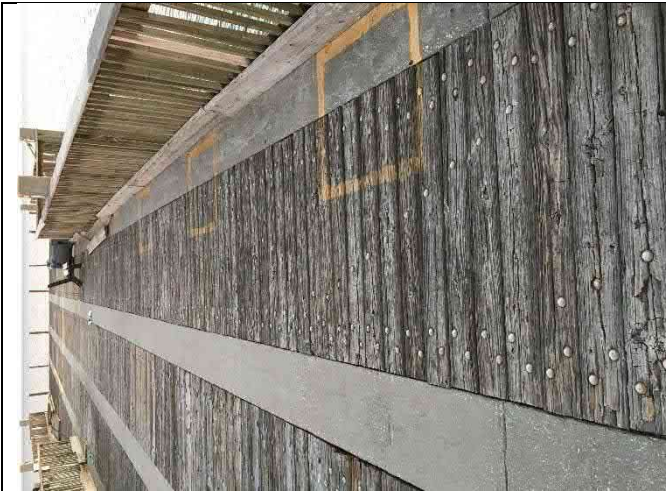
Span 44E – Railing loose with split wood members

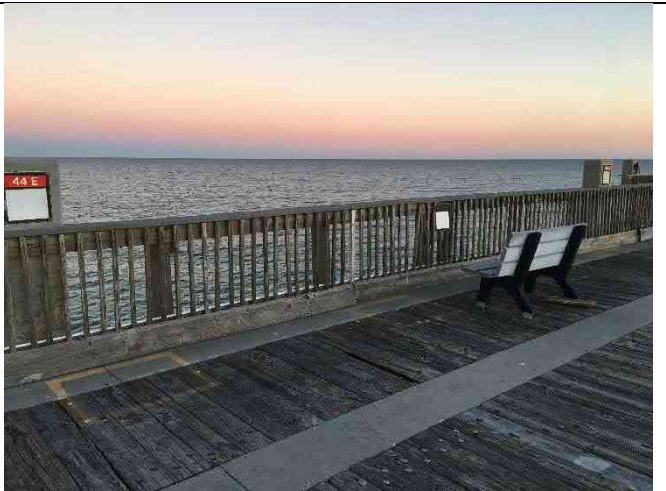
Span 44W – Railing loose with split wood members

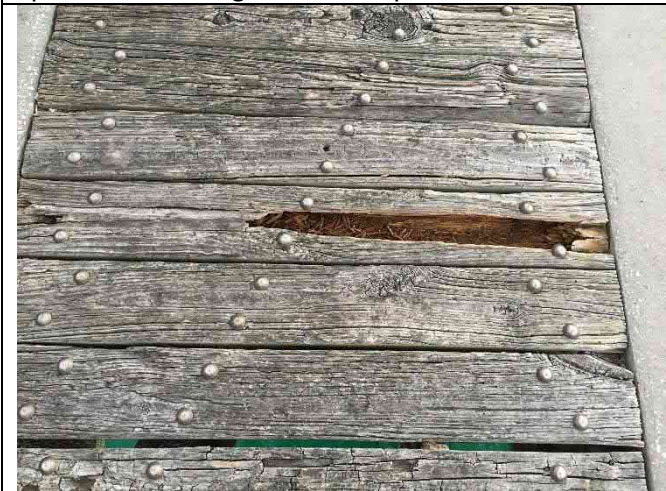
Span 44 – Deck damage with gaps and dips > 0.5"

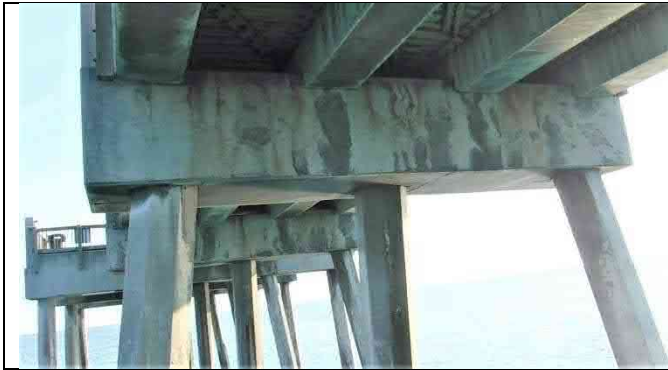
Bent 44 South Face – Beam 44-2 north end cracking, delamination, spall 24"x6"x3", longitudinal cracking

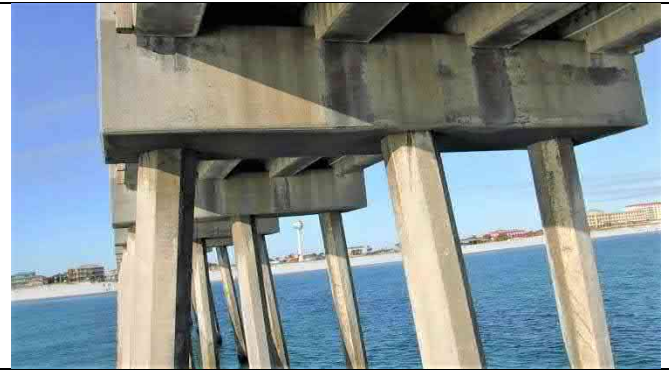
Bent 44E – Pile 44-2 top spall 20"x2"x1", Pile spall repair damage 3x4~4"x4"x1"

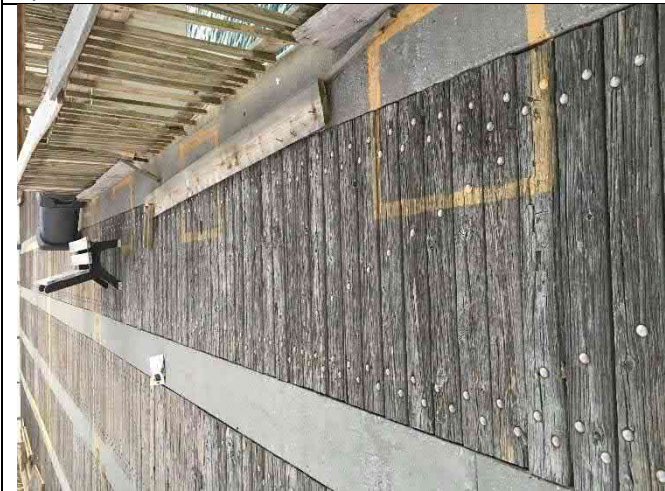
Span 45E – Railing damage

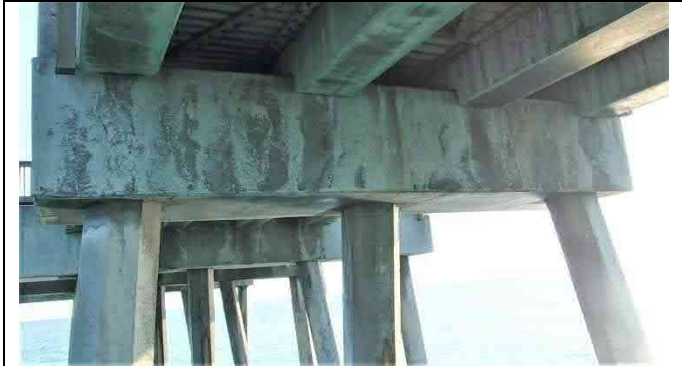
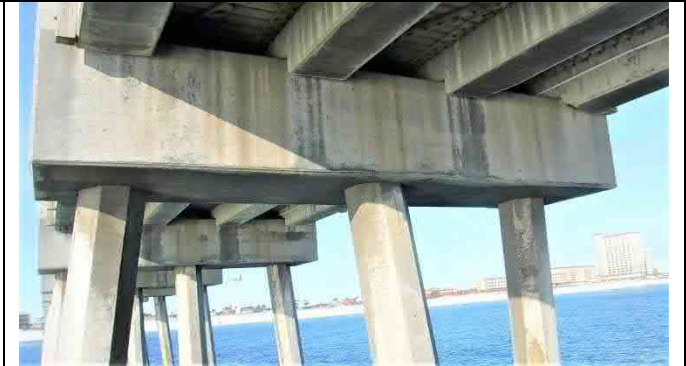
<p>Bent 45 North Face</p>	<p>Bent 45 South Face – Beam 45-1 north end cracking and spall 24"x6"x3"</p>

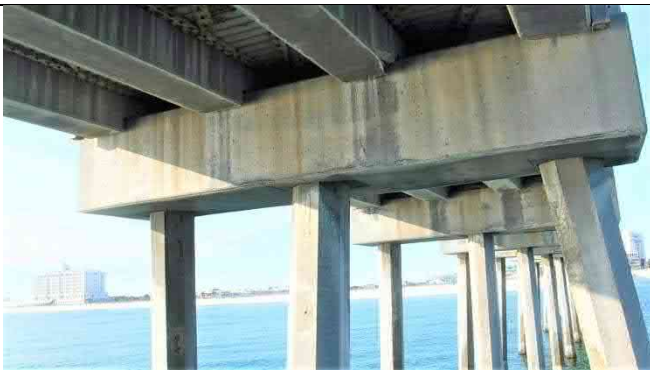
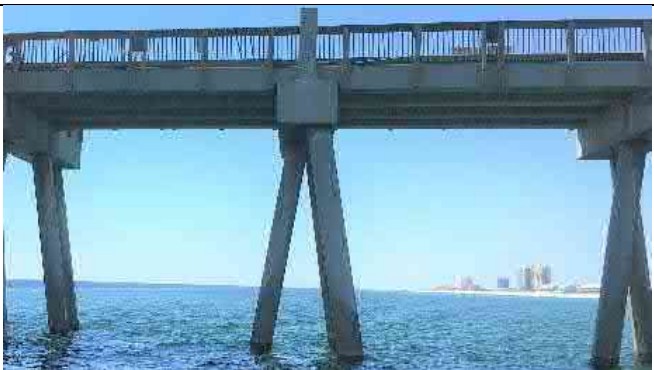
<p>Bent 45 South Face – Beam 45-2 north end cracking, delamination and spall 24"x24"x6", Pile 45-3 spall 10"x8"x1"</p>	<p>Bent 45E</p>

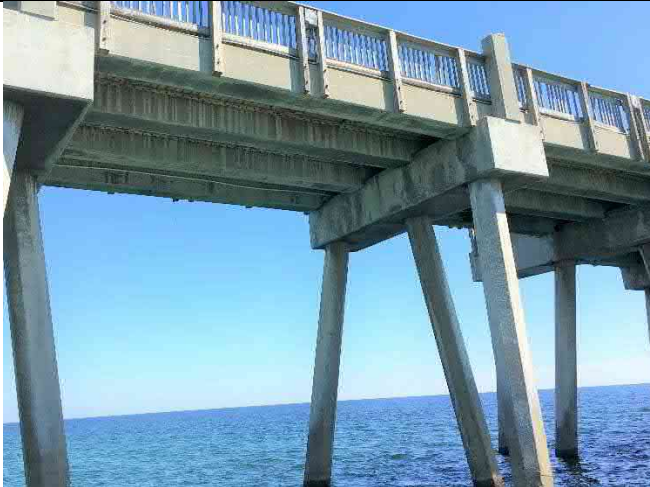
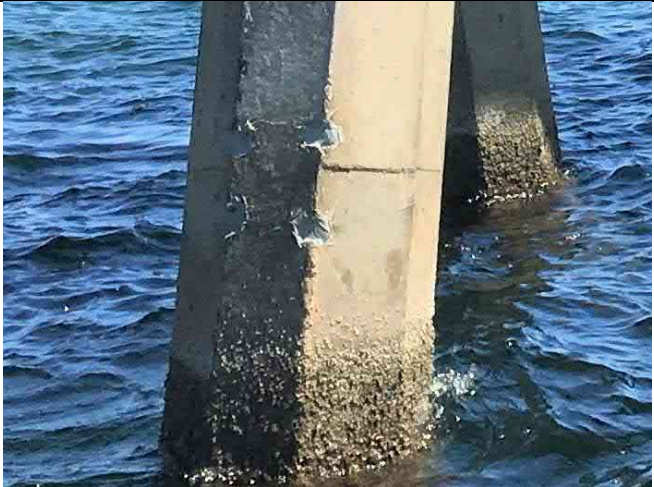
<p>Bent 45W – Beam 44-1 south end cracking, delamination, and spall 24"x6"x4"</p>	<p>Pile 45-3 – Pile spall repairs damaged all piles 3x4~4"x4"x1"</p>

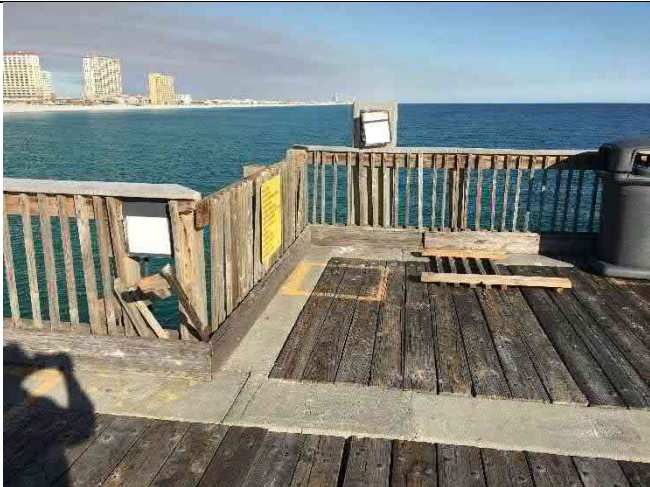
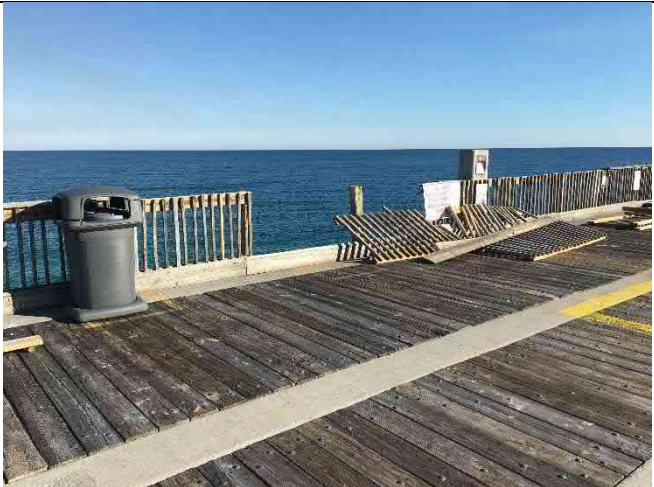
<p>Bent 46E – Railing, deck and sign damage</p>	<p>Span 46E – Railing damage</p>

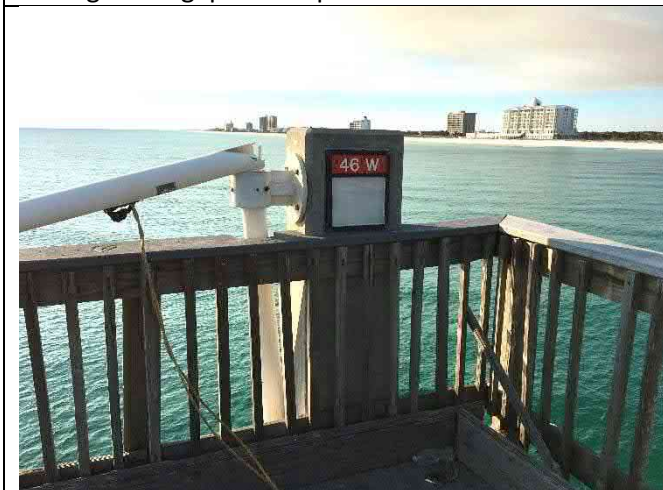
Bent 46W – Broken flagpole, railing damage
