# **Preliminary Engineering Assessment (PEA)**

## **Pensacola Beach Gulf Pier**

Escambia County, FL

April 5, 2021

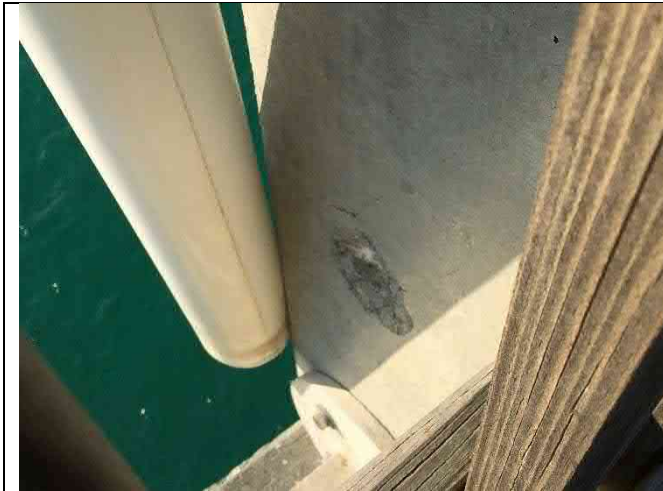
Bent 46W – Light pole column spall 5"x5"x1"

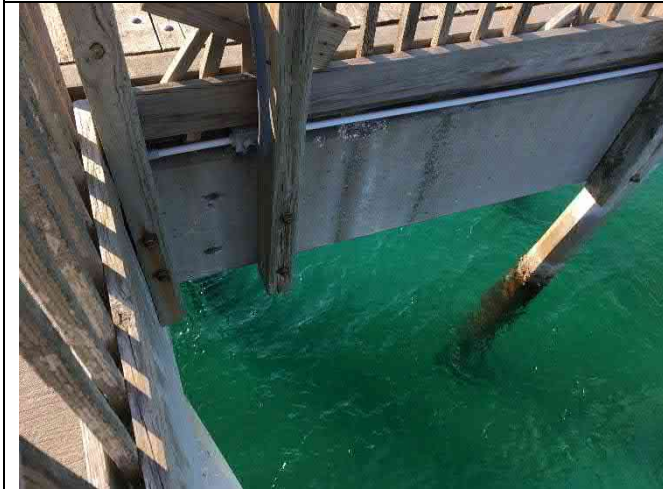
Bent 46E – Beam 45-1 spalls 2~3"x3"x2", spall 12"x3"x2" top flange

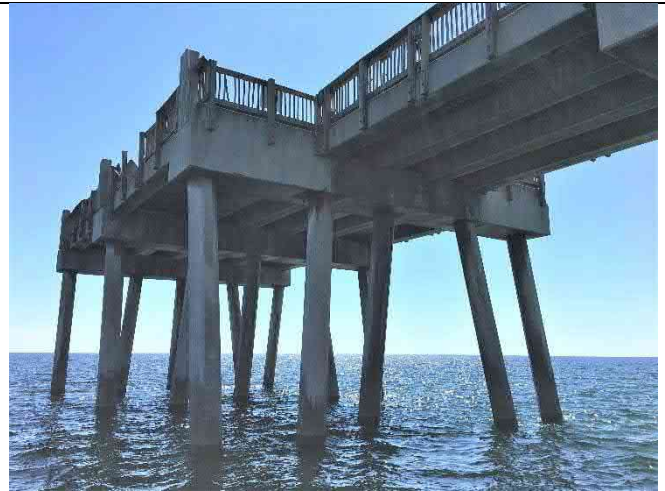
Bent 46E North Face – Pile 46-2 top spall 6"x6"x1"

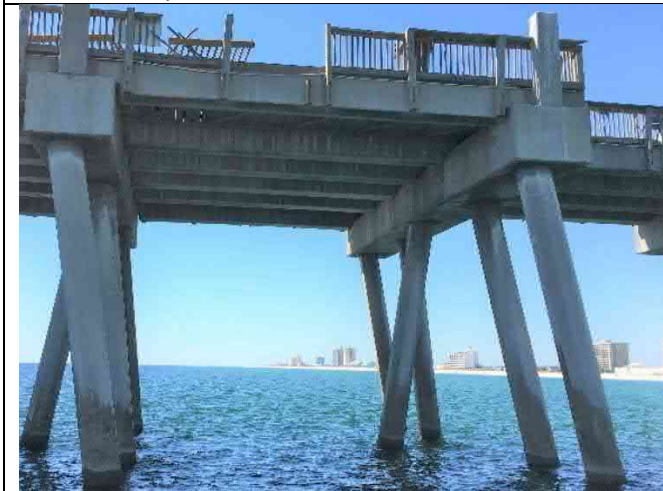
Bent 46E South Face – Pile spall repairs damaged 5x4~4"x4"x1"

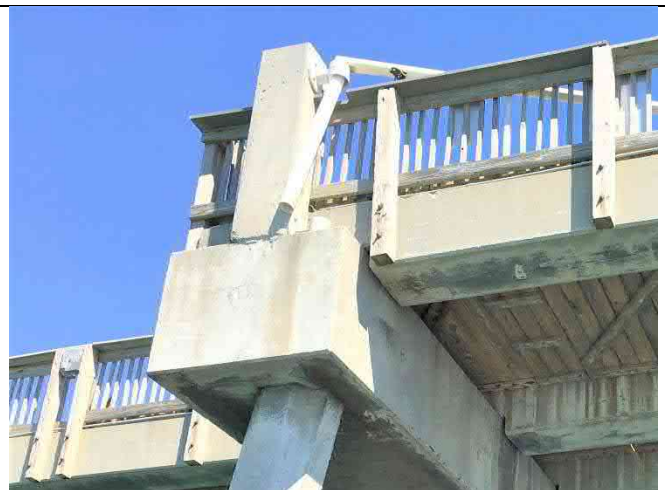
Bent 46W – Flagpole broke during storm

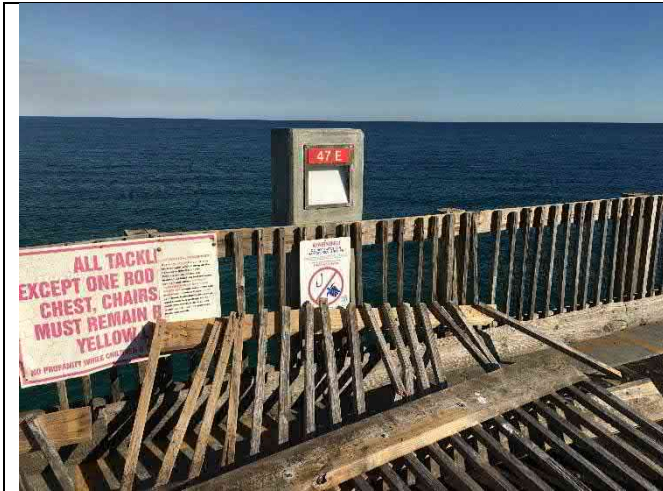
Bent 47E – Railing damage

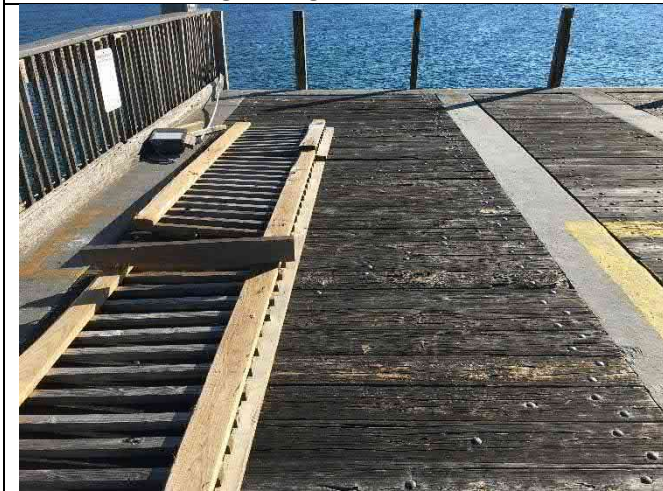
Span 47E – Deck and railing damage

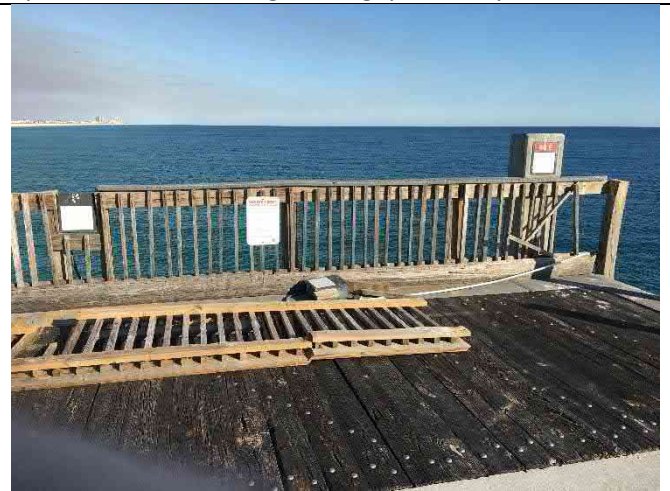
Span 47E - Deck and railing damage

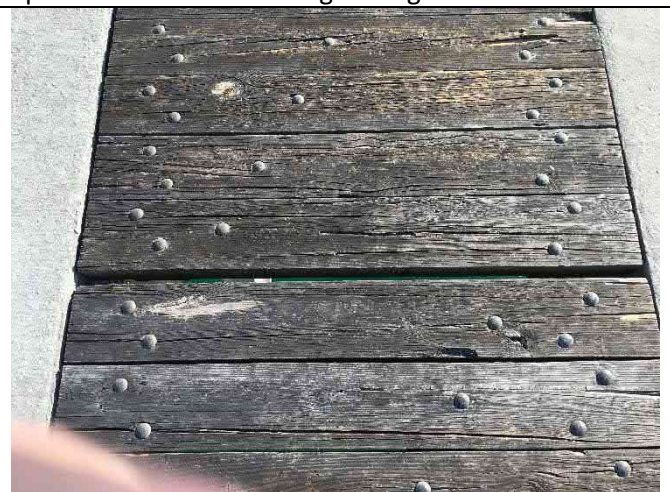
Span 47 – Deck damage with gaps and dips > 0.5"

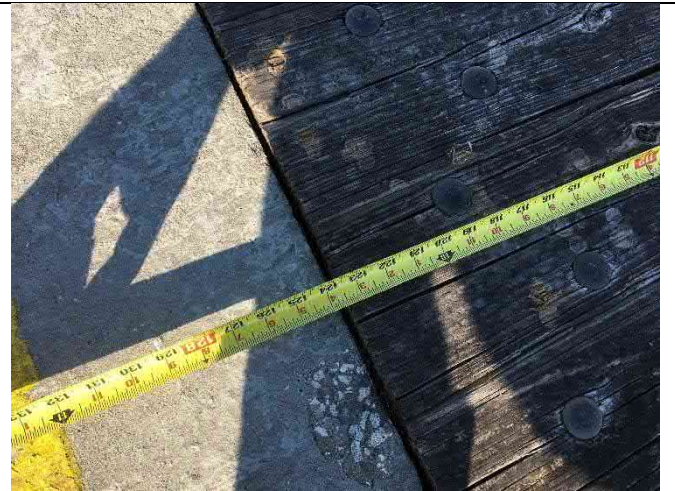
Beam 74-2 – Top flange spall 4"x2"x1"

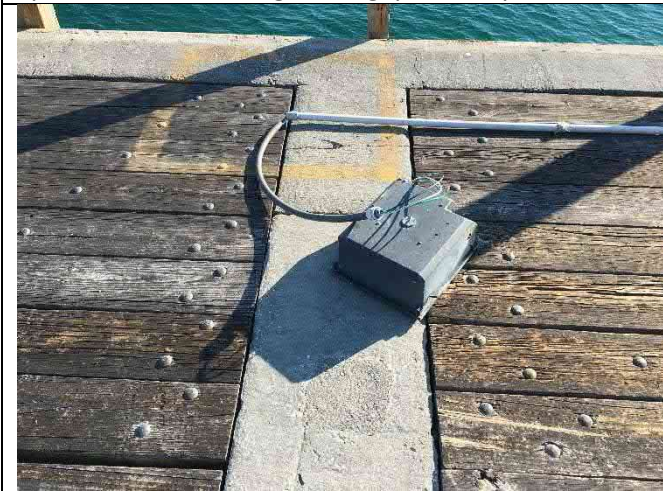
Span 47 – Lighting damage (common full length)

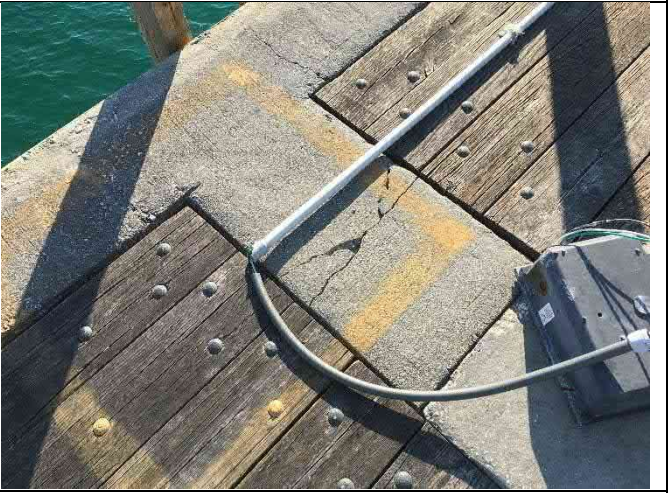
Bent 48 – Closure cracking	Bent 48 – Closure cracking

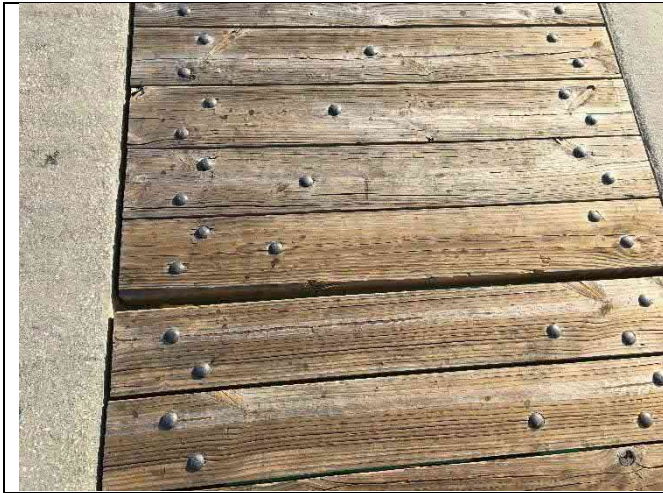
Span 47 – Deck damage with gaps and dips > 0.5"

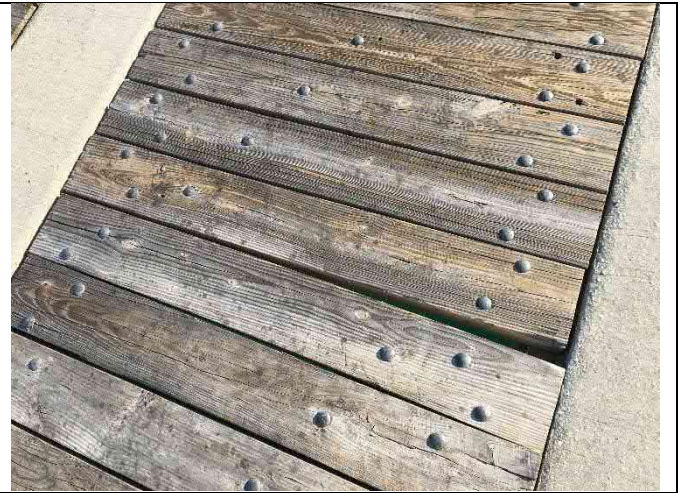
Span 47 – Deck damage with gaps and dips > 0.5"

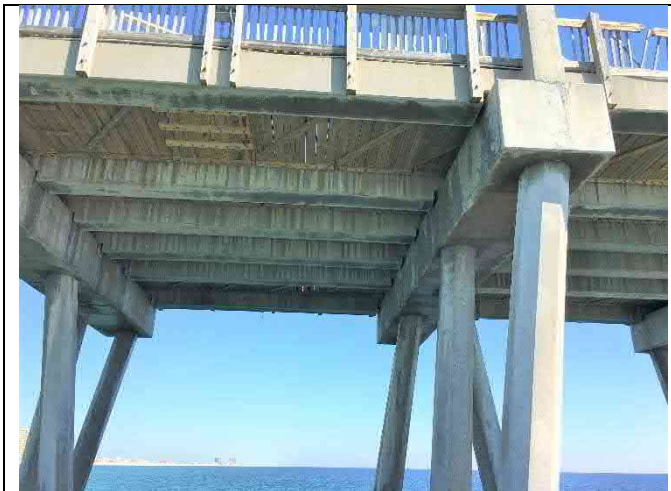
<p>Bent 47E</p>	<p>Bent 47E – Pile spall repairs damaged 5x4~4"x4"x1"</p>

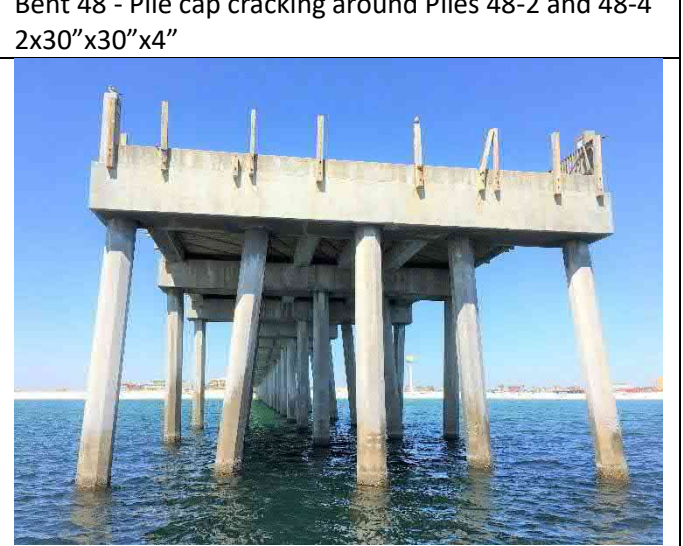
Bent 48 – Beams 47-3, 47-4, 47-5, 47-6 south end cracking, delamination, and spalls 4x24"x12"x3"	Bent 48 - Pile cap cracking around Piles 48-2 and 48-4 2x30"x30"x4"

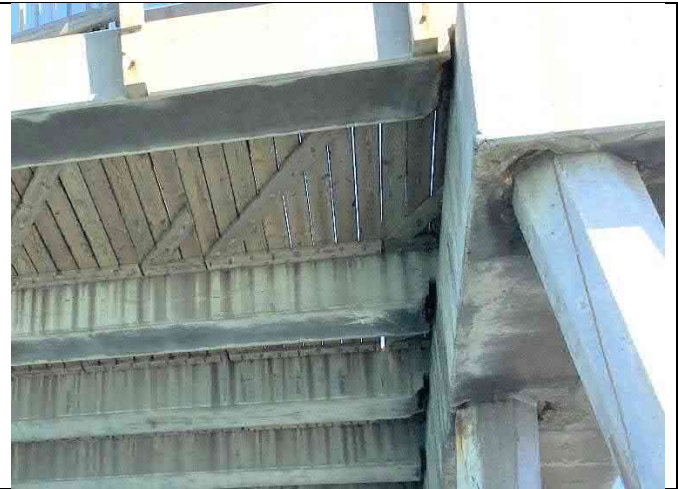
Bent 48 – Pile spall repairs damaged 5x4~4"x4"x1"

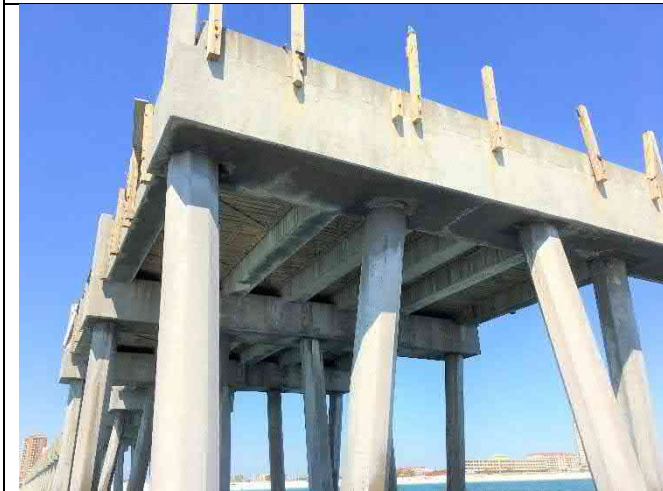
Bent 48W – Beams 48-3, 48-4, 48-5, 48-6 south end cracking, delamination, and spalls 4x24"x12"x3", Pile cap spall around Pile 48-5 30"x30"x4"
